Gesellschaft für
Reaktorsicherheit (GRS) mbH

Safety Assessment of the Nuclear Power Plant Greifswald, Units 1 to 4

A Documentation of Hitherto Existing Investigations
made by GRS

GRS-78 (February 1991)
ISBN 3 - 923875 - 28 - 2

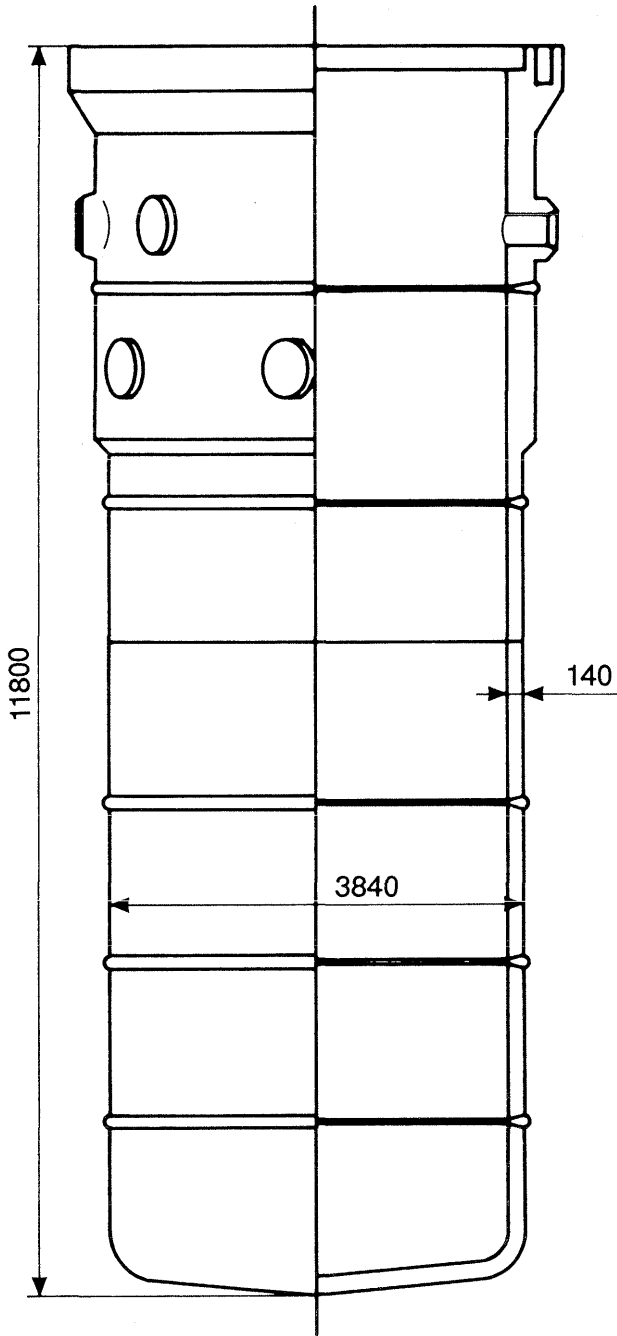
Figure 3-1 Reactor pressure vessel WVER-440 [DOE 87]

On the unplated inner surfaces of the RPVs corrosion was detected during former periodic inspections. The reason for this damage was declared to be unconditioned, oxygen-saturated water in connection with boric acid during longer shut-down periods. The corrosion pittings had a diameter of a coin and a depth of up to 7 mm and were all removed by grinding. After grinding, flaws were not detected.

The results of the last periodic inspections showed that the RPV has no flaws according to the magnetic powder method and no supplementary corrosion attack. Isolated indications of the ultrasonic test in the connecting welds of the belts were not long (20 to 40 mm).

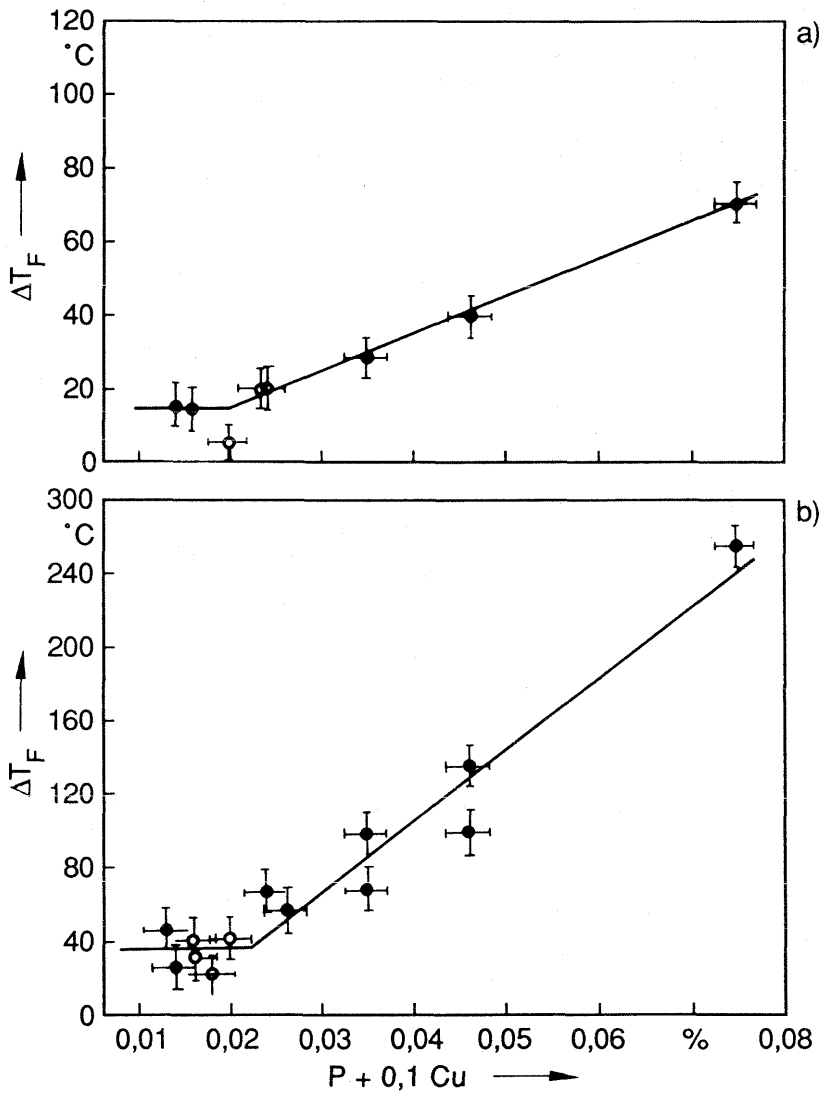
Fig. 3-2: Shift of the transition temperature of brittle fracture

- The values obtained for the brittle fracture transition temperature of the regions close to the core (weld, basis material) at the beginning of operation and now are given in table 3-2. When assessing values for the shift of the transition temperature of brittle fracture, it is necessary to make a supplementary assessment of eventual uncertainty bands on the basis of our actual knowledge. In this way, lack of information about the fraction of copper and phosphorus in the material of the regions concerned of the pressure vessel can be overcome by taking samples, as has been done already for unit 1. New results (cf. figure 3-2) and new understanding which indicate an increase of

- In total, it can be expected that the transition temperature to brittle fracture is below the operation temperature of 265°C for all RPVs in normal operation.

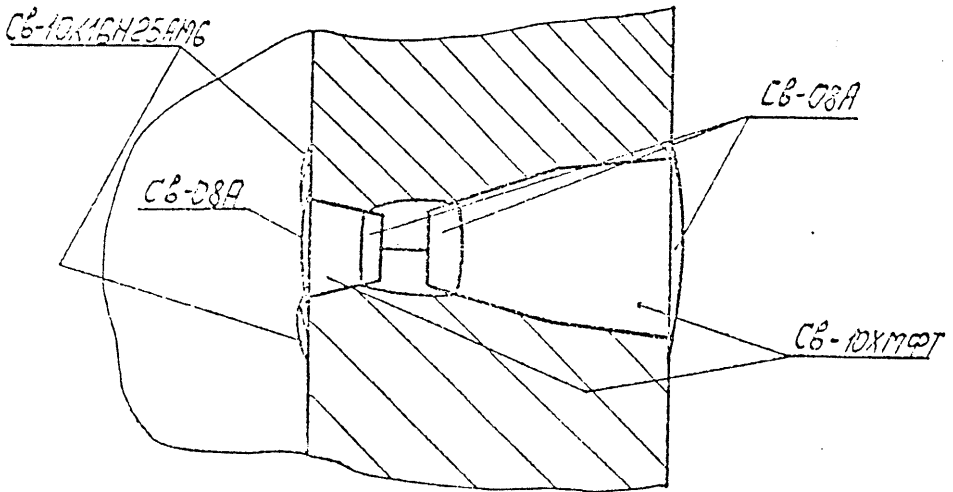
Nord, Blöcke 3,4, Blatt 11

In NPP Nord, units 3 and 4, the weld and basis material touch each other

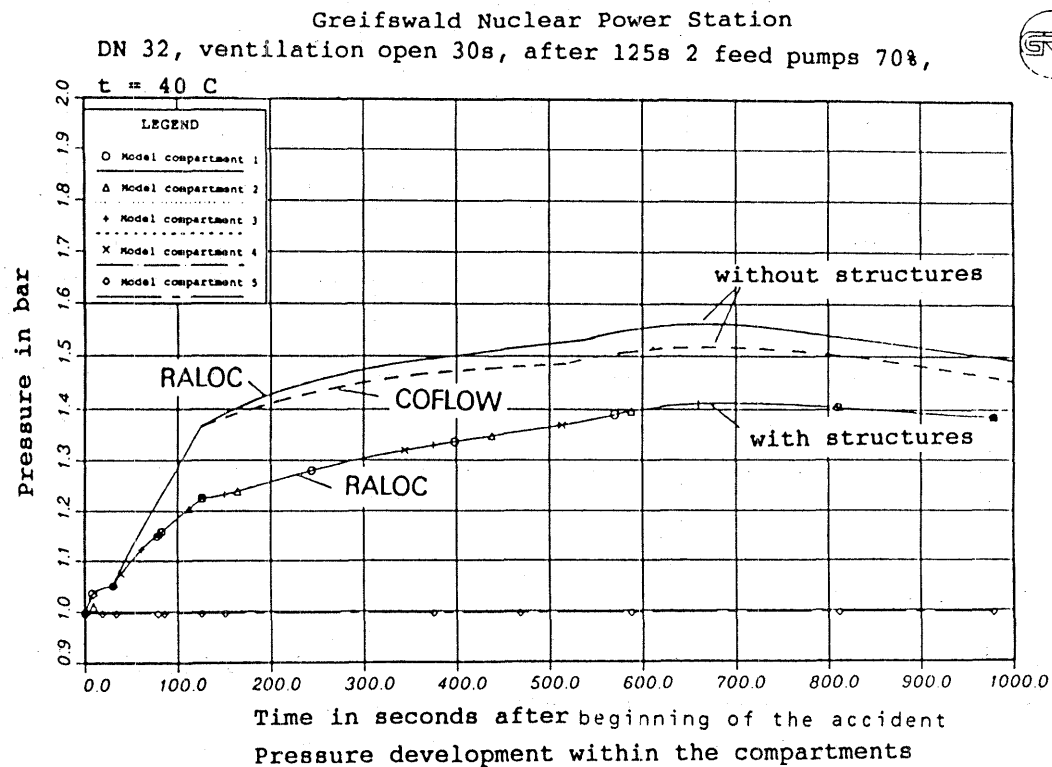
Fig. 6-3:
Calculation for the design basis accident

Fig. 6-3 shows the pressure time history within the pressure resistant compartment system under the aforementioned conditions; the upper curve shows the calculation without and the lower curve the pressure development with consideration of the heat removal into the steel and concrete structures of the pressure resistant compartment system. This provides confirmation of the statement in chapter 6.1.3 according to which in the design basis accident

(leak equivalent to nominal diameter 32) no response of the dampers takes place. The calculation without heat conductive structures, which is conservative with respect to the pressure development, is confirmed by comparison with the programme COFLOW (see Fig. 6-3).

If only one spray water cooler is available, the spray water flow rate is reduced from 155.5 to 145.6 kg/sec, and the spray water is increased from 40°C to 50°C. In this case (Fig. 6-4) the pressure within the pressure resistant compartment system remains below the operating pressure of the dampers. The removal of heat into the structures was taken into consideration here (see the lower curve in Fig. 6-3).

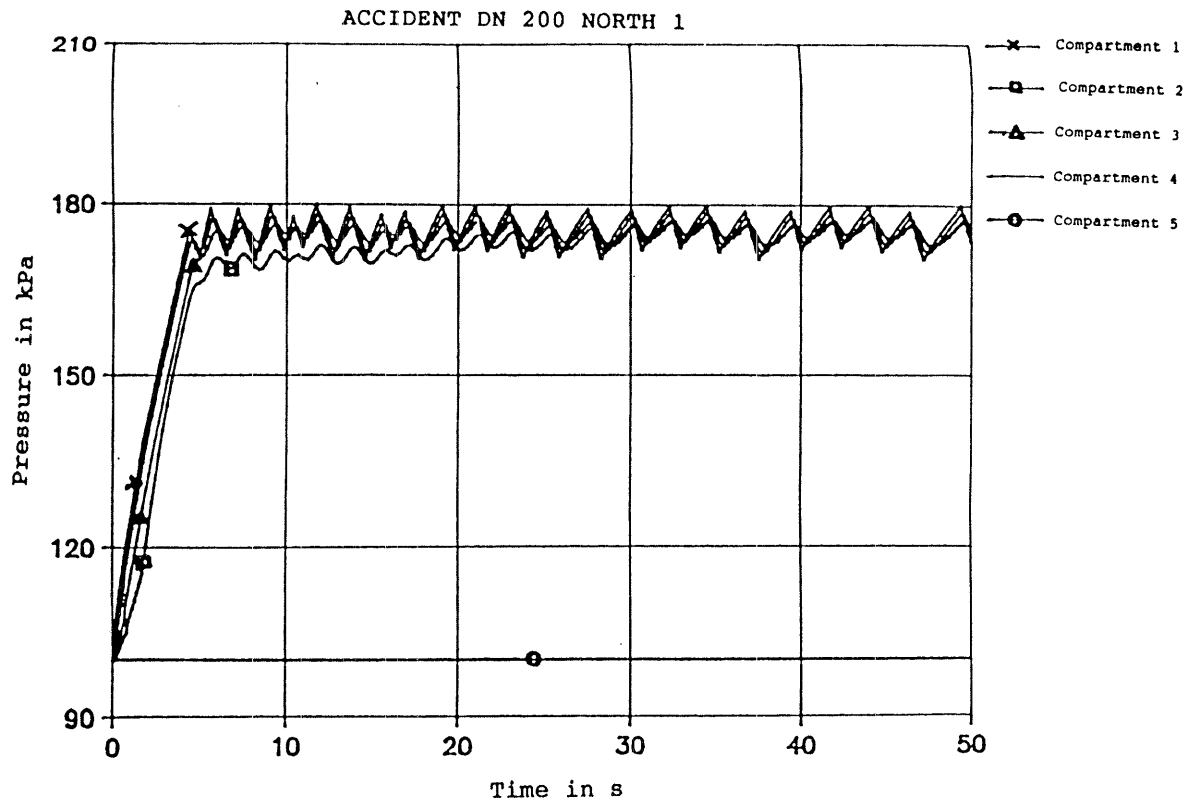
Fig 6-7:
Investigations concerning the damper function using BRACO.

The comparison with the pressure development determined using BRACO (from /6/, Fig. 6-7) shows the clear reduction in the frequency of opening of the dampers. As time passes, the amplitude and frequency of oscillation decrease, but in the case of the RALOC results, due to the consideration of mass (inertia) of the damper, an over-swing beyond the opening pressure of the large damper of 1.8 bar can nevertheless be observed. The markedly lower opening frequency, which becomes evident in a realistic simulation, should mean a higher degree of reliability in the operation, especially the closing function, of the dampers.
