Gesellschaft für Anlagenund Reaktorsicherheit (GRS) mbH

The Accident and the Safety of RBMK-Reactors

February 1996

GRS - 121

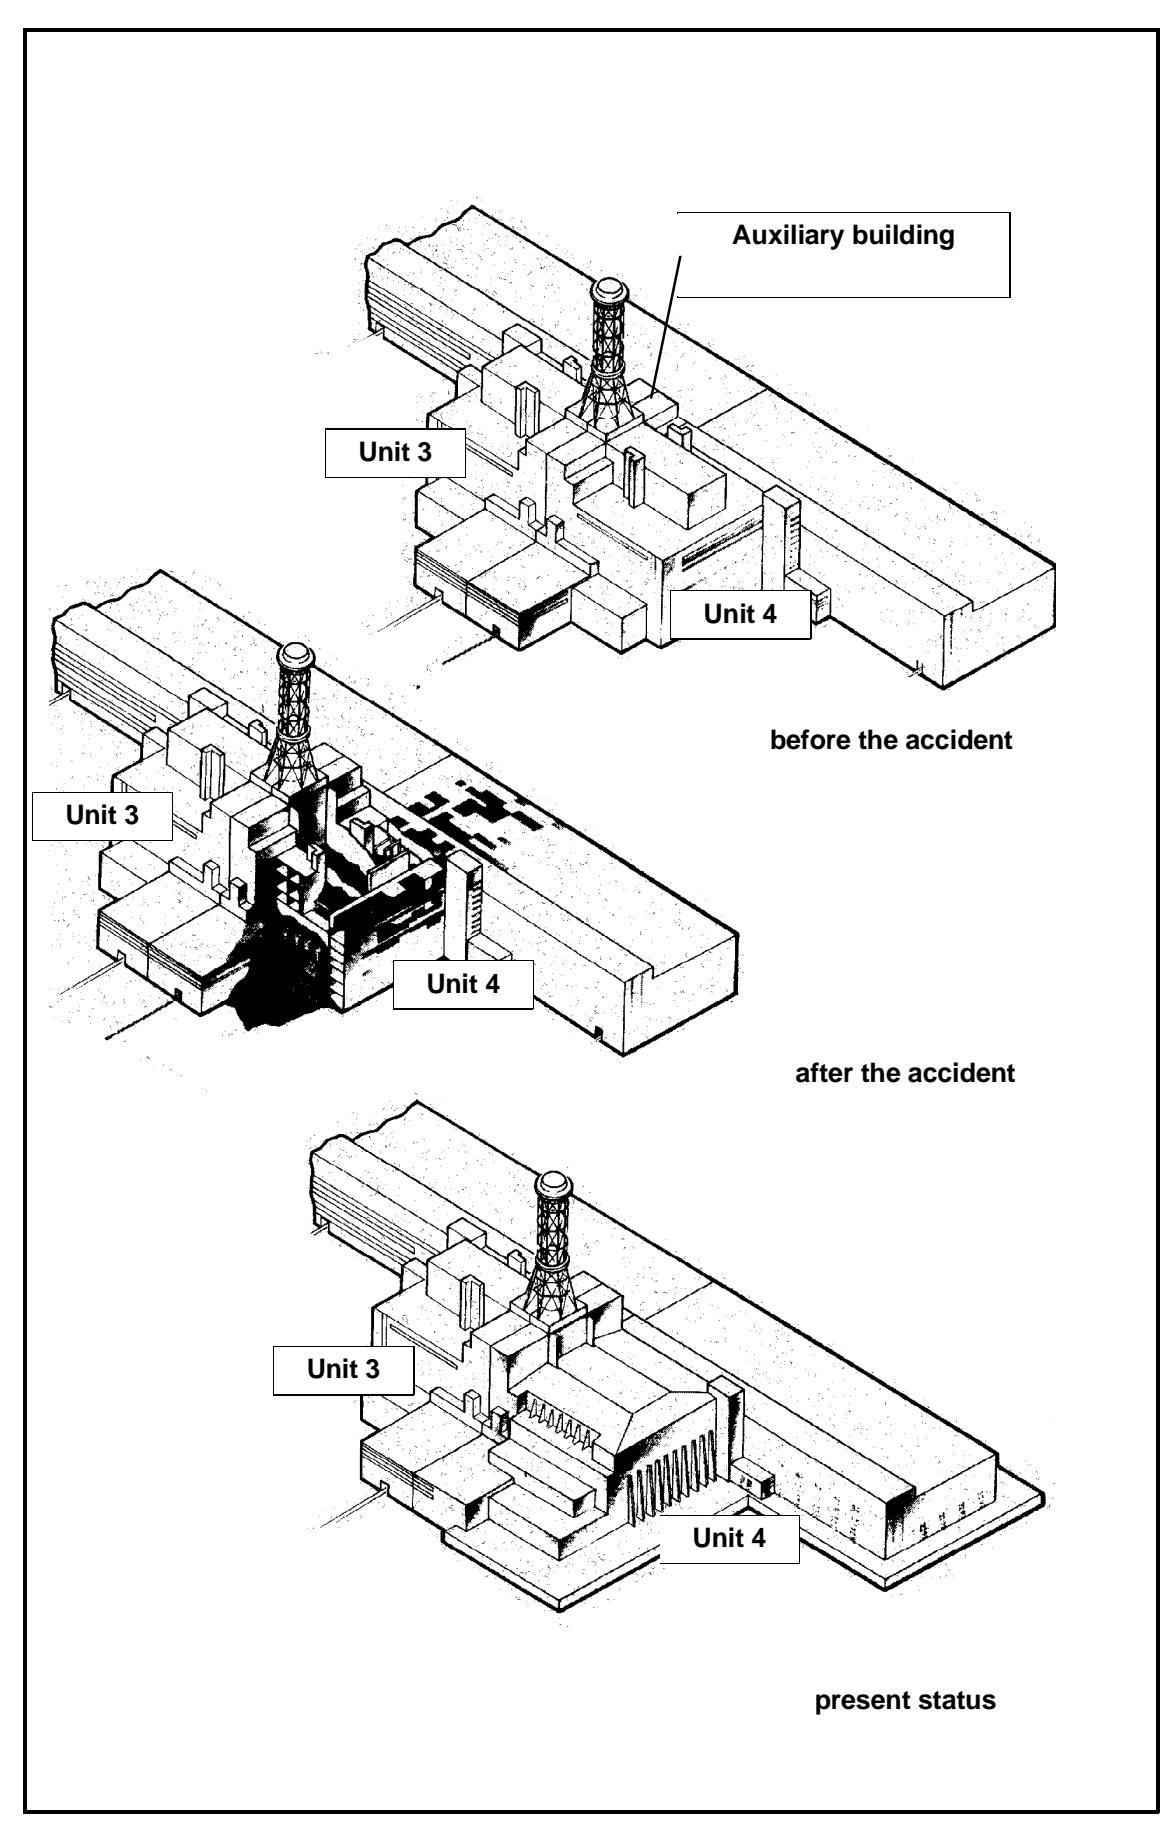
Fig. 1-4 Diagrammatic view of Unit 4 at Chernobyl before and after the accident

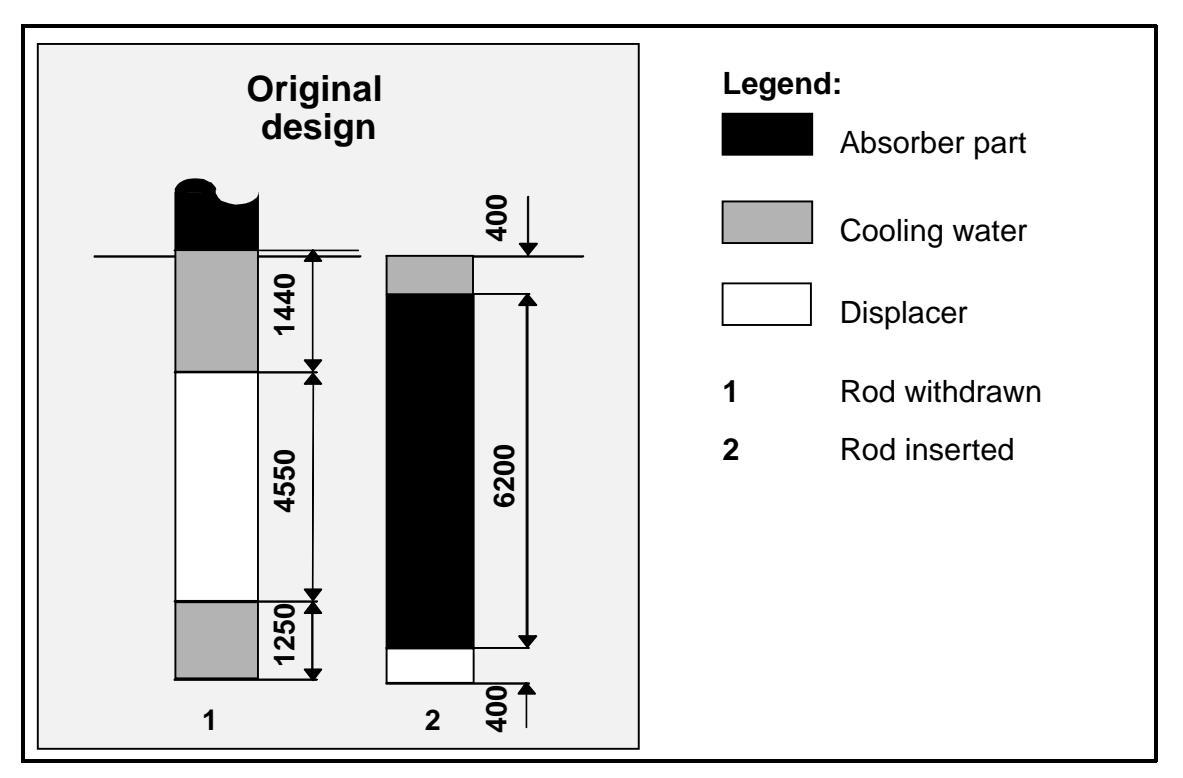
Fig. 1-17 Original design of the control and shutdown system of RBMK plants

One special feature of RBMK plants prior to the accident was a positive reactivity effect of the shutdown system. When the control rod is completely withdrawn, the displacement part is approx. in the centre of the reactor core. Above and below the displacement part the control rod channel is filled by water columns. If a control rod is inserted into the core from this position, the (neutron moderating) displacement part of graphite replaces the lower (neutron absorbing) water column. Thus the opposite of the intended effect is attained at first: The reactor power is not reduced by the admission of negative reactivity, but it is increased by a positive reactivity admission in the lower part of the core. The positive reactivity effect caused by the insertion of completely withdrawn control rods is also called "positive shutdown effect".

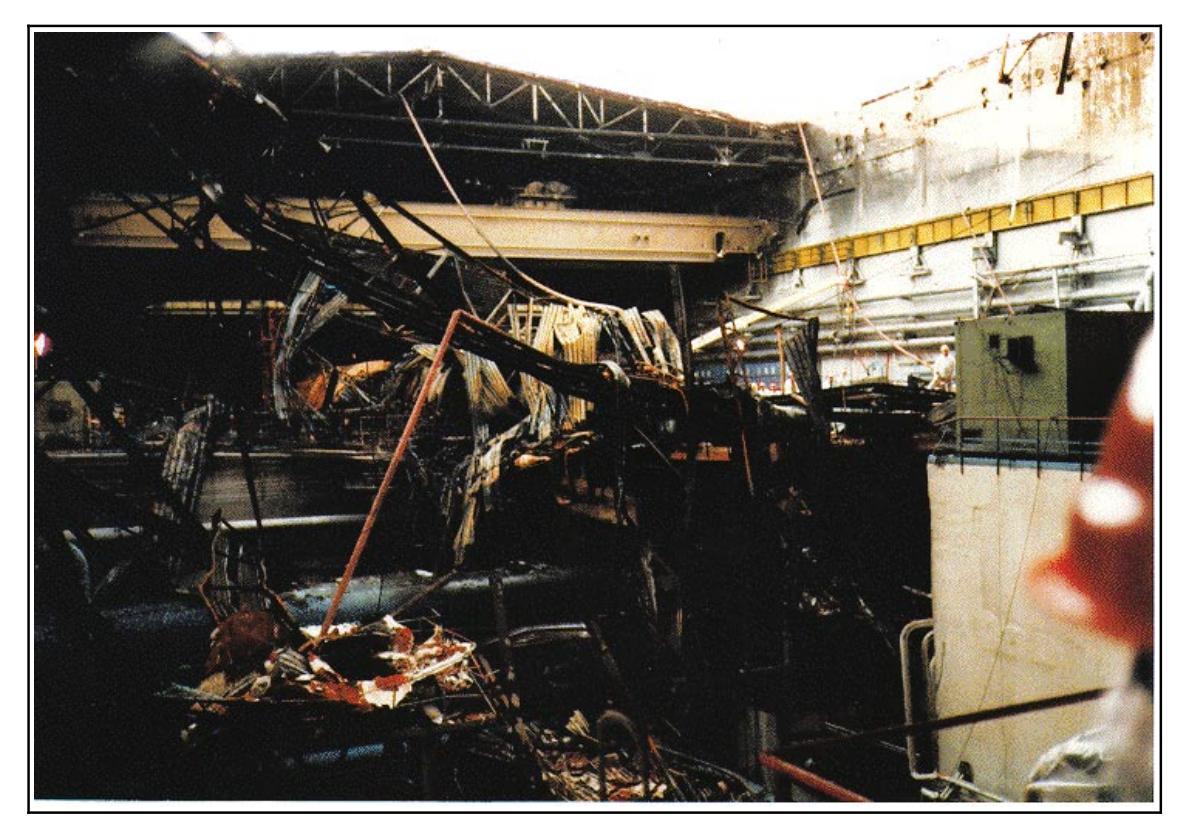
The main feedwater and emergency feedwater pumps had only slightly been damaged. Nevertheless, many tubes as well as the process control and electrotechnical parts have to be replaced completely.

Fig. 1-21 The fire in the turbine hall of Unit 2 at Chernobyl caused substantial damage

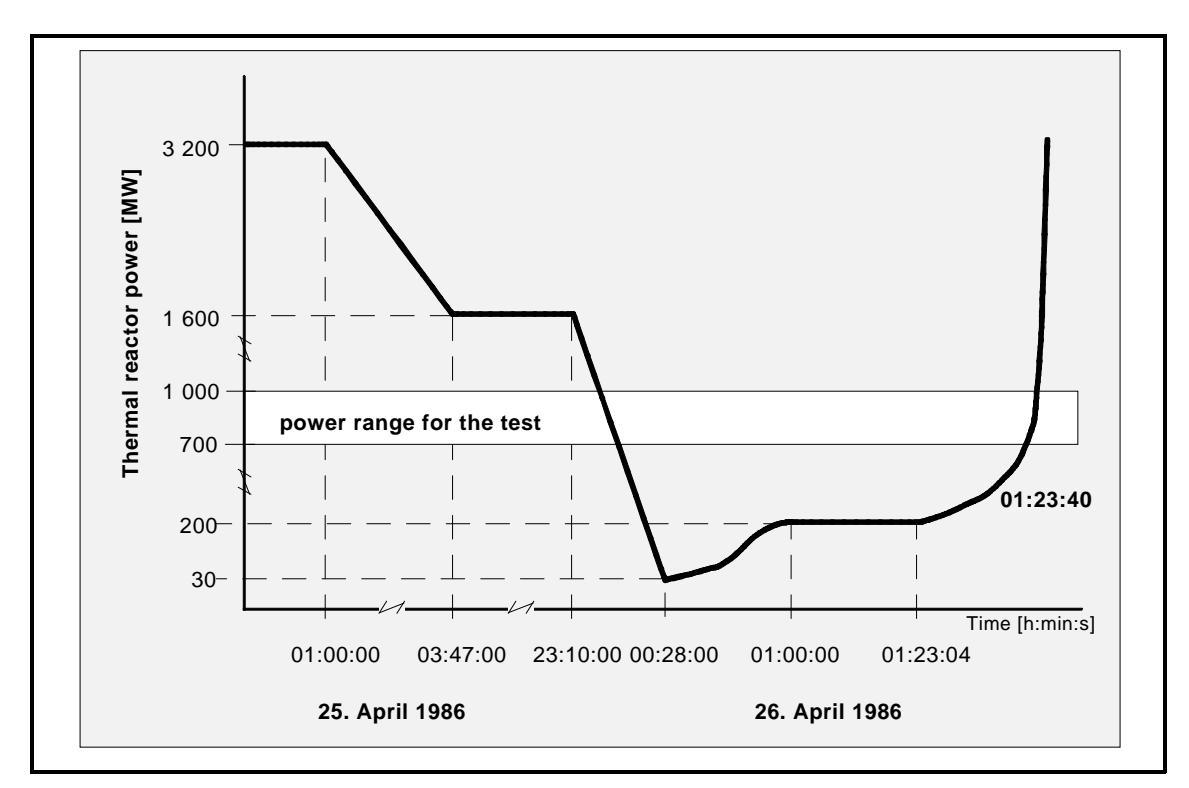
- About 40 minutes prior to the start of the test, at 0:43 h an important signal which would have led to an automatic emergency shutdown of the reactor upon initiation of the test, was rendered ineffective to be able to possibly repeat the test.

Fig. 2-1 Simplified sequence of the reactor power before the accident

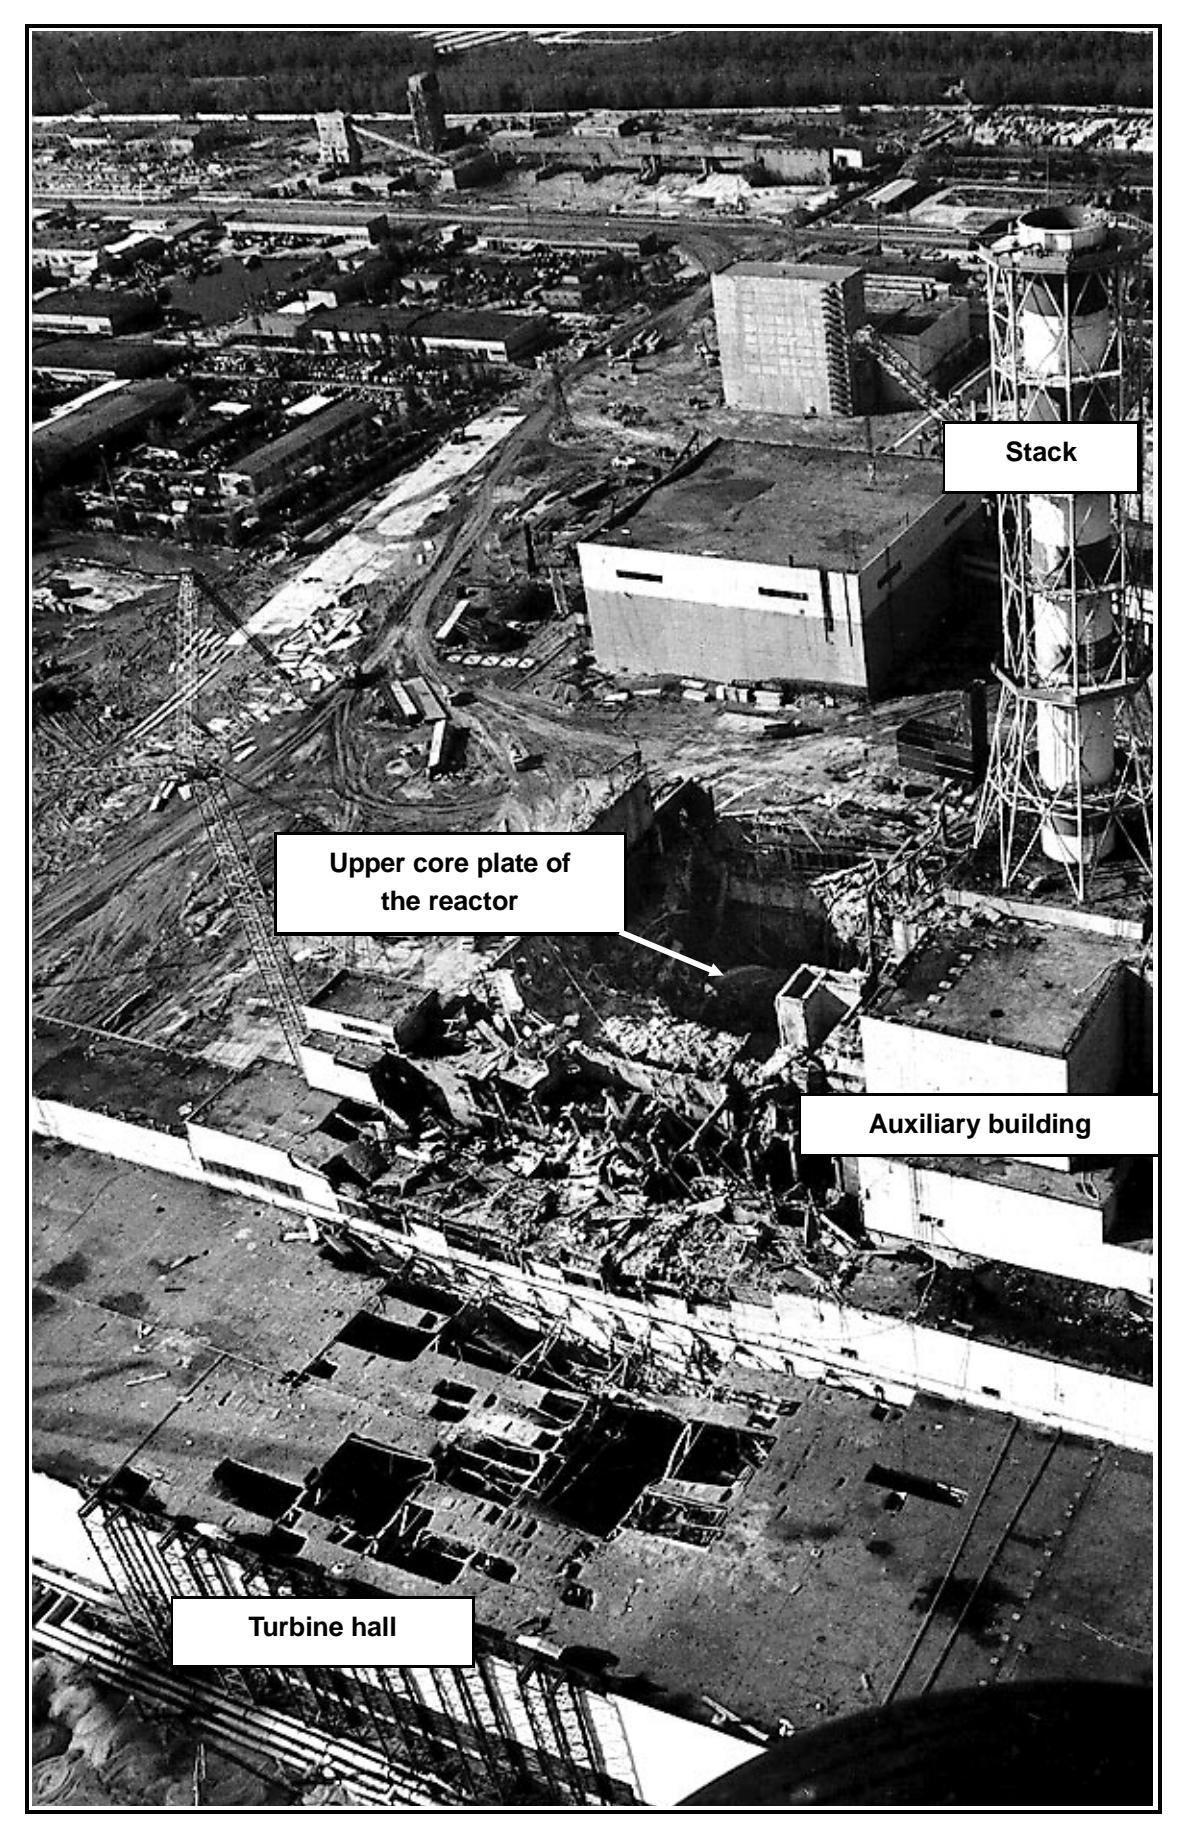
The expolsion destroyed large parts of the reactor building of Unit 4, the turbine hall as well as of the connecting building. The walls of the reactor hall were partially destroyed and the roof was destroyed completely. There were displacements in the drum separator compartments and the walls were damaged. The compartments with drives of the main coolant pumps were completely or partially destroyed. In contrast thereto, the hermetically closed compartments of the main coolant pumps remained intakt. The upper horizontal plate of the reactor ("Structure E") having a weight of approx. 3000 tons was raised and now stands at an angle of 15°. The lower supporting structures of the reactor vessel (Structure OR") lowered by approx. 4 m and crushed the connecting lines to the individual pressure tubes located below (Fig. 3-3 and 1-9). The south-eastern quadrant of the "Structure OR" as well as the emergency core cooling in the north-eastern part of the reactor building were destroyed completely. The reactor shaft in which the reactor was located is practically empty. A large proportion of the nuclear fuel was ejected into the reactor hall and is now below the original reactor position as solidified lava.

Fig. 3-1 Extent of destruction of Unit 4 at Chernobyl

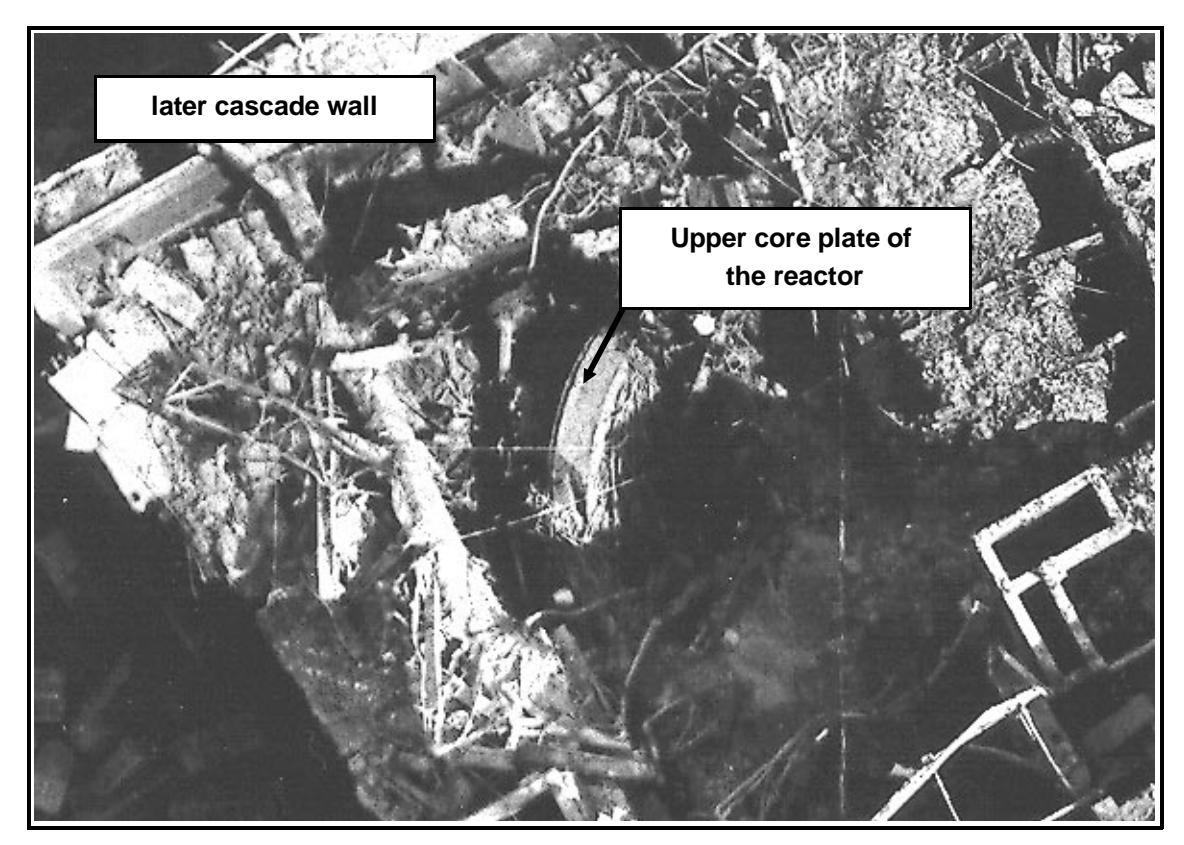
- **Fig. 3-2** View through the destroyed roof into the reactor hall. The upper core plate of the reactor (weight approx. 3 000 tons) was raised by the explosion and now stands at an angle of 15°.

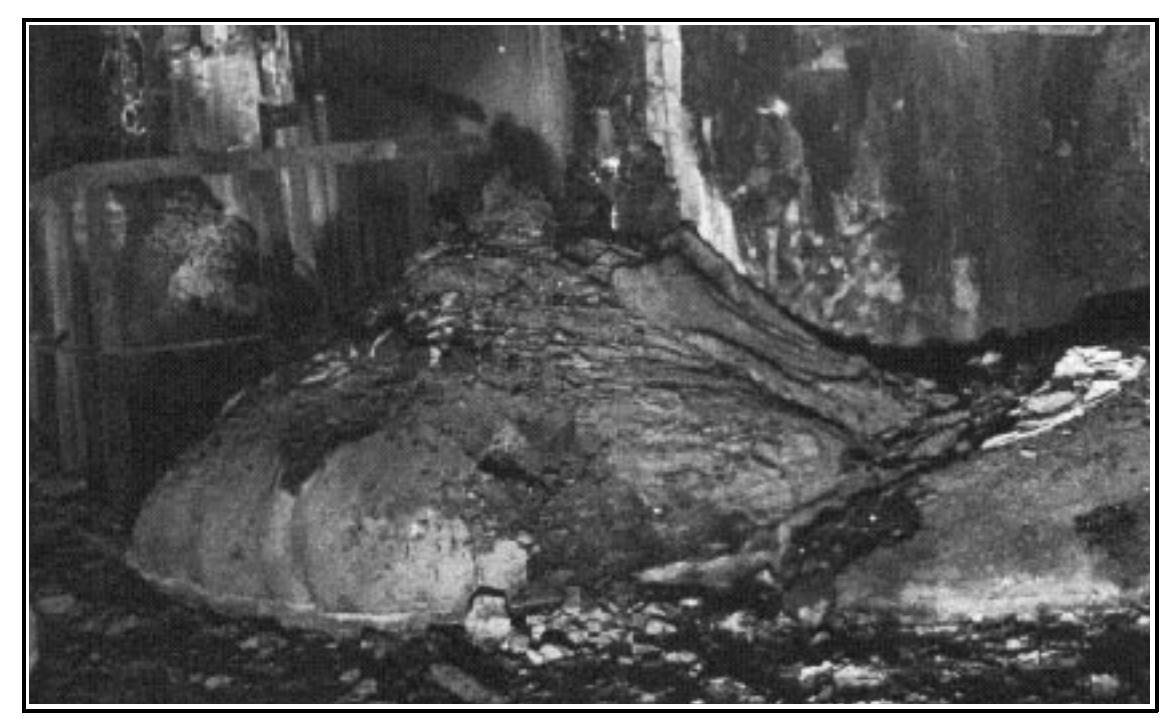
Fig. 4-7 "Elephant foot" having a diameter of about 2 m formed of molten fuel and sand

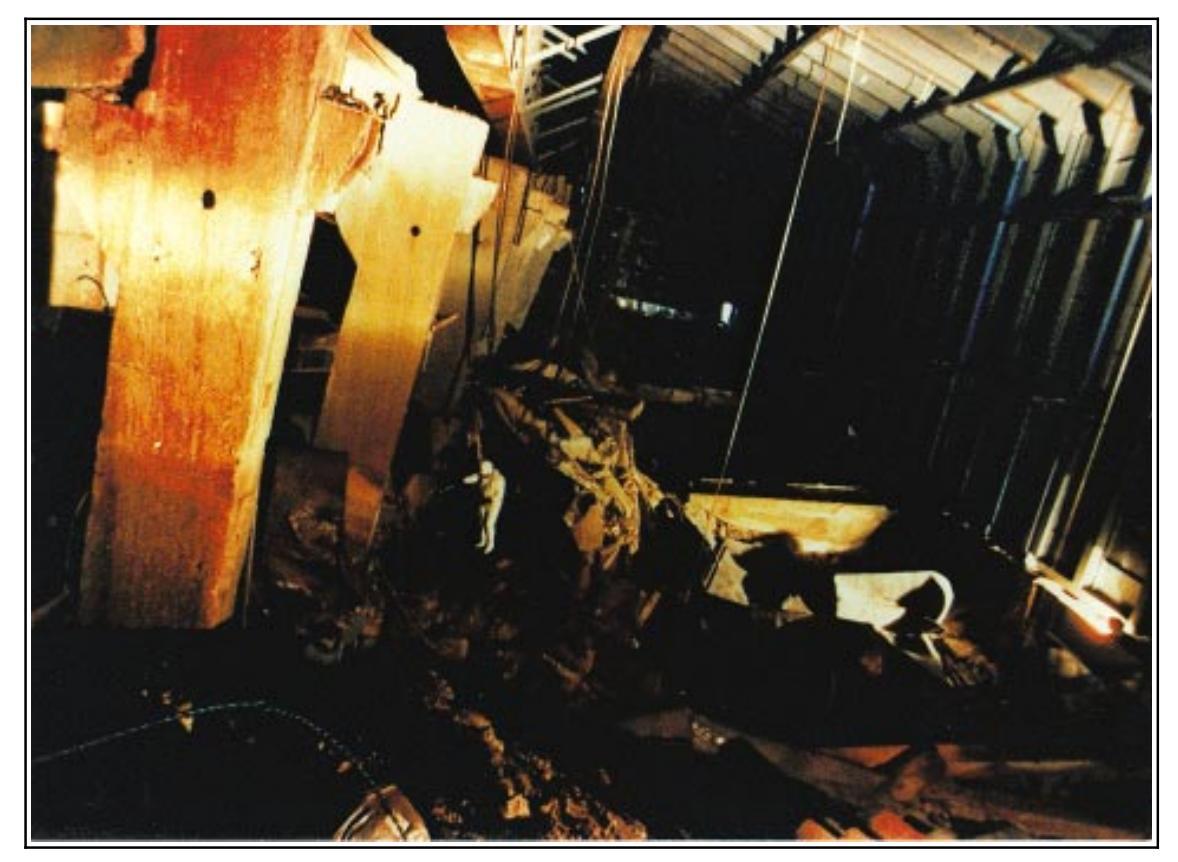
Fig. 4-9 Inside the Sarcophagus: supports twisted out of their position can be seen on the left. The southern external cover of the Sarcophagus can be seen on the right.
