**Final Evaluation of
the Project “Thermal
Simulation of Drift
Emplacement“
(TSDE-Project)**

Final Report

November 2003

GRS - 194
ISBN 3-931995-62-3

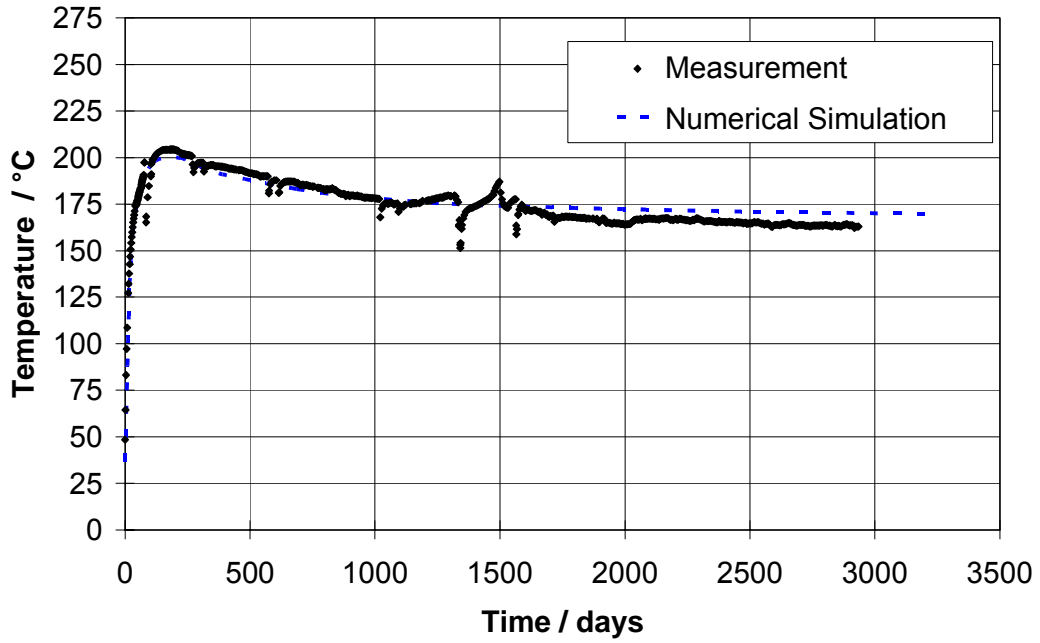
Fig. 1.3 Temperature increase at the central heater cask surface

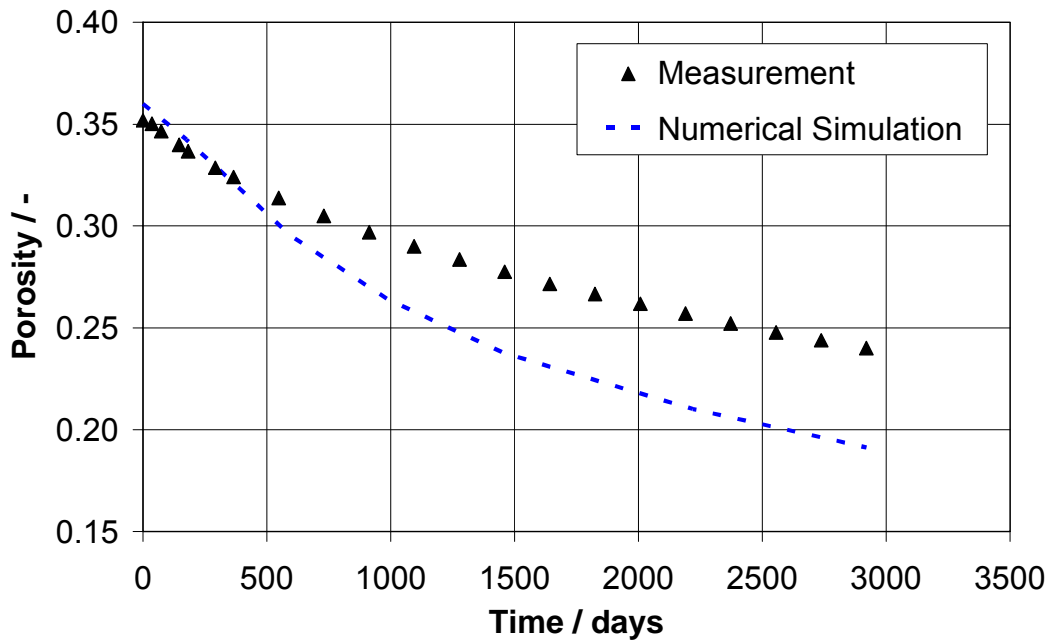
Fig. 1.4 Development of backfill porosity

The measured and calculated /PUD 98/ decrease of backfill porosity is shown in Figure 1.4. The comparison indicates an overestimation of backfill compaction in the warmer central part of the test field thus suggesting a stiffer backfill behaviour *in situ* compared to laboratory experiments on the basis of which constitutive equations and material parameters have been developed. But due to early instrument failure in the central heater area, convergence measuring data were only available from the peripheral heaters. Thus, only these values could be compared with the predictive calculations which had been performed for the central heater area.

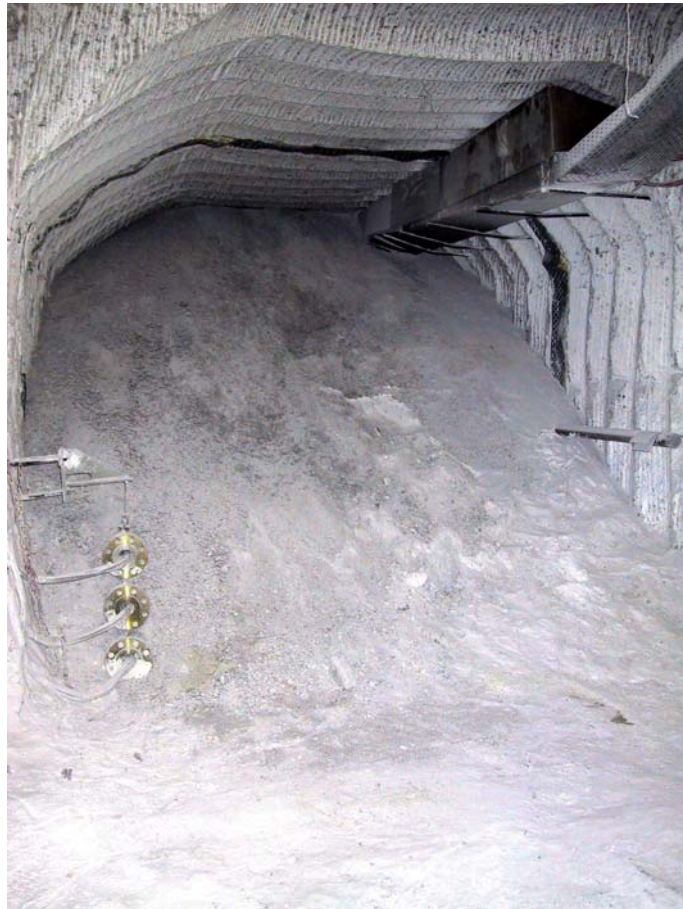
To confirm the grain segregation assumption, the grain size distribution of the undisturbed, non-heated backfill from the slope at the entrance of drift A, which had not been compacted, was analyzed (Fig. 4.1.6).

Fig. 4.1.6 Backfill slope at the entrance of drift A

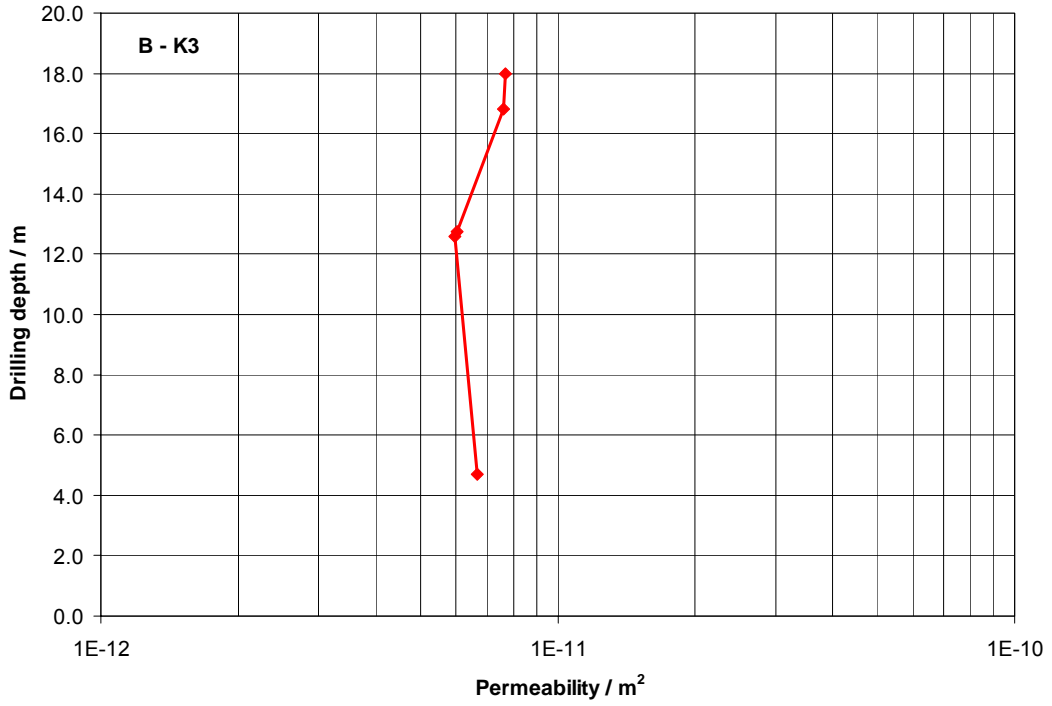
In cored borehole K3, permeability remains rather constant at about 7E-12 m² along the borehole length from the non-heated backfill to the heated area (Fig. 4.1.14). Though a little low, this permeability value is in good agreement with the permeabilities observed at the other sampling cross sections at the same drift height of 2.89 m.

Fig. 4.1.14 Permeability distribution in cored borehole K3

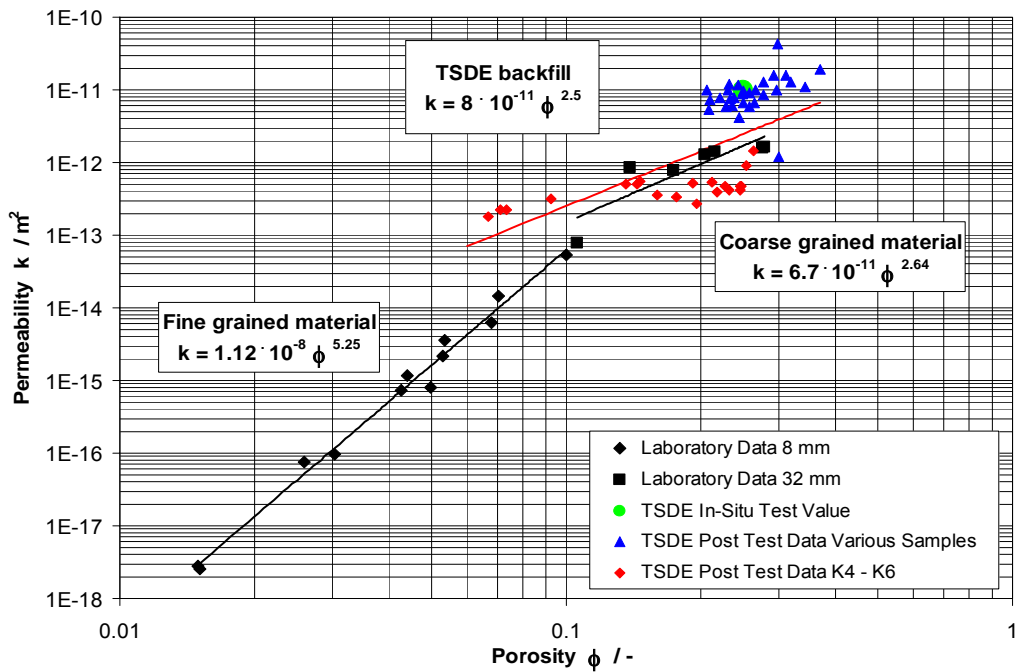
Fig. 4.1.20 Comparison of the permeability of the TSDE backfill samples with data from other investigations performed on Asse backfill

In Figure 4.1.20, these results are compared with previous tests on backfill samples and *in-situ* data /ROT 01/. It can be seen that the permeability values obtained on the large core samples K4 to K6 are 5 to 10 times lower than those determined in previous tests and *in situ* at the same porosity values. However, these permeability values are comparable with the results obtained on coarse grained crushed salt with grain sizes less than 32 mm. By fitting all data of the TSDE backfill, a permeability – porosity relation of $k = 8E-11 \cdot \Phi^{2.5}$ was determined.

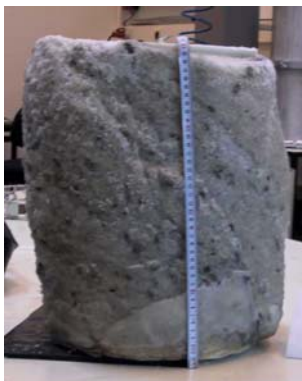
K4-1

$\sigma_a - \sigma_r = (18.7 - 4)$ MPa
shear damage

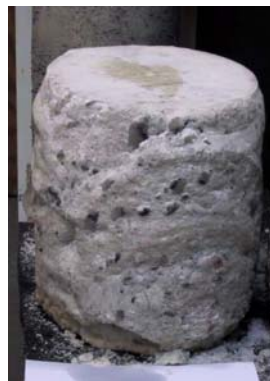
K5-1

$\sigma_a - \sigma_r = (20 - 4)$ MPa
shear damage

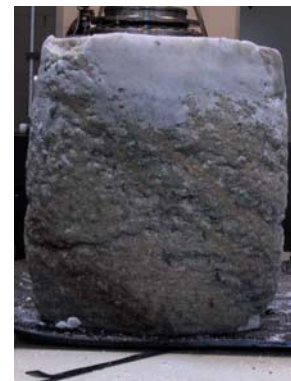
K6-3

$\sigma_a - \sigma_r = (58.4 - 10)$ MPa
no shear damage

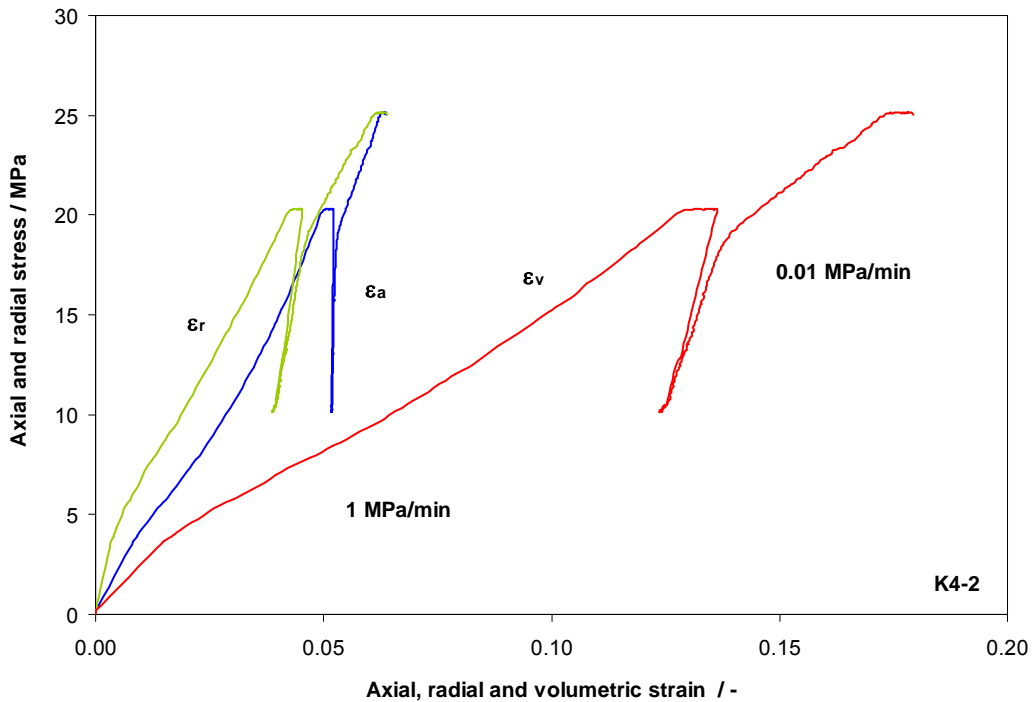
Fig. 4.2.2 Hydrostatic compaction behaviour of backfill sample K4-2

Figures 4.2.2 and 4.2.3 illustrate the stress – strain curves ($\sigma_a = \sigma_r - \varepsilon_a / - \varepsilon_r / - \varepsilon_v$) of the tests K4-2 and K5-2. Figure 4.2.4 gives the porosity as a function of mean stress ($\phi - \sigma_m$), also including the data of the hydrostatic compaction part of the test K6-3.

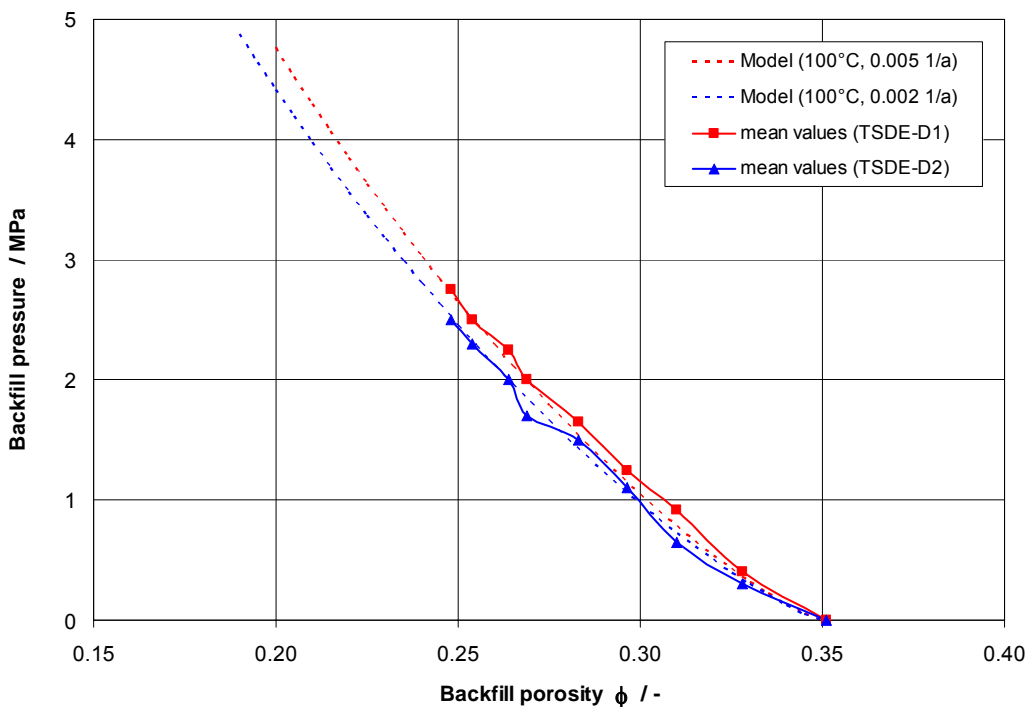
The associated compaction parameters were determined by fitting the test data: $A = 6E8 \text{ s}^{-1}$, $Q = 156 \text{ kJ/mole}$, $n = 12$, $m = 15$. The Q -value was chosen directly from the oedometric tests on crushed salt with grain sizes less than 32 mm /ZHA 01/. The triaxial compression tests in the laboratory benchmark programme /ZHA 01/ indicated that the values of the parameters n , m and Q are not very dependent on the test type like oedometric or hydrostatic loading test. In the model calculation, an initial porosity of 0.30 and compaction rates of $2E-5$ and $2E-4 \text{ s}^{-1}$ were used. The compaction rates correspond to the average values of the volumetric strain rates applied by the stress rate of 1 MPa/min in the tests. Figure 4.2.4 shows a good agreement between model calculation and laboratory experiments. Using the parameters and average conditions from the test field (temperature = 100°C , compaction rates = $2E-3 \text{ a}^{-1}$ and $5E-3 \text{ a}^{-1}$, initial porosity = 0.35), the average compaction behaviour of the backfill was predicted. The calculation results coincide quite well with the *in-situ* measurements (Fig. 4.2.6).

Fig. 4.2.6 Comparison between measured and calculated backfill pressure as a function of average porosity

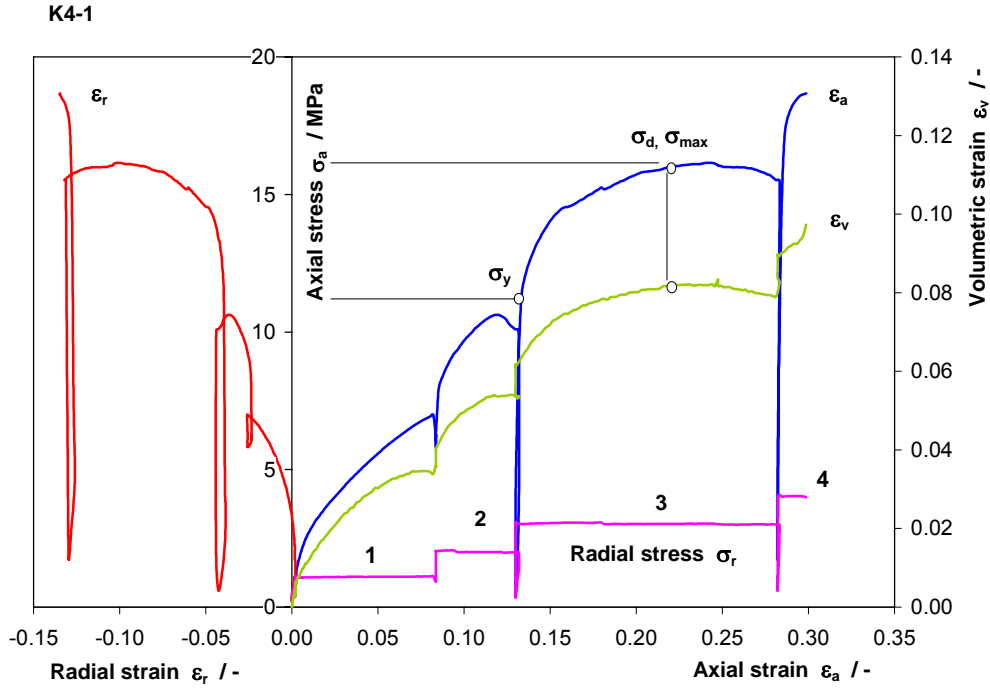
Fig. 4.2.7 Deviatoric stress - strain behaviour of backfill sample K4-1 under multi-failure compression

Figures 4.2.7 to 4.2.10 show the results of the four triaxial tests with axial stress – axial strain ($\sigma_a - \varepsilon_a$), axial stress – radial strain ($\sigma_a - \varepsilon_r$), radial stress – axial strain ($\sigma_r - \varepsilon_a$), and volumetric strain – axial strain ($\varepsilon_v - \varepsilon_a$). From the plots, the yield stress σ_y (elastic limit), the dilatancy point σ_d , the peak strength σ_{max} , and elastic parameters for each constant confining pressure can be taken (Fig. 4.2.7: Test K4-1). The following phenomena can be observed:

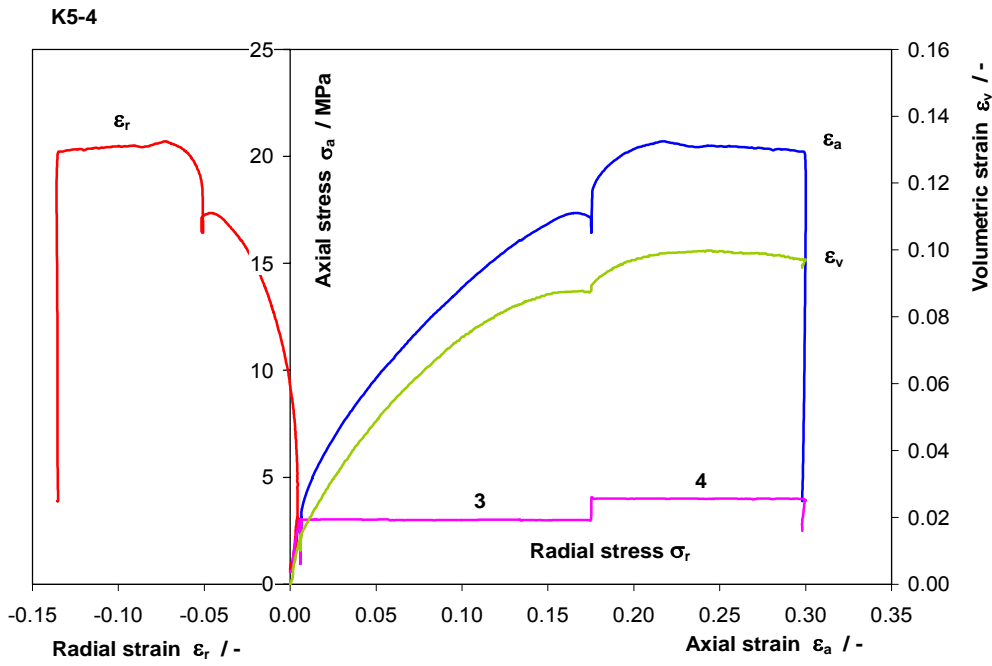
Fig. 4.2.9 Deviatoric stress - strain behaviour of backfill sample K5-4 under multi-failure compression

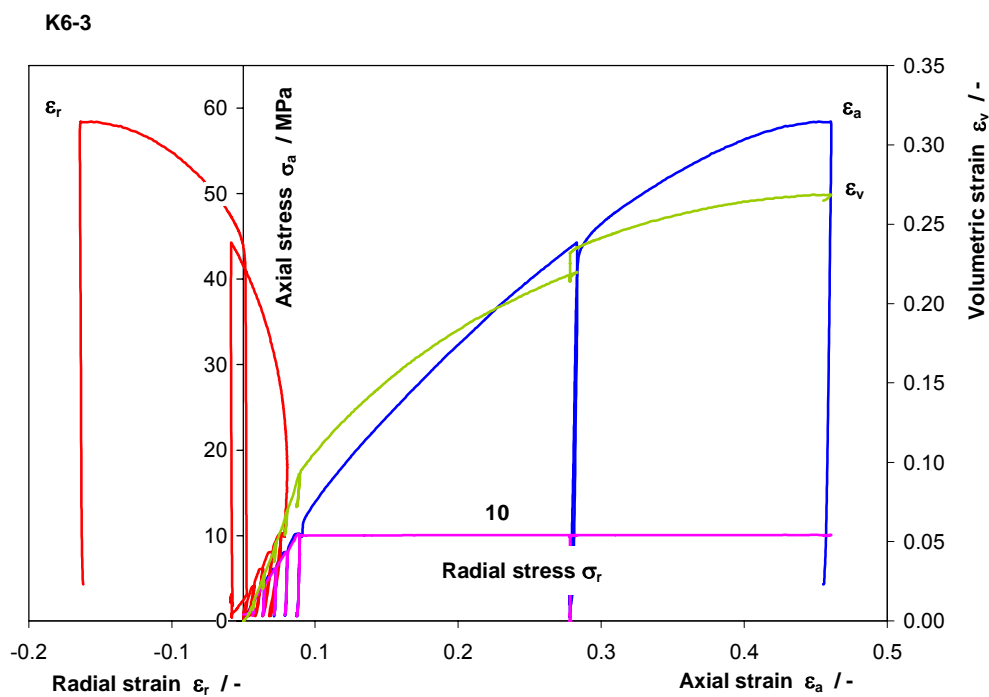
Fig. 4.2.10 Deviatoric stress - strain behaviour of backfill sample K6-3 under multi-failure compression

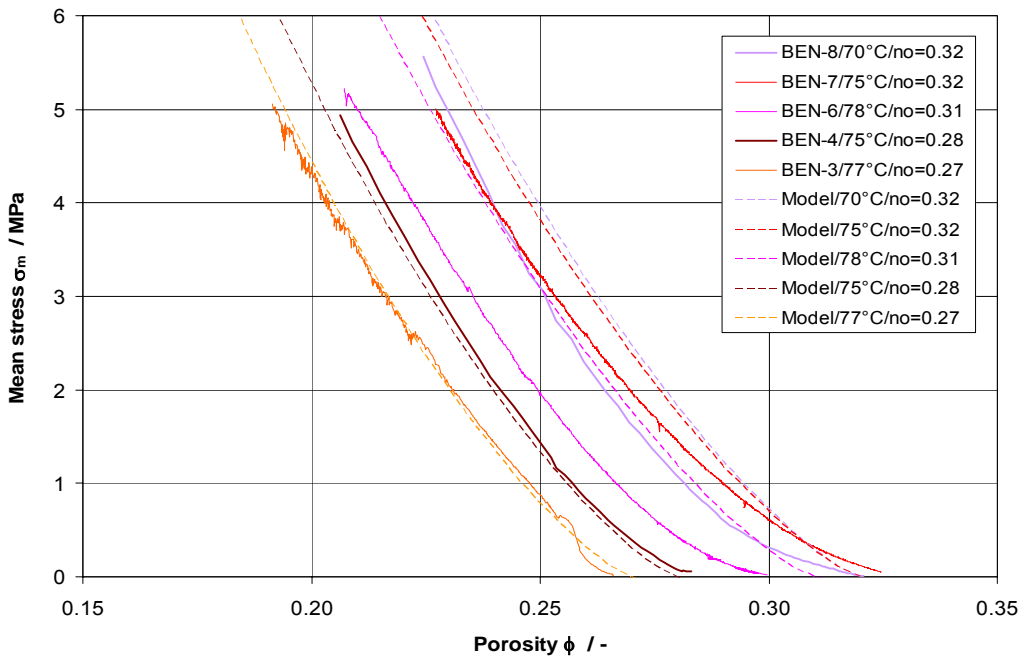
Fig. 4.3.19 Comparison between measured and calculated mean stress as function of porosity at elevated temperature

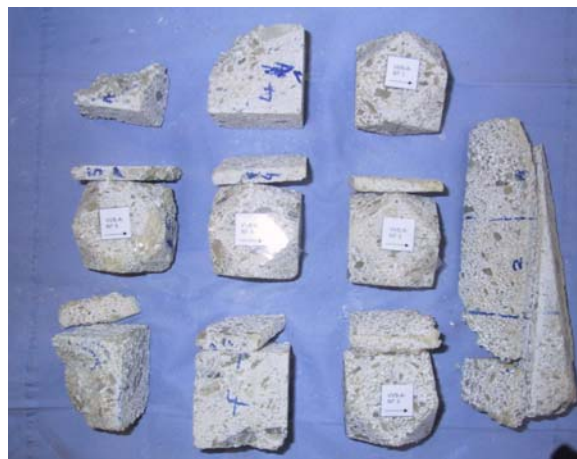
Fig. 4.4.2 Sample VVS-A-MI8. a: Identification of specimens. b: Prepared cubes for neutron texture analysis and slices for thin sections

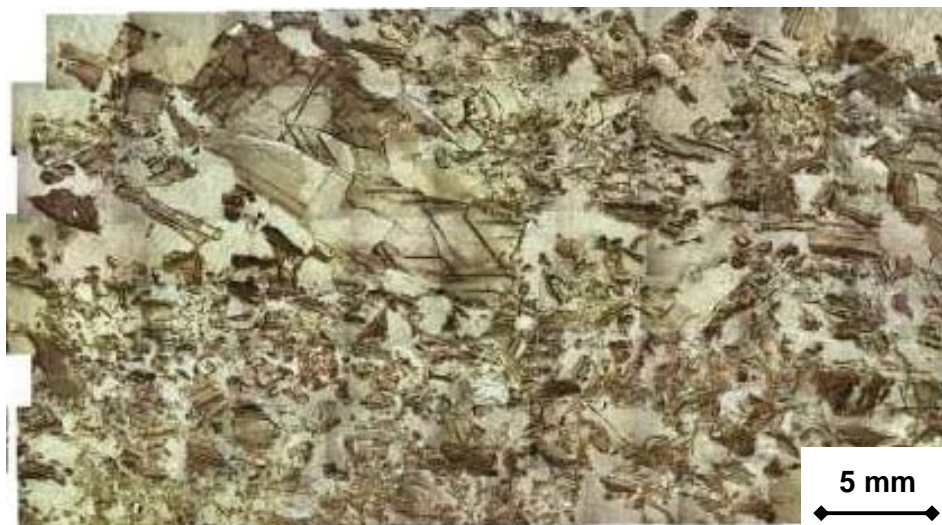
Fig. 4.4.3 Microstructure of thin section VVS-A-MI8/NT2

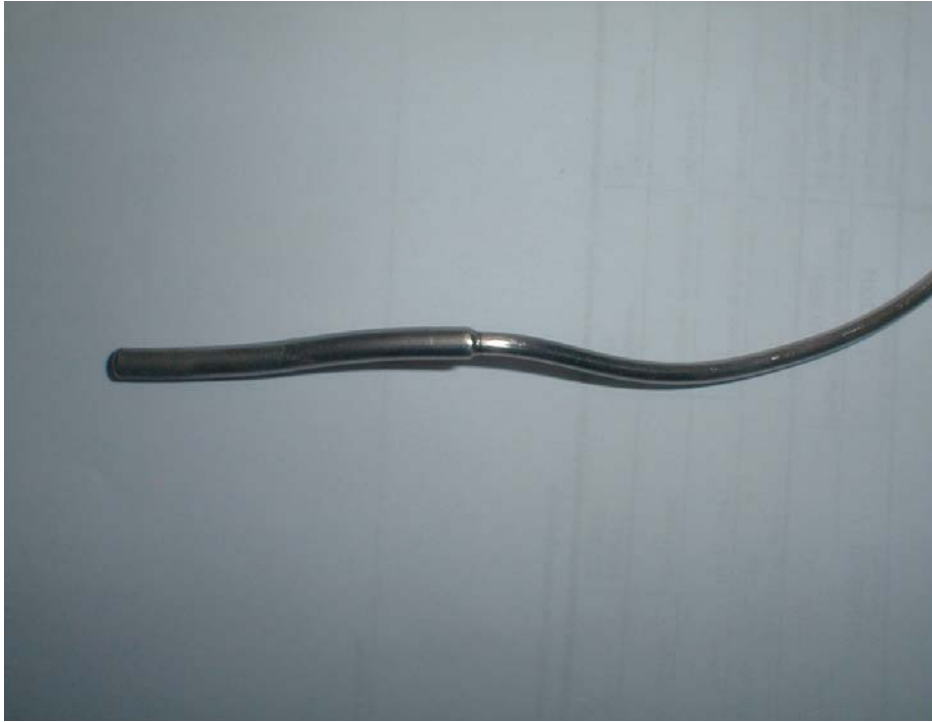
Fig. 5.2.5 Damaged temperature sensor from cross section F1

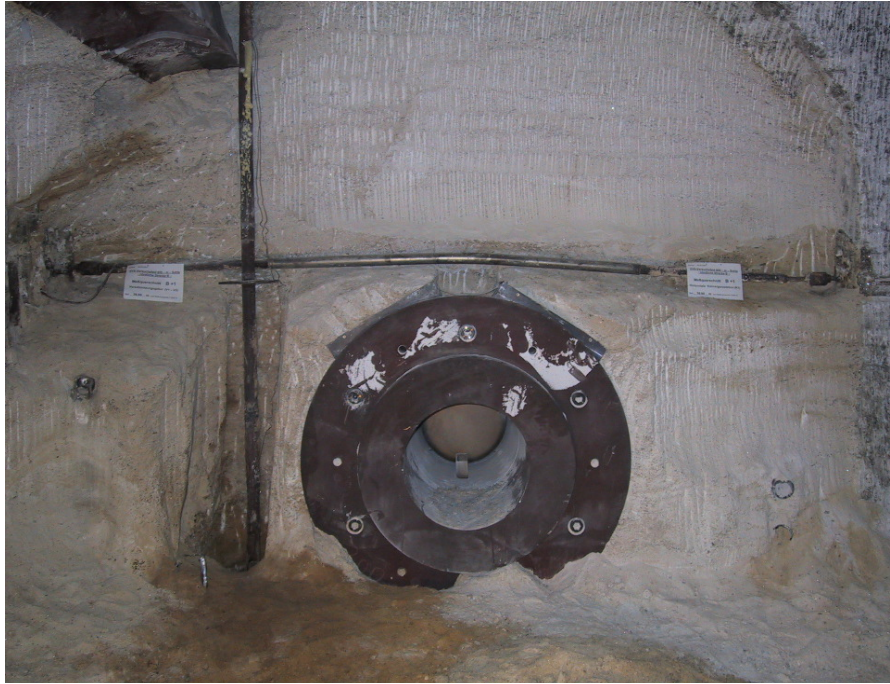
Fig. 5.3.1 Bent horizontal convergence measuring device *in situ* (cross section B⁺¹)

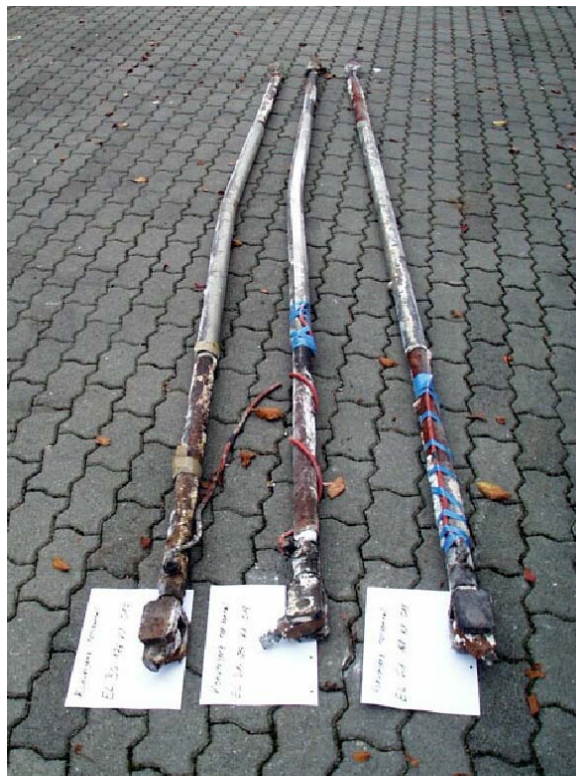
Fig. 5.3.2 Horizontal convergence measuring devices from cross sections B⁺¹ and D1⁻¹ (both bent) and G1 (not bent) showing different corrosion of the protection tubes

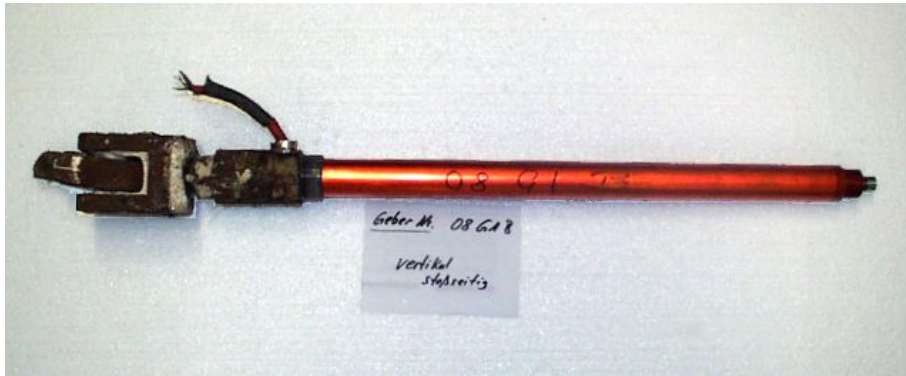
Fig. 5.3.3 Electric displacement transducer type Glötzl GWD 35/400 (sensor 8) after dismantling (spherical joint of the protection tube still mounted)

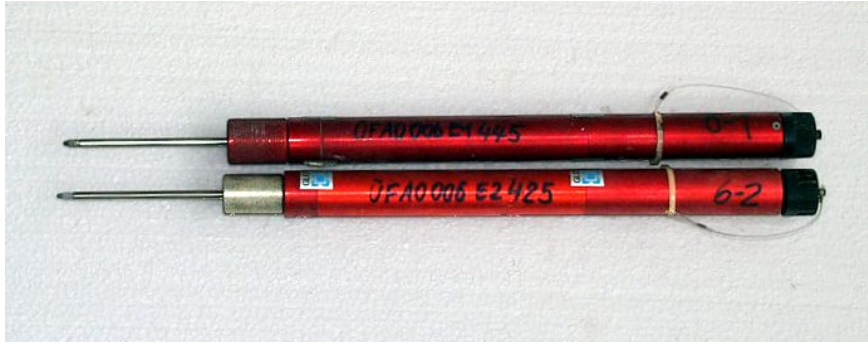
Fig. 5.3.14 Electric displacement transducers type GWW 50/50 (borehole 006: sensors 1 and 2)

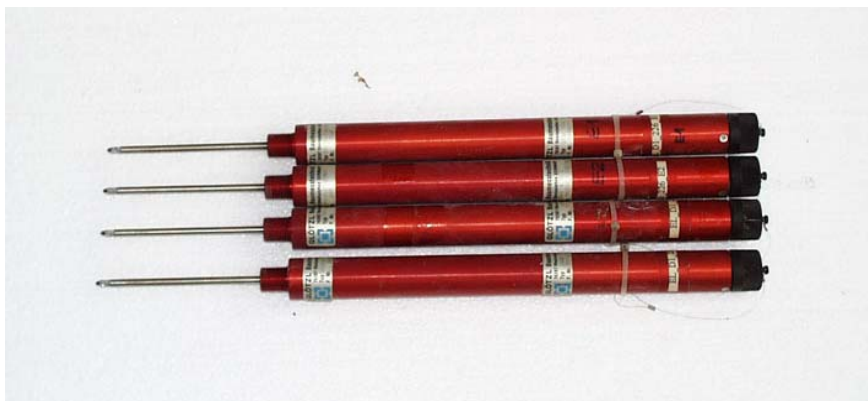
Fig. 5.3.16 Electric displacement transducers type GWW 100 I (borehole 226: sensors 37 to 40)

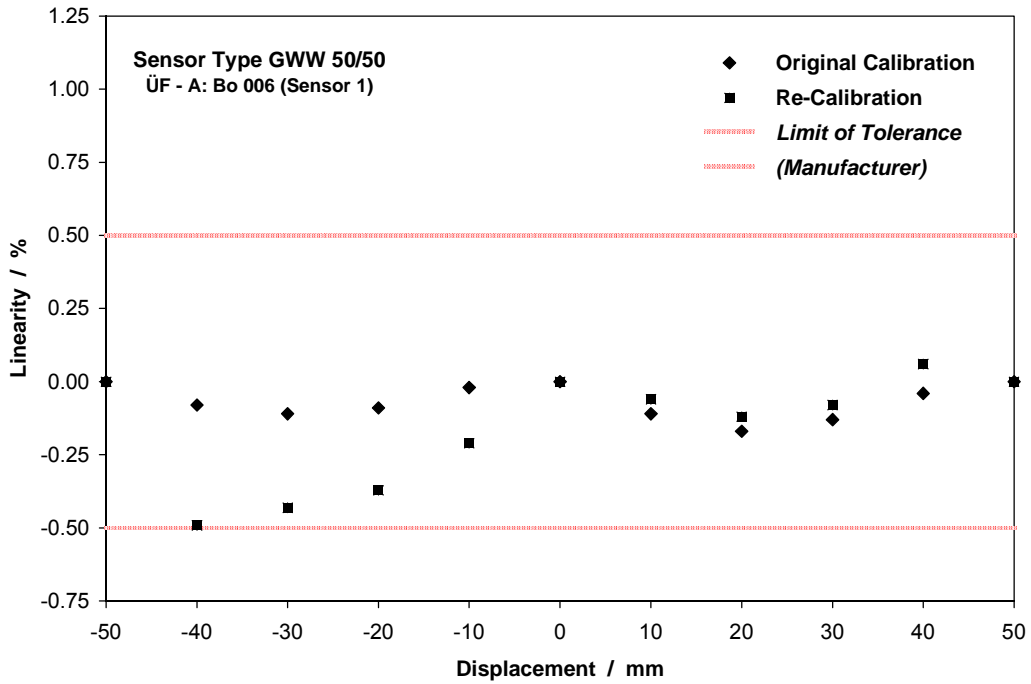
Fig. 5.3.17 Calibration of sensor 1 of borehole 006 (type GWW 50/50)

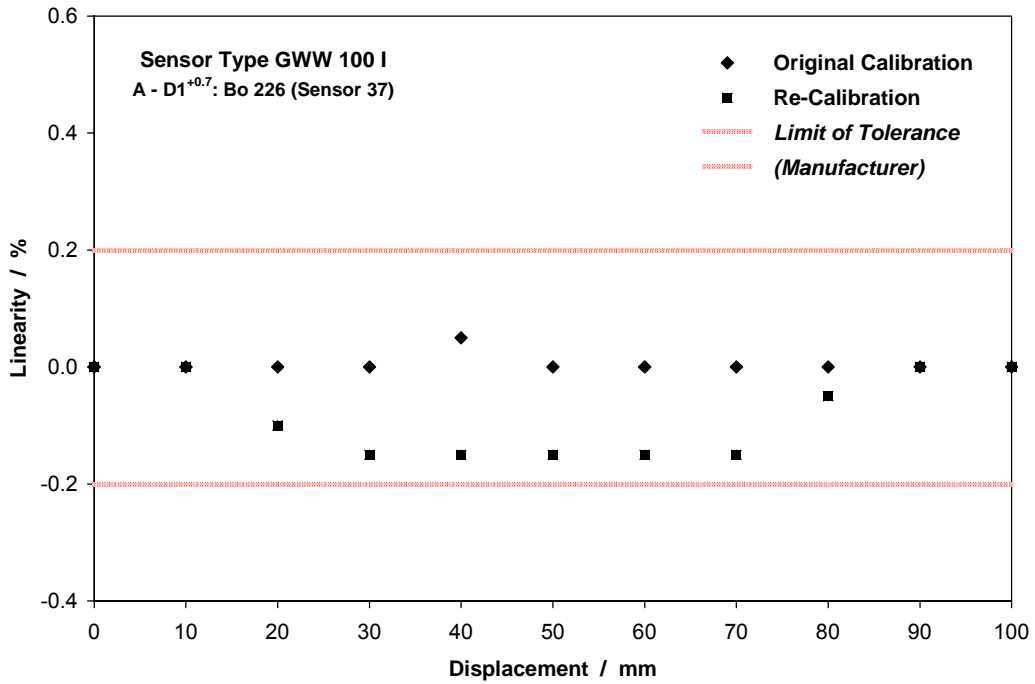
Fig. 5.3.22 Calibration of sensor 37 of borehole 226 (type GWW 100 I)

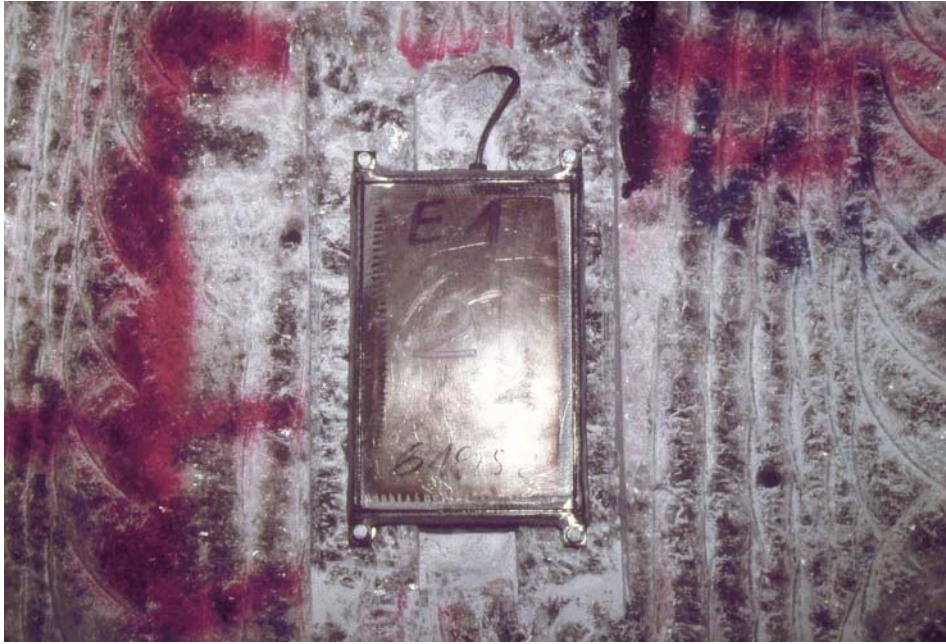
Fig. 5.4.1 Pressure gauge 61975 *in situ* at the drift wall (bottom side)

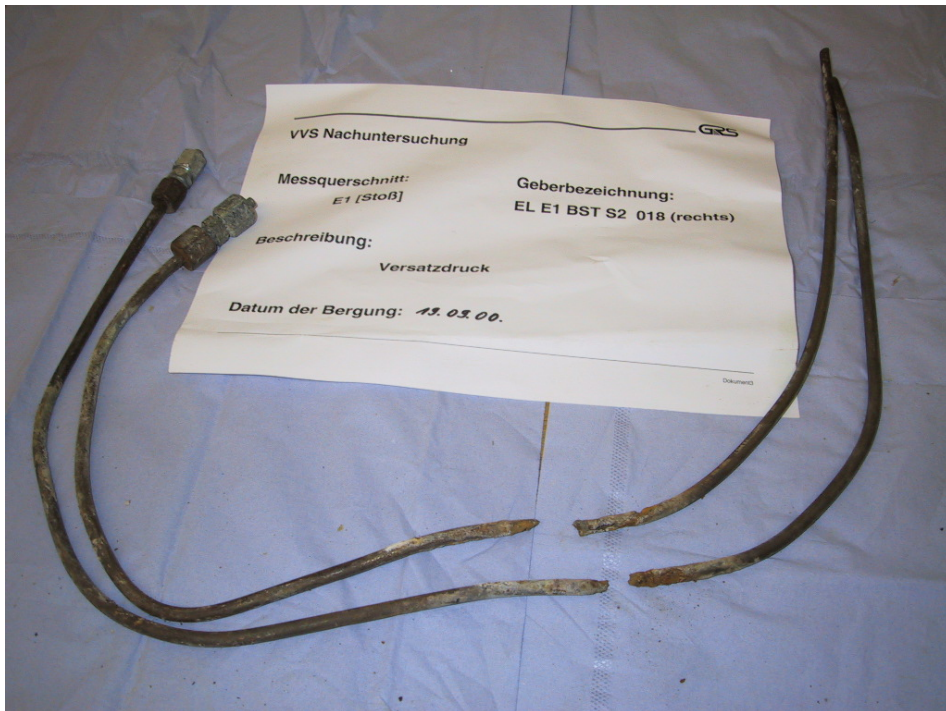
Fig. 5.4.2 Corroded hydraulic measuring lines of pressure gauge 61975

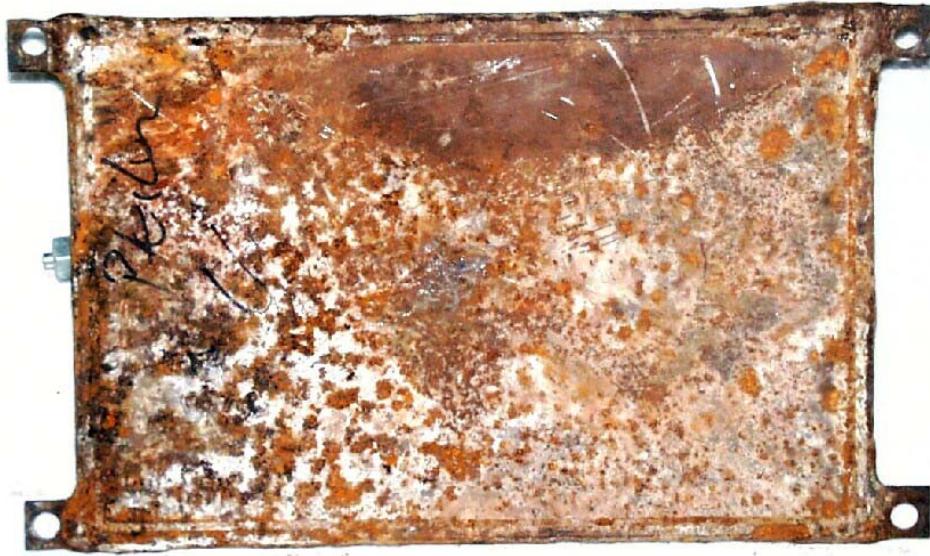
Fig. 5.4.3 Pressure gauge 61960 (bottom side) with corroded surface

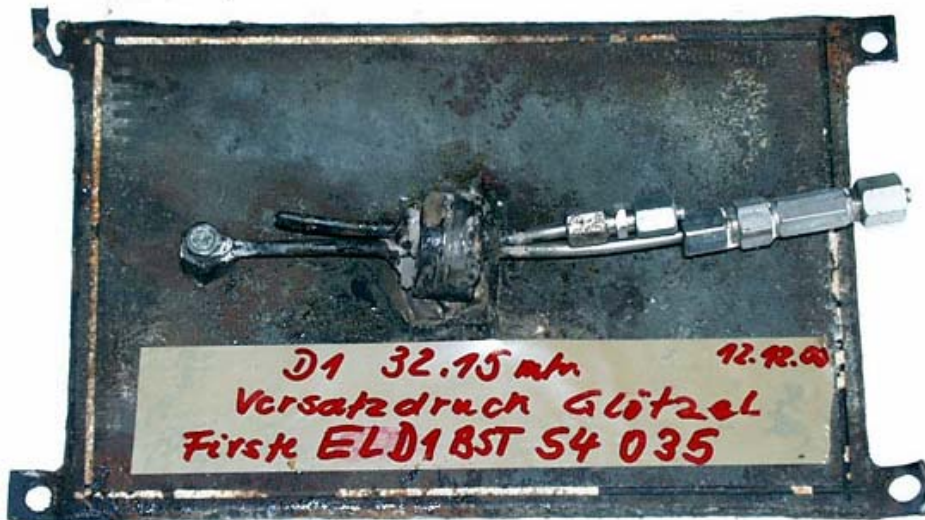
Fig. 5.4.4 Pressure gauge 61972 (upper side) with damaged attachment lugs

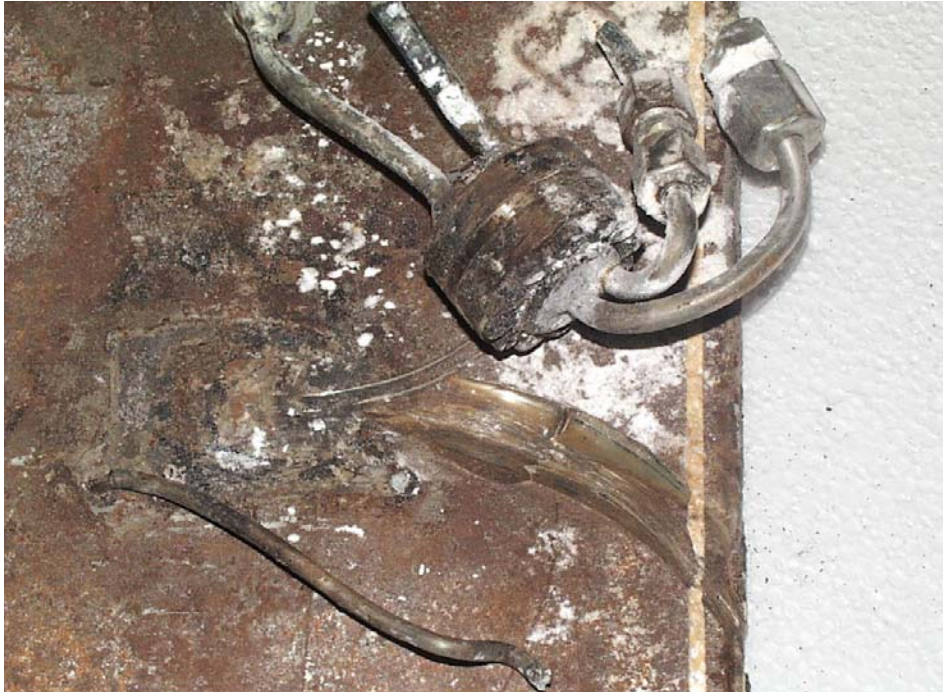
Fig. 5.4.5 Pressure gauge 61966 (upper side) – damaged by the continuous miner during drift excavation

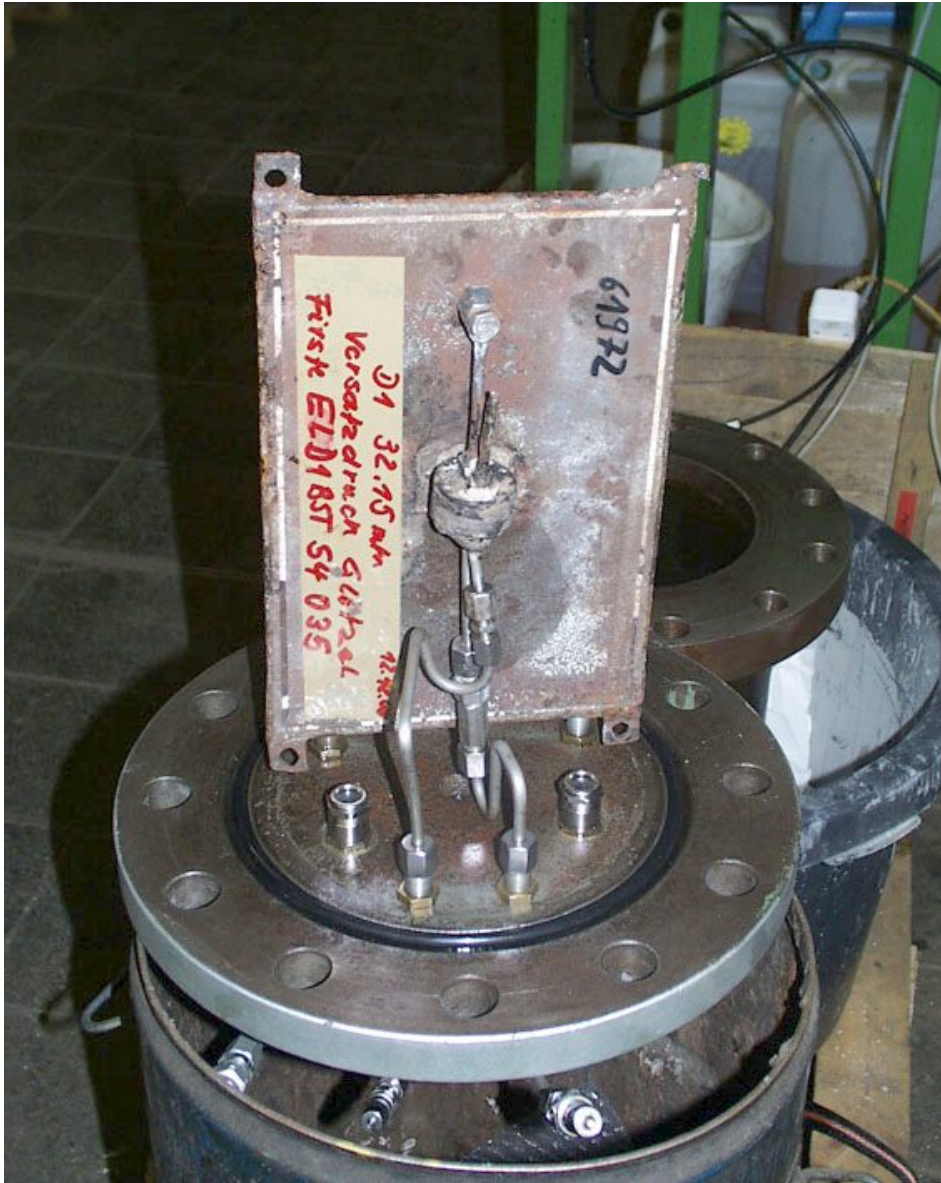
Fig. 5.4.7 Pressure gauge 61972 before calibration in the autoclave

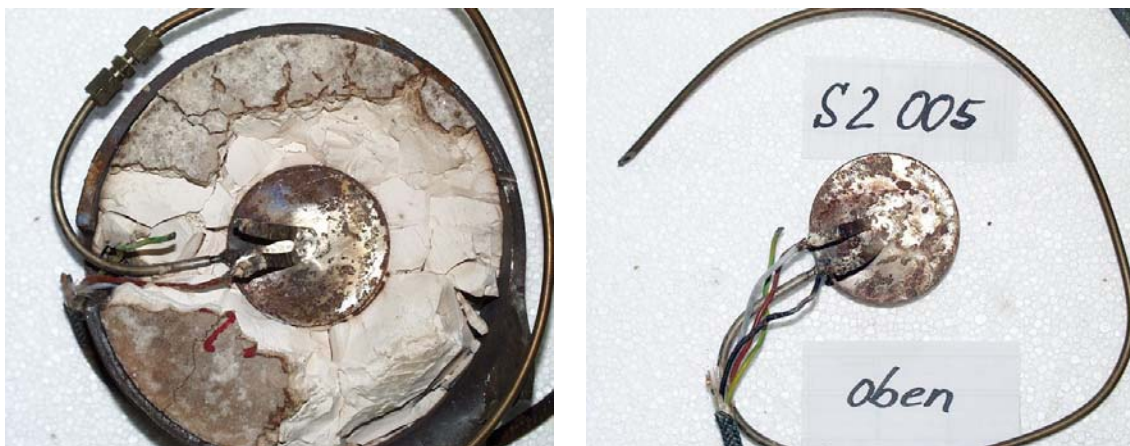
Fig. 5.4.11 AWID gauge 257 with pneumatic and electric measuring lines. a: During removal of its saltcrete embedding. b: After retrieval.
