Gesellschaft für Anlagenund Reaktorsicherheit (GRS) mbH

The Accident and the Safety of RBMK-Reactors

February 1996

GRS - 121

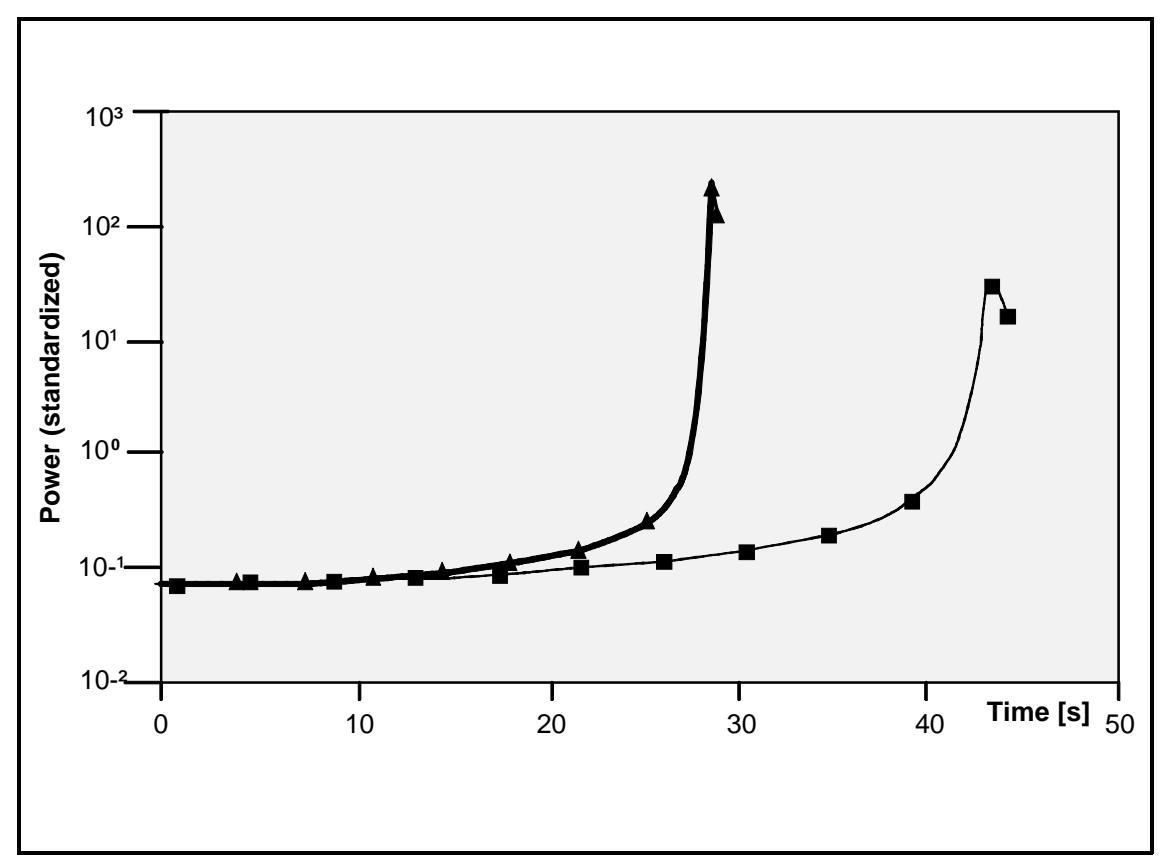
Fig. 2-2 shows which consequences such a high void effect can have under accident conditions. The fat curve shows the power increase for the marginal conditions during the accident. A reduction of the coolant flow rate by 0.8 %/s caused by the phasing out of the main coolant pumps was assumed. For the thin curve with the same conditions it was assumed that the ORM of 30 control rods was observed in contrast to the accident. There is a delayed power increase with a lower maximum.

The computations show that with the former design prompt-supercritical reactor conditions were possible in both cases, i.e. upon loss of coolant or coolant flow rate reduction, respectively. They also show that the observance of the ORM limits alone was insufficient to prevent prompt-supercritical reactor excursions.

Fig. 2-2 Reactivity transients upon 7% thermal power of an RBMK-1000

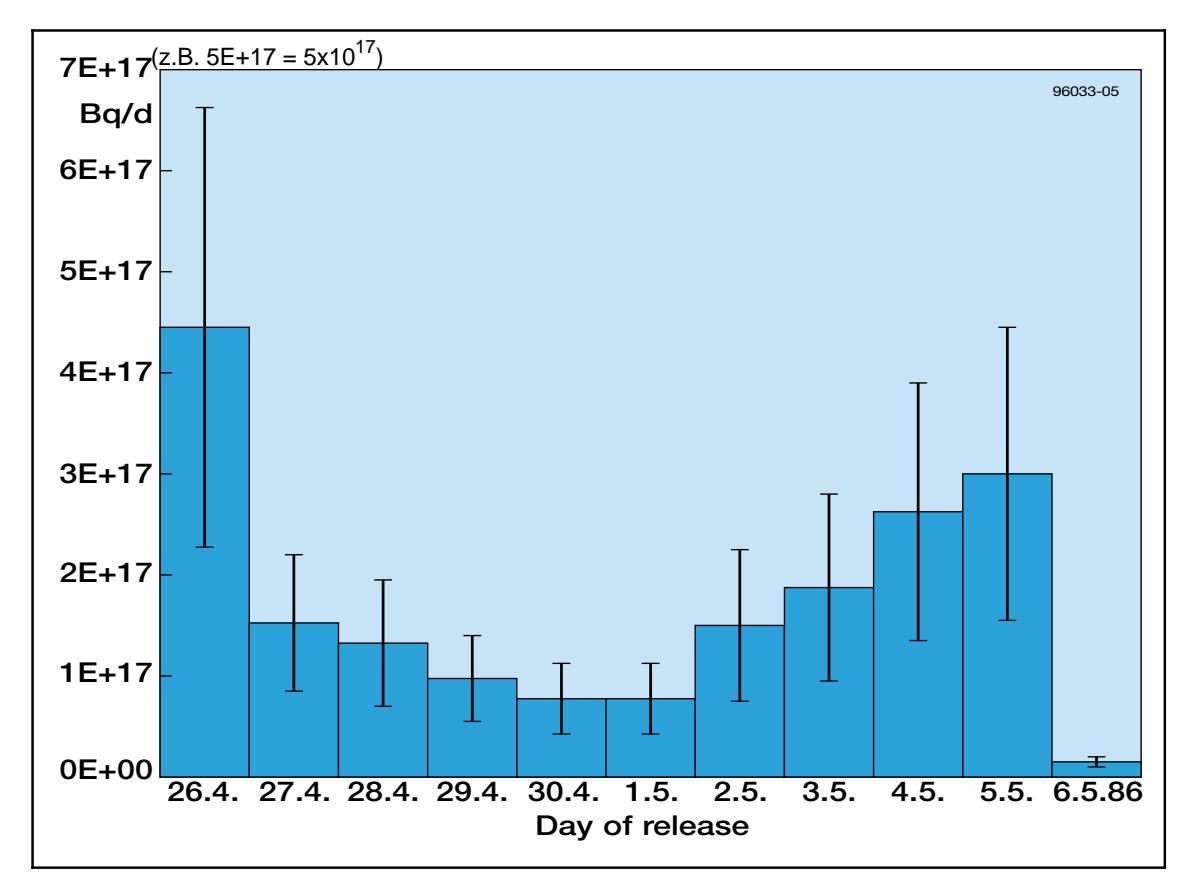
The massive release of radioactive substances lasted for ten days. The intensity of the release and the composition of the radionuclides released can be subdivided into four phases (Fig. 3-4):

- Phase 3: The release clearly increases. The materials covering the destroyed core impair heat removal. This leads to heating the reactor up to a temperature exceeding 2 000°C. The remaining iodine is at first expelled out of the hot fuel. The composition of the other substances released almost corresponds to the respective proportions in the nuclear fuel.
- Phase 4: On May 6 the release decreases abruptly. This is surprising and until today cannot completely be explaind. Essential influences are ascribed to the countermeasures and to the formation of least volatile compounds of the radionuclides.

In the course of the accident the remaining nuclear fuel in the reactor shaft melts, it mixes with the structure material and flows along the corridors and through the openings into the compartments below the reactor shaft. The molten mass mixes with further substances, especially with the materials thrown down, like lead and sand. A total of

Fig. 3-4 The amount of the radioactive substances released within the first ten days (with ranges of uncertainty)

5 000 tons of material are dropped by helicopters to terminate the release of radioactive substances. The core melting mass finally solidifies.

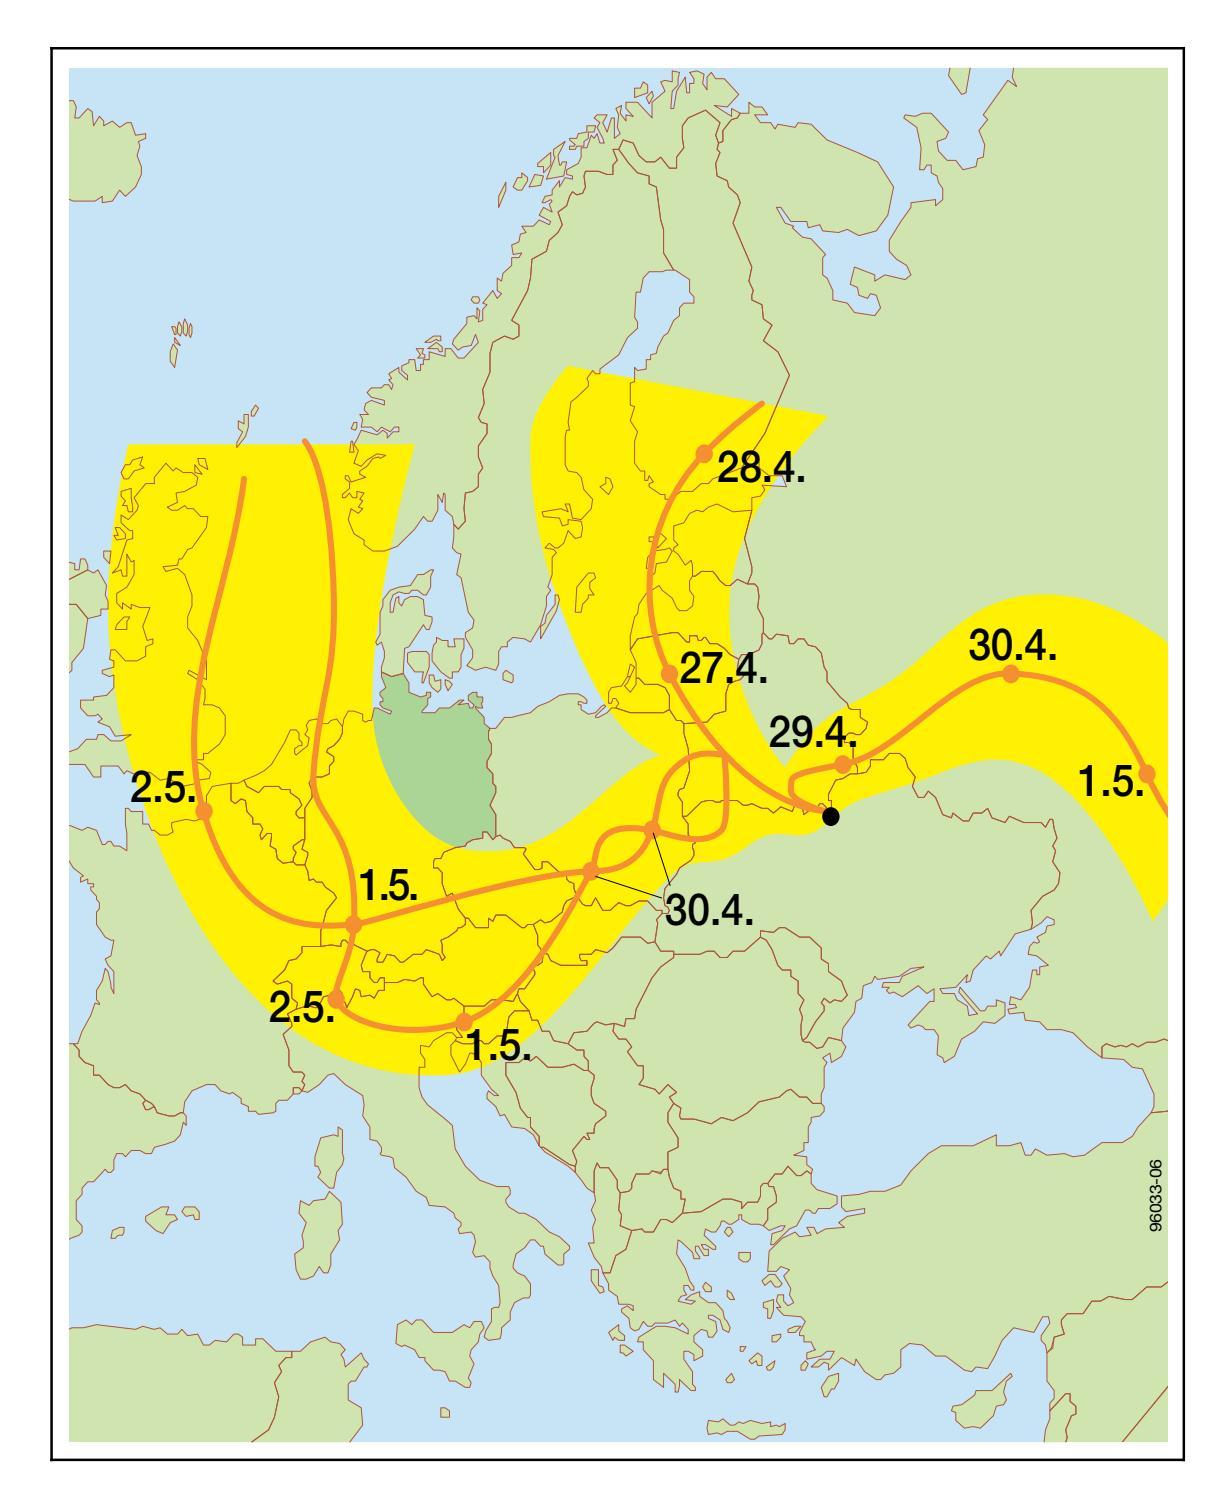
Fig. 3-5 Main spreading directions from April 27 until May 2, 1986

During the entire release period of about ten days the weather conditions in the closer and further surrounding of the site changed considerably. The radioactive substances released by the explosion and the fire on April 26, 1986 were at first transported in a great height in northwestern direction via Belorussia to Finland and to the central and northern part of Sweden. On the following day the wind turned west. The way of the radioactively contaminated air masses led via Poland, Czech Republic and Austria to South Germany where they arrived between April 30 and May 1 (see Fig. 3-5).

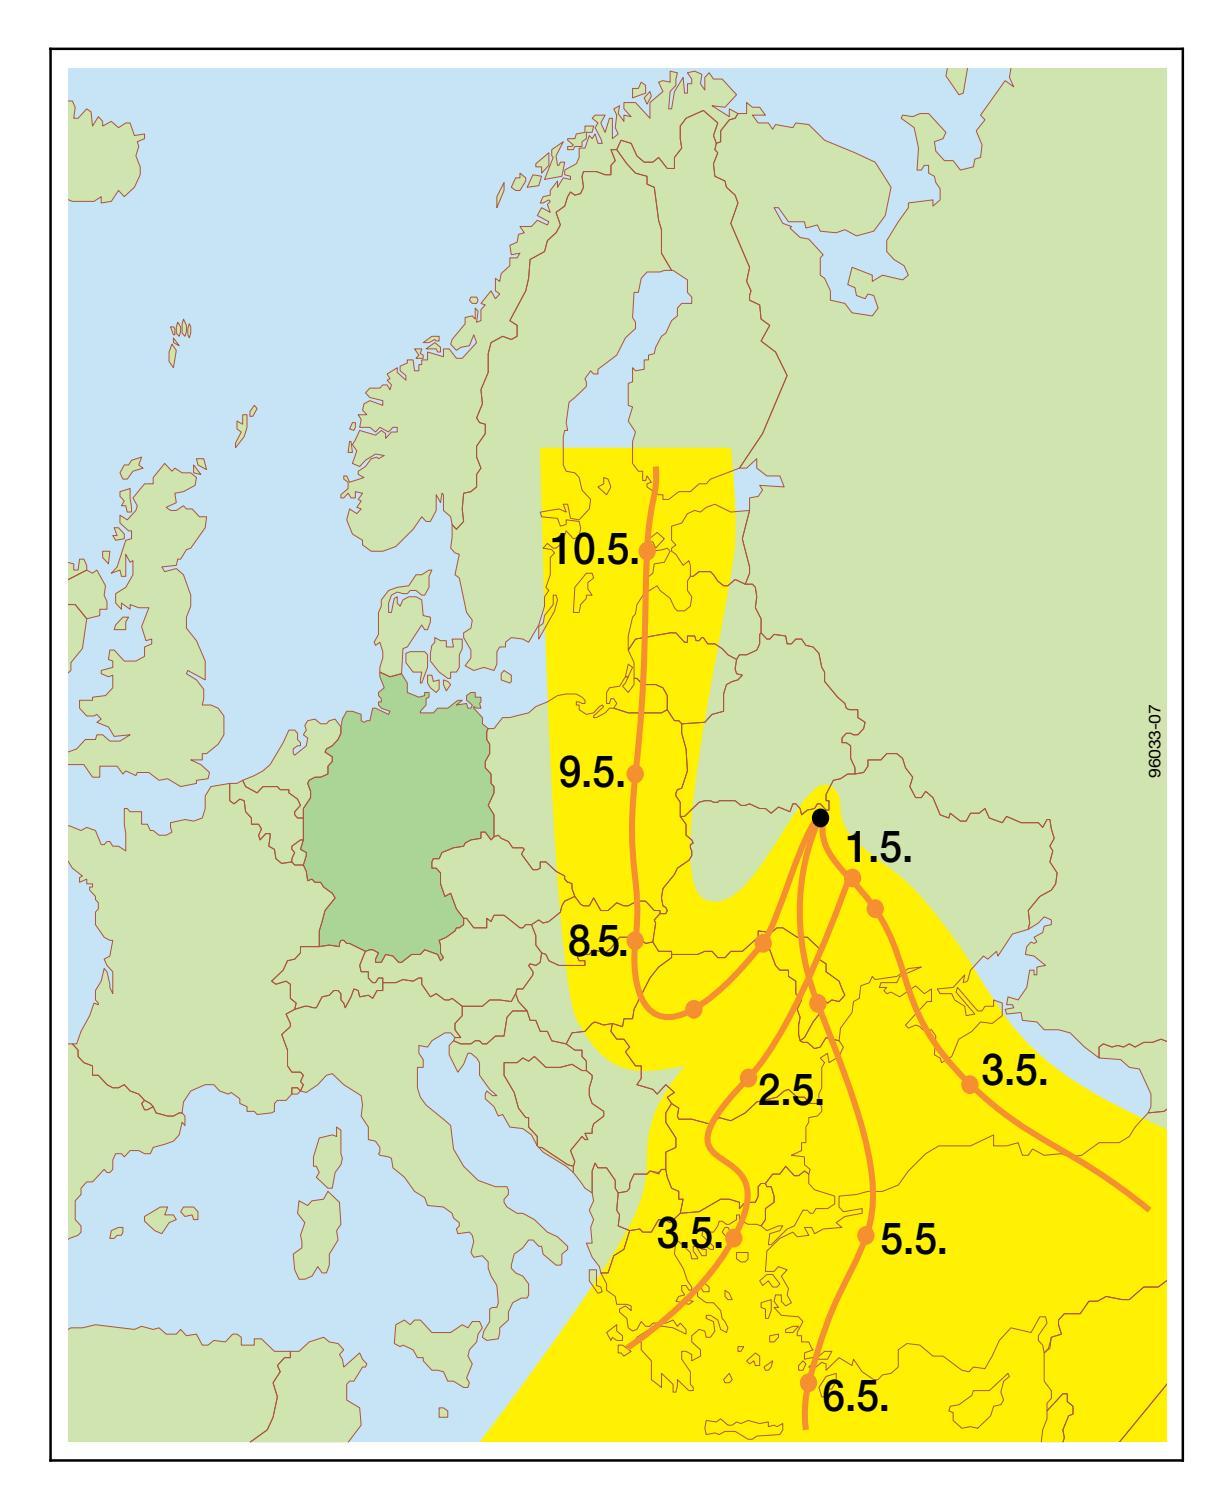
Fig. 3-6 Main spreading directions from May 1 until May 10, 1986

The amount of contamination was not only determined by metereological parameters like wind direction and wind speed. The intensity of the occuring rainfalls by which the radioactive substances were washed out and precipitated was very decisive.

Accordingly there are locally very different degrees of contamination. In addition, ground relief and vegetation, e.g. forest areas, also play a role.

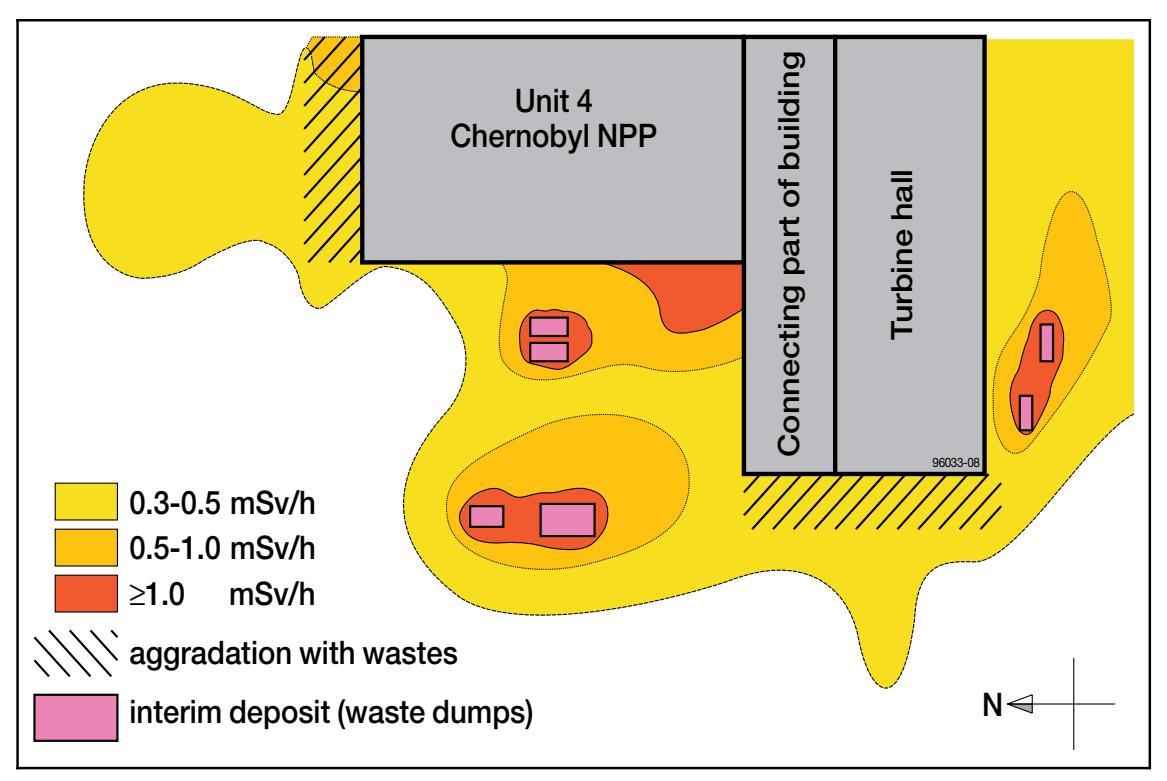
Fig. 3-7 Cartogram of the local dose rate of caesium 137 at a height of one metre above the ground surface

The radiation fields existing on the Chernobyl Nuclear Power Plant site today, especially near the destroyed Unit 4, are known. There are tables of measured values and cartograms indicating the dose rates measured in a distance of some metres and from different heights in a tight grid of measured values. Fig. 3-7 shows a cartogram of the local dose rate 1 m above the ground. The determining radionuclide is caesium-137. The dose rate of gamma radiation in the direct surrounding of the Sarcophagus as well as the connecting building and the turbine hall of Unit 4 1 metre above the ground is approx. 0.3 to 0.5 mSv/h. The dose rate in distances of up to about 150 m of the buildings mentioned is about 0.1 to 0.2 mSv/h.

On the site there are about ten depositiories with radioactive substances, above all at the western wall of the Sarcophagus. Highly radioactive wastes, possible fragments out of the reactor core are assumed in at least three of these deposits. Two deposits with a dose rate exceeding 10 mSv/h are located approx. in the middle of the western wall, in a distance of about 20 m, a third with a dose rate exceeding 50 mSv/h in a distance of

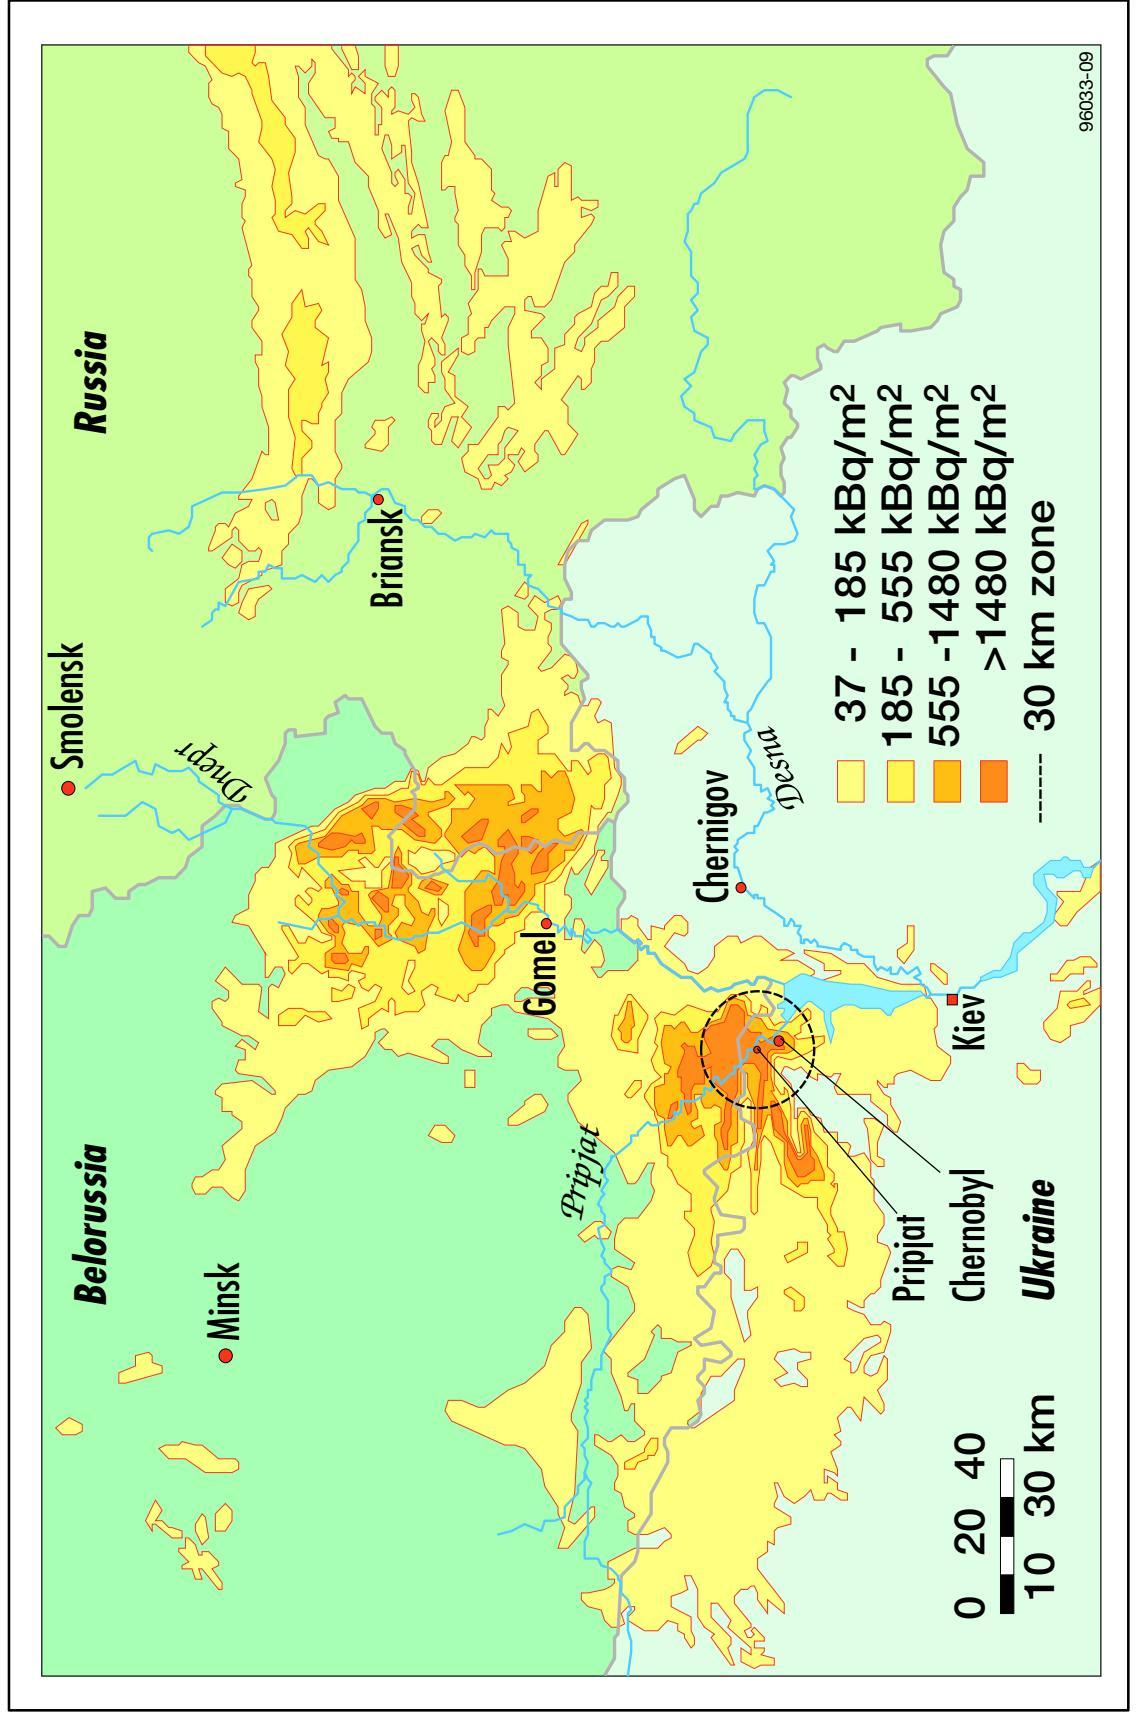
Fig. 3-9 Caesium 137 contamination in the Ukraine, Belorussia and Russia

In the first months after the release, the radioactive iodine which leads to an exposure of the thyroid, was particularly important. But because of the short half-life-value, the effect of the radioactive iodine remained restricted to this period. Now caesium 137 with its half-life-value of about 30 years is the critical nuclide. It was spread over vast areas (Fig. 3-9).

The areas in Russia, the Ukraine and Belorussia contaminated with caesium, strontium and plutonium are illustrated in Fig. 3-9 to 3-11. The contaminations in West-European countries were much lower.

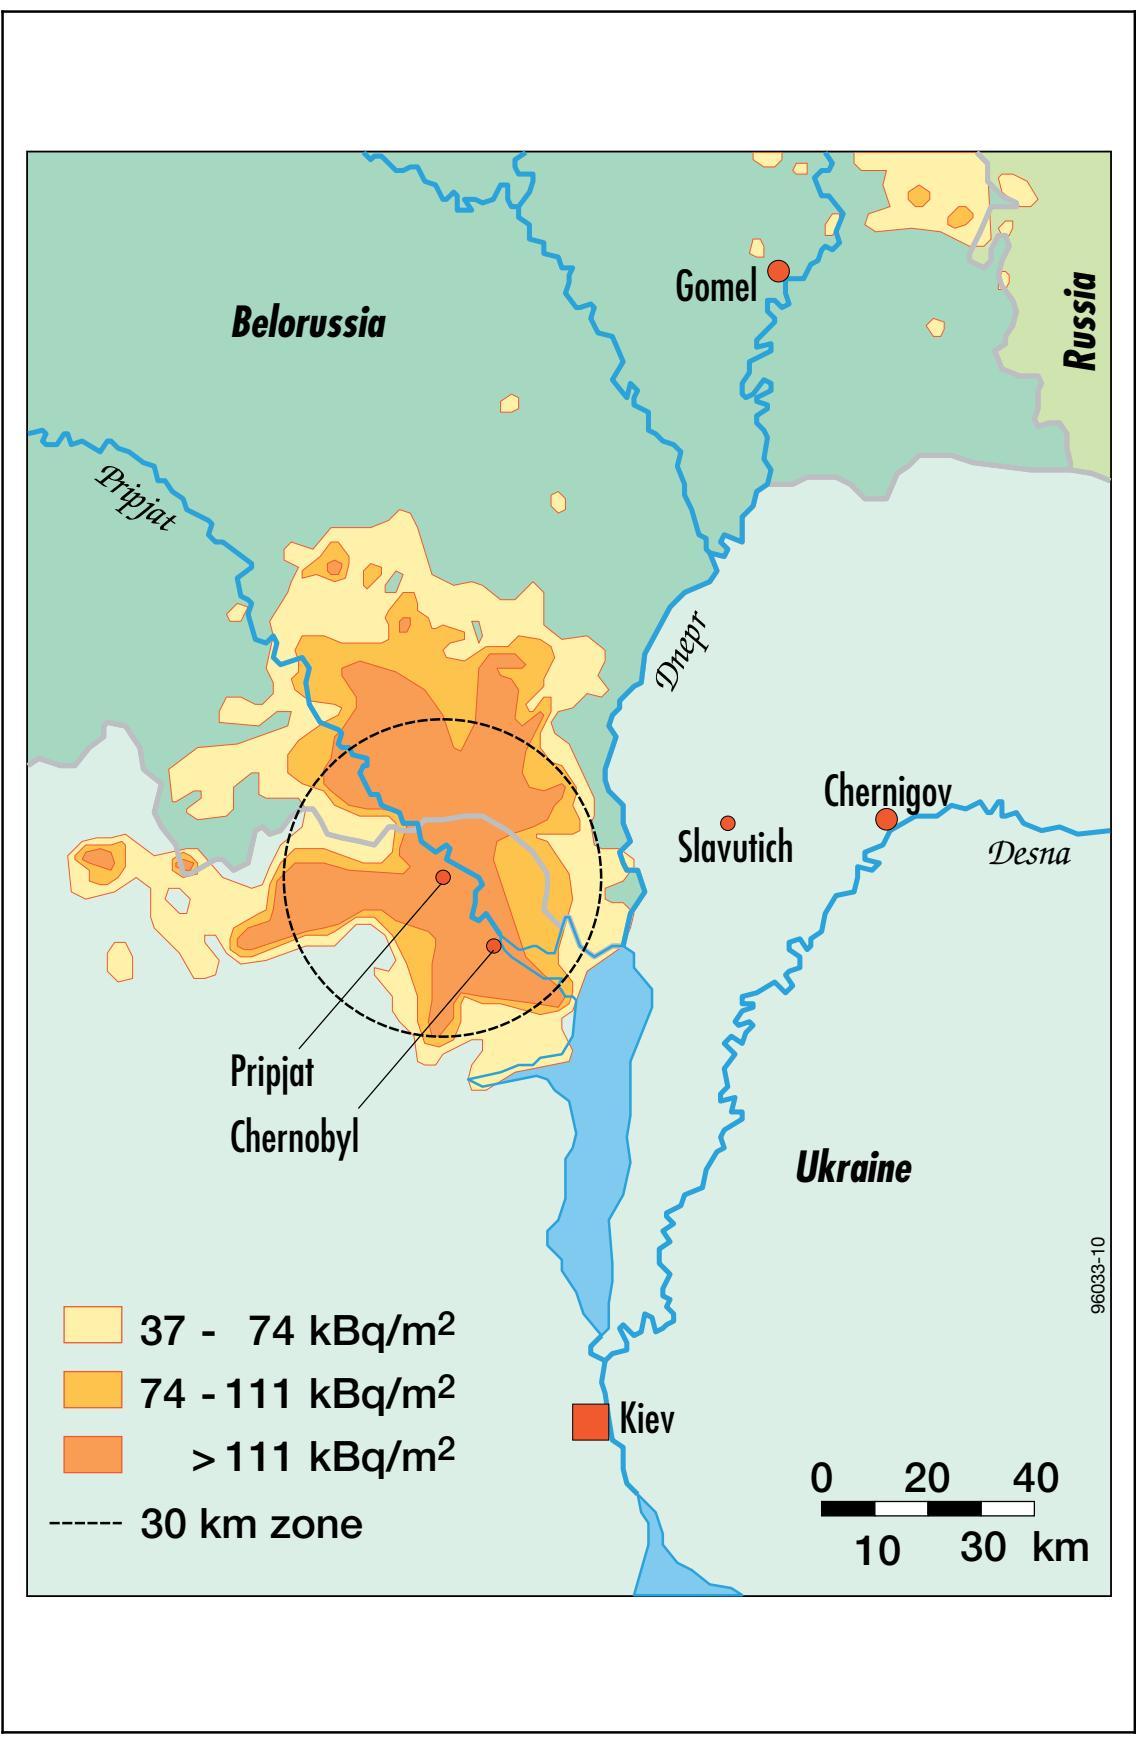
Fig. 3-10 Strontium 90 contamination in the larger surrounding of the Chernobyl plant

Apart from the close area of the prohibited 30 km-zone around the Chernobyl Nuclear Power Plant and the areas around Gomel, the strontium 90 nuclide with a half-life-value of about 28 years is less significant. Although a pure beta-emitter does not contribute to external radiation exposure, it is particularly dangerous because of its accumulation in vegetable food and because of its properties as a substance which lodges in bones.

The overall strontium activity released is much lower than the caesium activity and it was spread over shorter distances.

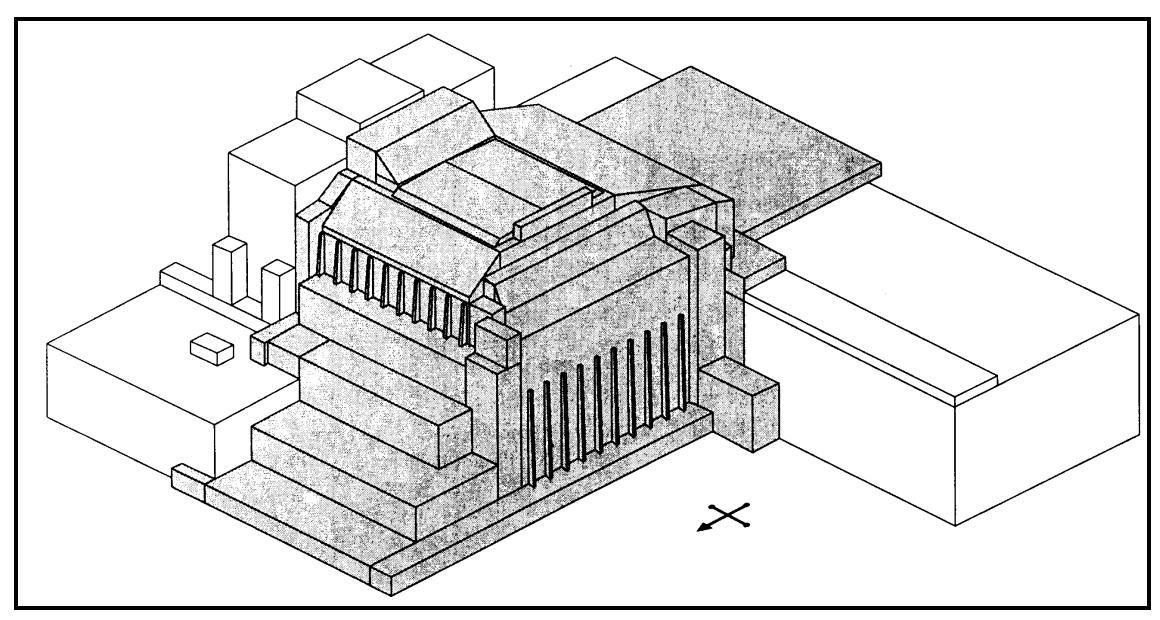
Fig. 4-1 Diagrammatic view of the Sarcophagus built from May until October 1986

After the explosion in Unit 4 at Chernobyl, the isolation of the destroyed reactor from the environment represented a priority to prevent a further release of radioactive substances. For this purpose the construction referred to as "object shelter" or "Sarco-phagus", consisting of concrete and steel was built around the destroyed reactor. Because of the urgency, there was no time for detailed planning.

Special requirements resulted from the objective to further operate the third reactor unit of the nuclear power plant, which among other things was connected with the destroyed reactor via the common tubine hall and the auxiliary building. This necessitated a constructional separation of the two units.

In the turbine hall a separation wall was erected between the area of Units 3 and 4. In the auxiliary building located between the two reactor units (Fig. 1-8) compartments near the fourth unit were completely filled with concrete so that a strong barrier of up to 6 m was created.

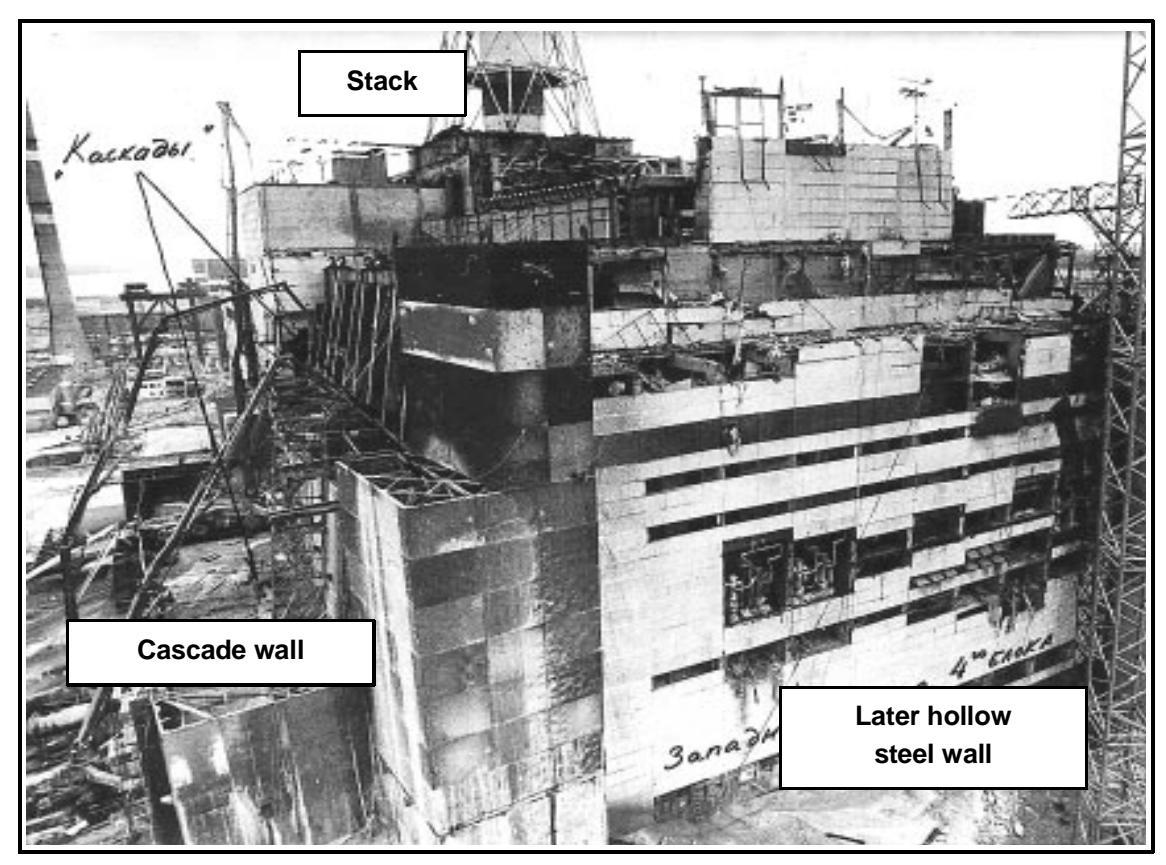
Fig. 4-2 View on the "cascade wall" under construction and the western wall in front of which the hollow steel wall was erected

On the northern side a protection wall of concrete about 50 m high leading upwards in four cascades was erected (Fig. 4-2). A considerable part of the radioactive debris ejected out of the reactor during the explosion is said to have been encased with concrete in this cascade wall which is about 20 m thick at its the lower end. On photos taken at the time of erection it can be seen that even larger units were encapsulated here. In front of the western wall of the reactor building which largely remained intact a hollow steel wall with buttresses was erected.

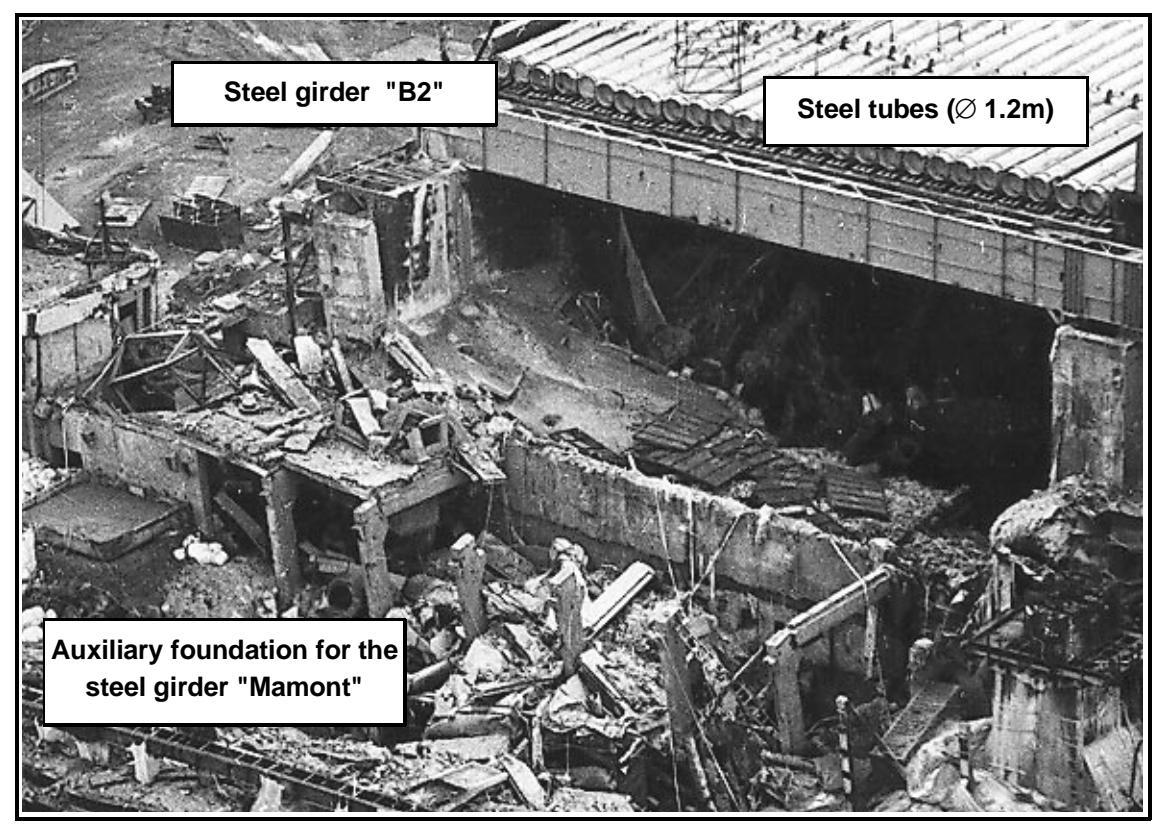
Fig. 4-3 Destroyed Unit 4 during the construction phase of the Sarcophagus

The intact western wall of the reactor building and two intact concrete steel air shafts on the eastern side were used as the supporting construction for the roof of the Sarcophagus. Two steel girders B1 and B2 (Fig. 4-3) rest on these structures as main support of the roof of the Sarcophagus. Steel tubes having a diameter of 1.2 m were laid onto these two steel girders and a roof construction of steel and profiled roofing plates were put onto these steel tubes. Today this ceiling structure covers the former reactor hall to the top.

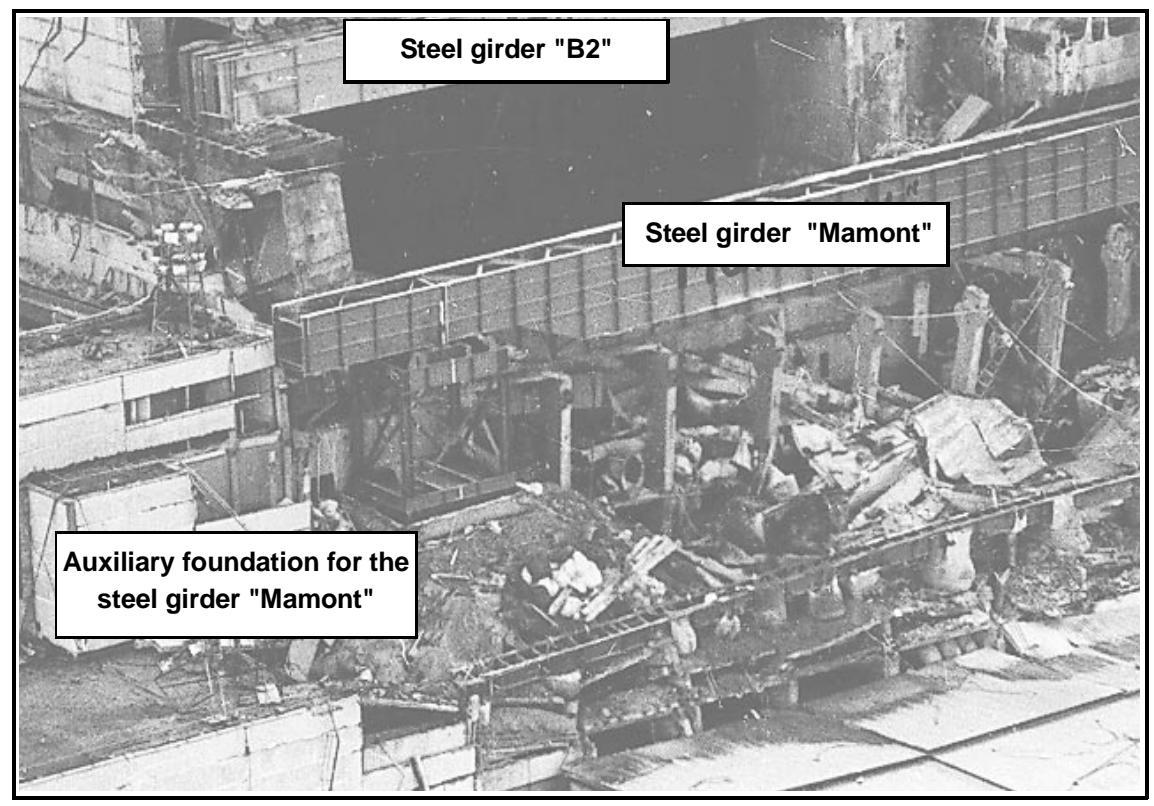
Fig. 4-4 Steel girder "Mamont" on the southern side of the destroyed unit which rests on auxiliary foundations

At the northern side, the cascade wall was practically led to the roof. On the southern side two big steel girders "Mamont" and "Osminok" were built in (Fig. 4-4). These rest

on auxiliary foundations or on the remaining parts of the fourth Unit destroyed, respectively. The roof construction was extended beyond these girders to the south, where it is connected to the roof of the turbine hall.

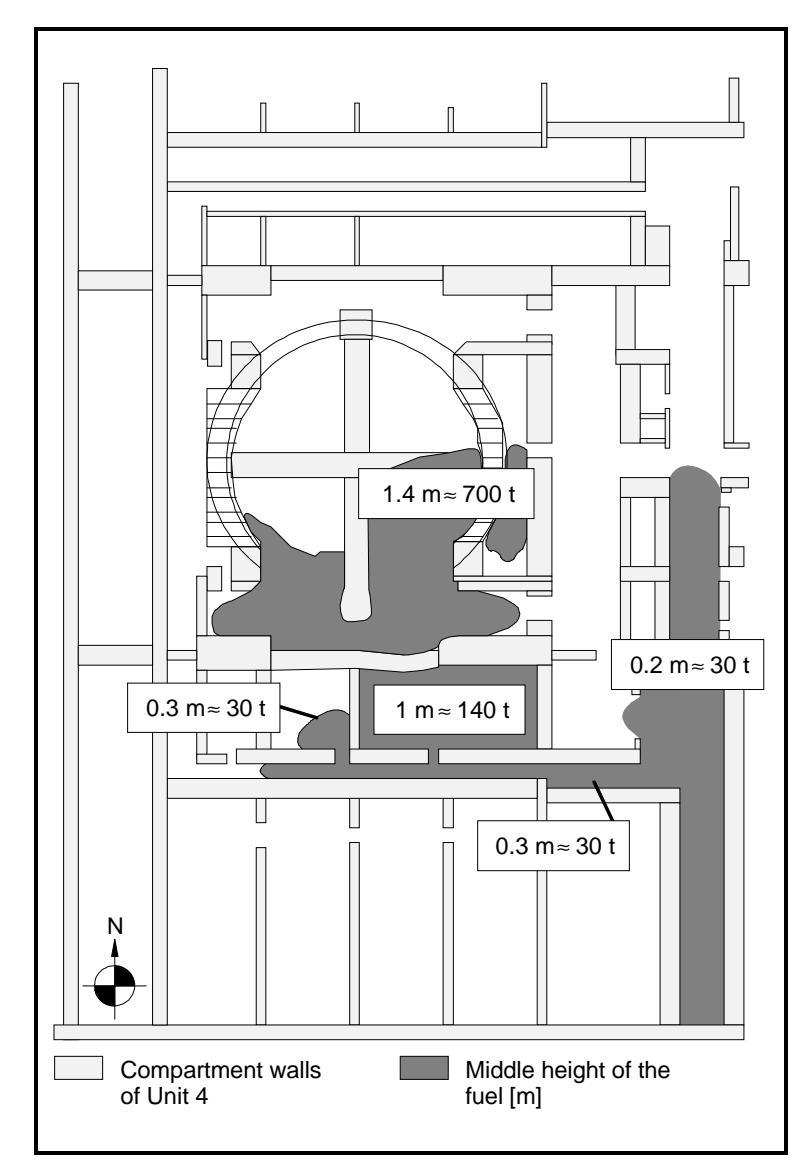
Fig. 4-6 Horizontal distribution of the molten nuclear fuel (lava) inside the Sarcophagus

The largest proportion of the nuclear fuel which had remained in the reactor shaft melted at first after the accident because of the decay heat and then flew through openings into lower compartments. It mixed with other substances and solidified to a glass-like mass, "lava", which in the course of the time and under the influence of radiation, heat and humidity turned into a porous state. Today the surface temperature of the lava is close to room temperature.

The spatial distribution of the nuclear fuel is roughly known. In the lower compartments there are between 100 and 130 tons. A more exact determination is difficult, as many of these compartments were partially or completely filled up with concrete. 50 to 80 tons of fuel are presumed in the destroyed reactor hall and in the northern cascade wall. In addition, there are about 20 tons of spent fuel elements which were stored in spent fuel pits outside the reactor at the time of the accident.

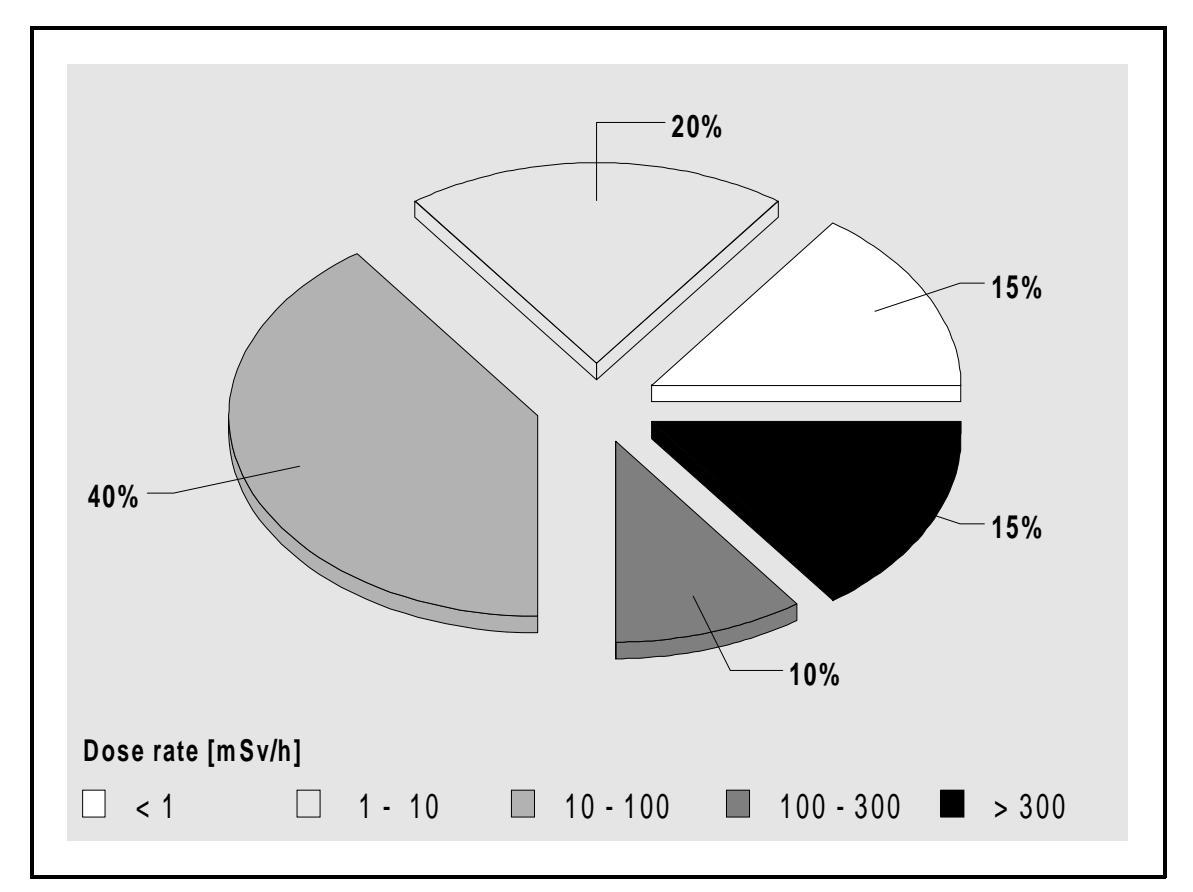
Fig. 4-8 Fraction of rooms inside the Sarcophagus having a specified dose rate

Most compartments of the Sarcophagus are accessible for a short period or at least accessible by robots. The intensity of the radioactive radiation is well known there. It strongly varies depending on the presence of fuel-containing masses and radioactive dusts, on the degree of destruction as well as on the filling with substances like concrete or sand.

The contamination of the buildings adjacent to the destroyed reactor unit varies considerably. The degasifier floor, for example, is only relatively weakly contaminated, as most of its walls remained intact. For this reason hardly any radioactive material could intrude. In contrast thereto, parts of the nuclear fuel ejected during the accident contamianted extinguishing water and radioactive dust reached into the turbine hall, the roof of which had been destroyed. Today the local dose rate in the turbine hall is about 10 to 20 mSv/h, in the roof area above the destroyed reactor the dose rates are up to 390 mSv/h.

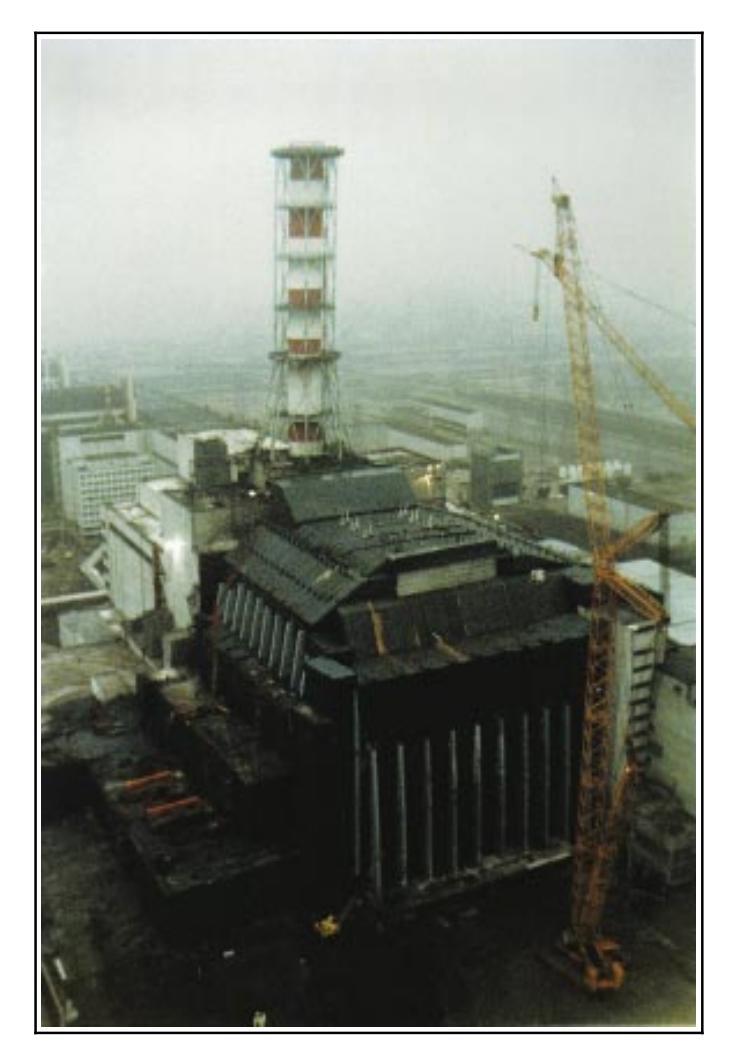
Fig. 4-10 The Sarcophagus shortly before completion

During its erection a part of the components of the Sarcophagus was designed and manufactured in accordance with standard engineering criteria. There is little reason to doubt the carrying capacity of these building components. Restrictions do, however, result from the installation conditions determined by the high radioactive radiation. Thus many components were installed in a remote-controlled way so that building components could not always precisely be placed in the planned position. In addition, some essential supporting structures could not be screwed or welded, as usual, but only be placed on top of each other. This does not create severe problems for the accommodation of vertical loads, but upon horizontal stress these connections only function via frictional resistance, so that the carrying capacity may be lowered considerably.

accident. Such building components, especially air shafts at the eastern side which had remained intact and the western wall of the reactor building represent essential supports for the upper part of the Sarcophagus and have to accommodate the respective loads. The assessment of their strctural perfomance is not easy as a more detailed examination of their quality prior use was not possible because of the high radiation. Such building components could at least partially have been damaged.

Inside the Sarcophagus corrosion processes damaging concrete surfaces as well as steel constructions and uncovered reinforcing steel, for example of components damaged earlier, are important. The water present in the Sarcophagus, the rainwater intruding through joints and gaps and the humidity connected therewith promote these processes.

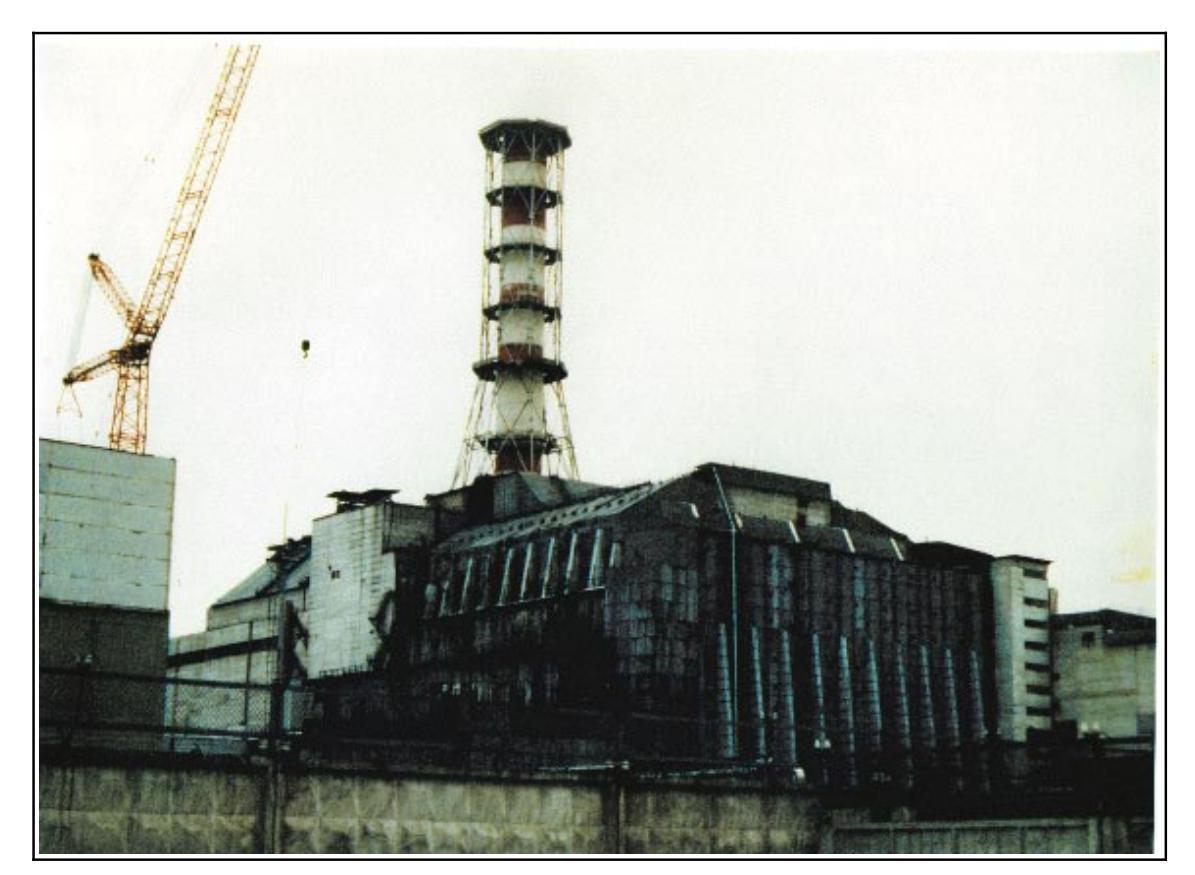
Fig. 4-11 The completed Sarcophagus

The Sarcophagus had originally been designed for a period of approx. 30 years. It withstood the external impacts of the last ten years. To these impacts also belong earthquakes, like the earthquakes of May 30 and 31, 1990, for example, the seismic centre of which was located in the Carpathian Mountains (with magnitudes of 6.8 or 6.3, resp. on the Richter scale). The earthquake did not cause any visible changes to the outside of the Sarcophagus. But there were transformations at the gaps of some walls inside the Sarcophagus. The stability analyses carried out by Ukrainian research institutes identified deficiencies, especially with respect to the quality of the constrctuion works. But finally no facts were identified according to which a collapse of the Sarcophagus in the next years seems to be likely. Today the assessment of the stability for the entire period of 20 years implies considerable uncertainties. Concrete technical concepts for upgrading measures are already being discussed at different places and they should permit a reduction of the endangerments with reasonable efforts. The next

Concrete steps for the reconstruction of the Sarcophagus are, however, more important than improved analyses, especially as a reconstruction cannot be avoided in the longterm. One important question here is which steps should be taken in which sequence.

In its considerations the Ukrainian government has so far concentrated on the construction of a new, structurally independent enclosure which encapsulates the Sarcophagus existing today (Sarcophagus 2). A possible retreat of the ruins of the fourth reactor unit and the existing Sarcophagus for such a concept would be carried out within the new enclosure. A feasibility study commissioned by the European Union considers the superstruction of the entire double unit, i.e. of the destroyed fourth and the third reactor unit still operating. The costs for implementing this demanding concept were estimated to amount to about 2 billion DM (prices of 1995).
