Gesellschaft für Anlagenund Reaktorsicherheit (GRS) mbH

The Accident and the Safety of RBMK-Reactors

February 1996

GRS - 121

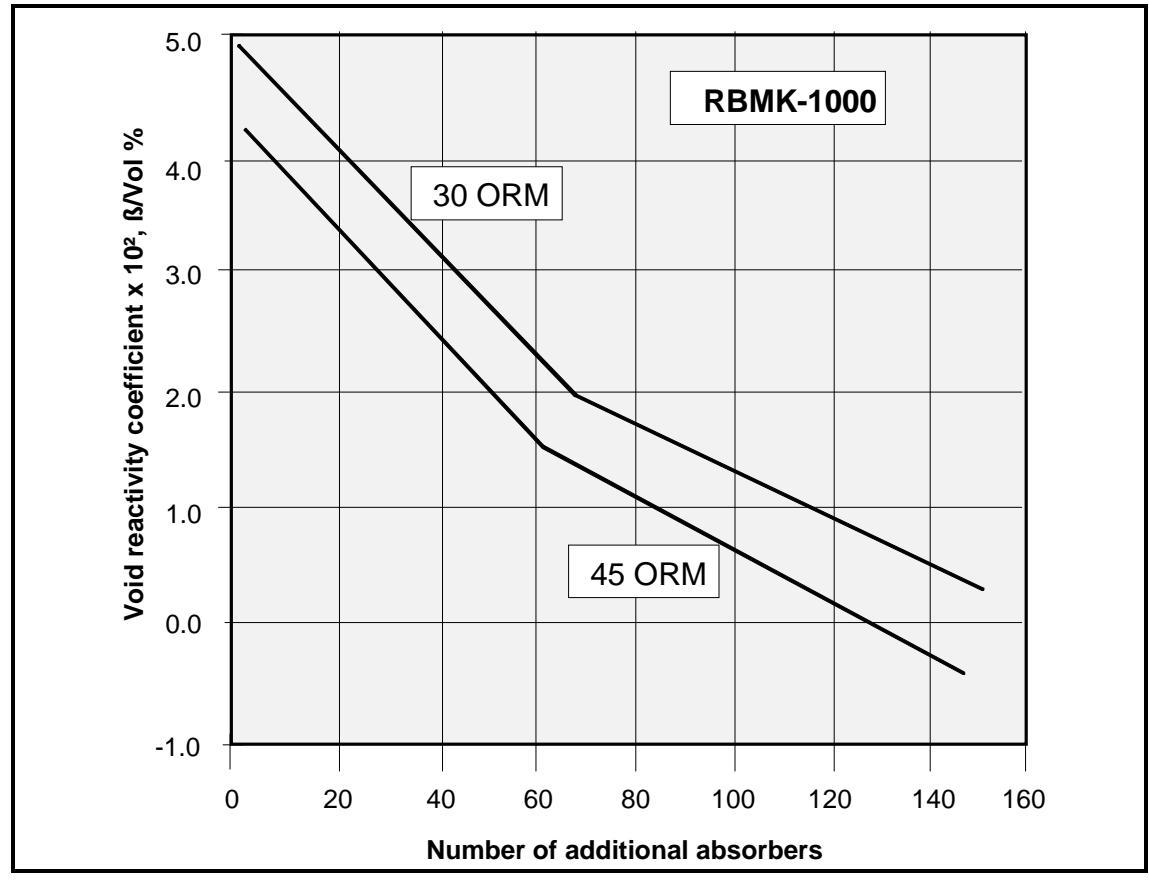
Fig. 7-1 Void reactivity depending on the number of additional absorbers

A short time before the accident the positive void effect of reactivity in the Chernobyl Nuclear Power Plant, Unit 4 in a state of low power and with an operational reactivity margin (ORM) of about 7 control rods was at least 5 ß. This positive void effect was decisive for the initiation of the accident and the disastrous procedure and it can be

regarded as the greatest safety deficiency of RBMK plants at the time of the accident. Its reduction became very important for a further operation of the RBMK plants.

Already a short time after the accident constructive measures were taken to reduce the positive void effect, in particular by additional stationary absorber rods in the reactor core. About 80 of these absorbers were installed per reactor (Fig. 7.1), in some plants even more. The additional absorbers have limited the usability of the fuel, i.e. lowered the fuel burnup achievable. To compensate this effect, the fuel enrichment of uranium 235 was increased, namely from 2.0 to 2.4 % in most plants (Fig. 7-2) leading to a further reduction of the positive void effect. This increase effects a further, though smaller reduction of the positive void effect. The burnt-up fuel elements are continuously replaced by new ones with an enrichment of 2.4 %. This process has not yet been completed in all RBMK plants. In Units 1 and 3 of the Chernobyl Nuclear Power Plant, for example, about 1200 each of the about 1600 fuel elements in the core are loaded with an enrichment of 2.4 %.

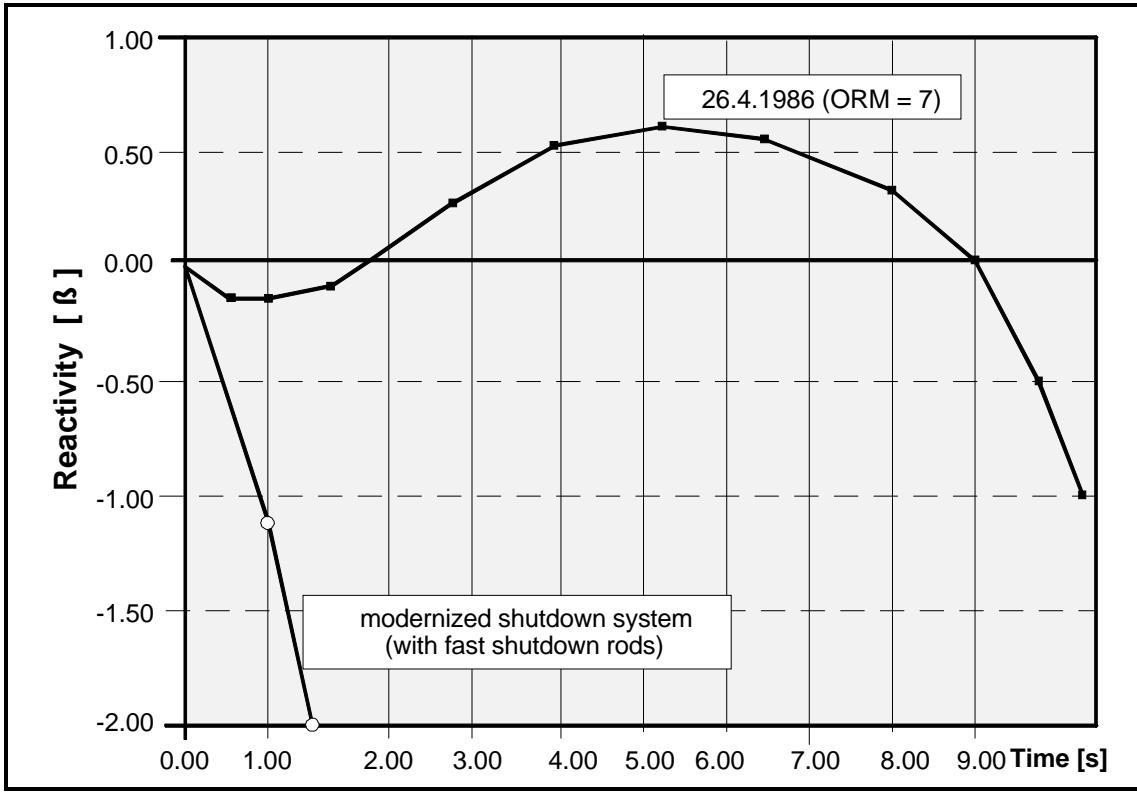
Fig. 7-4 Effectiveness of the shutdown system with respect to reactivity in RBMK plants as a function of time

The following reactivity effects are attained for the shutdown system of RBMK of the second and the third generation with 211 control rods: The reactivity effectiveness of the fast shutdown rods is about 2 ß, while the reactivity effectiveness of all control rods of manual and automatic control amount to about 12 ß. These values refer to a rod-free reactor core. For an ORM of 45 control rods common during power operation, the shutdown reactivity is reduced to about 9 to 10 ß. Upon reactor shutdown all control

rods are actuated simultaneously so that the other control rods drop with the 24 fast shutdown rods which results in a reactivity effectivity of about 1.5 ß/s at the beginning of the fast shutdown.

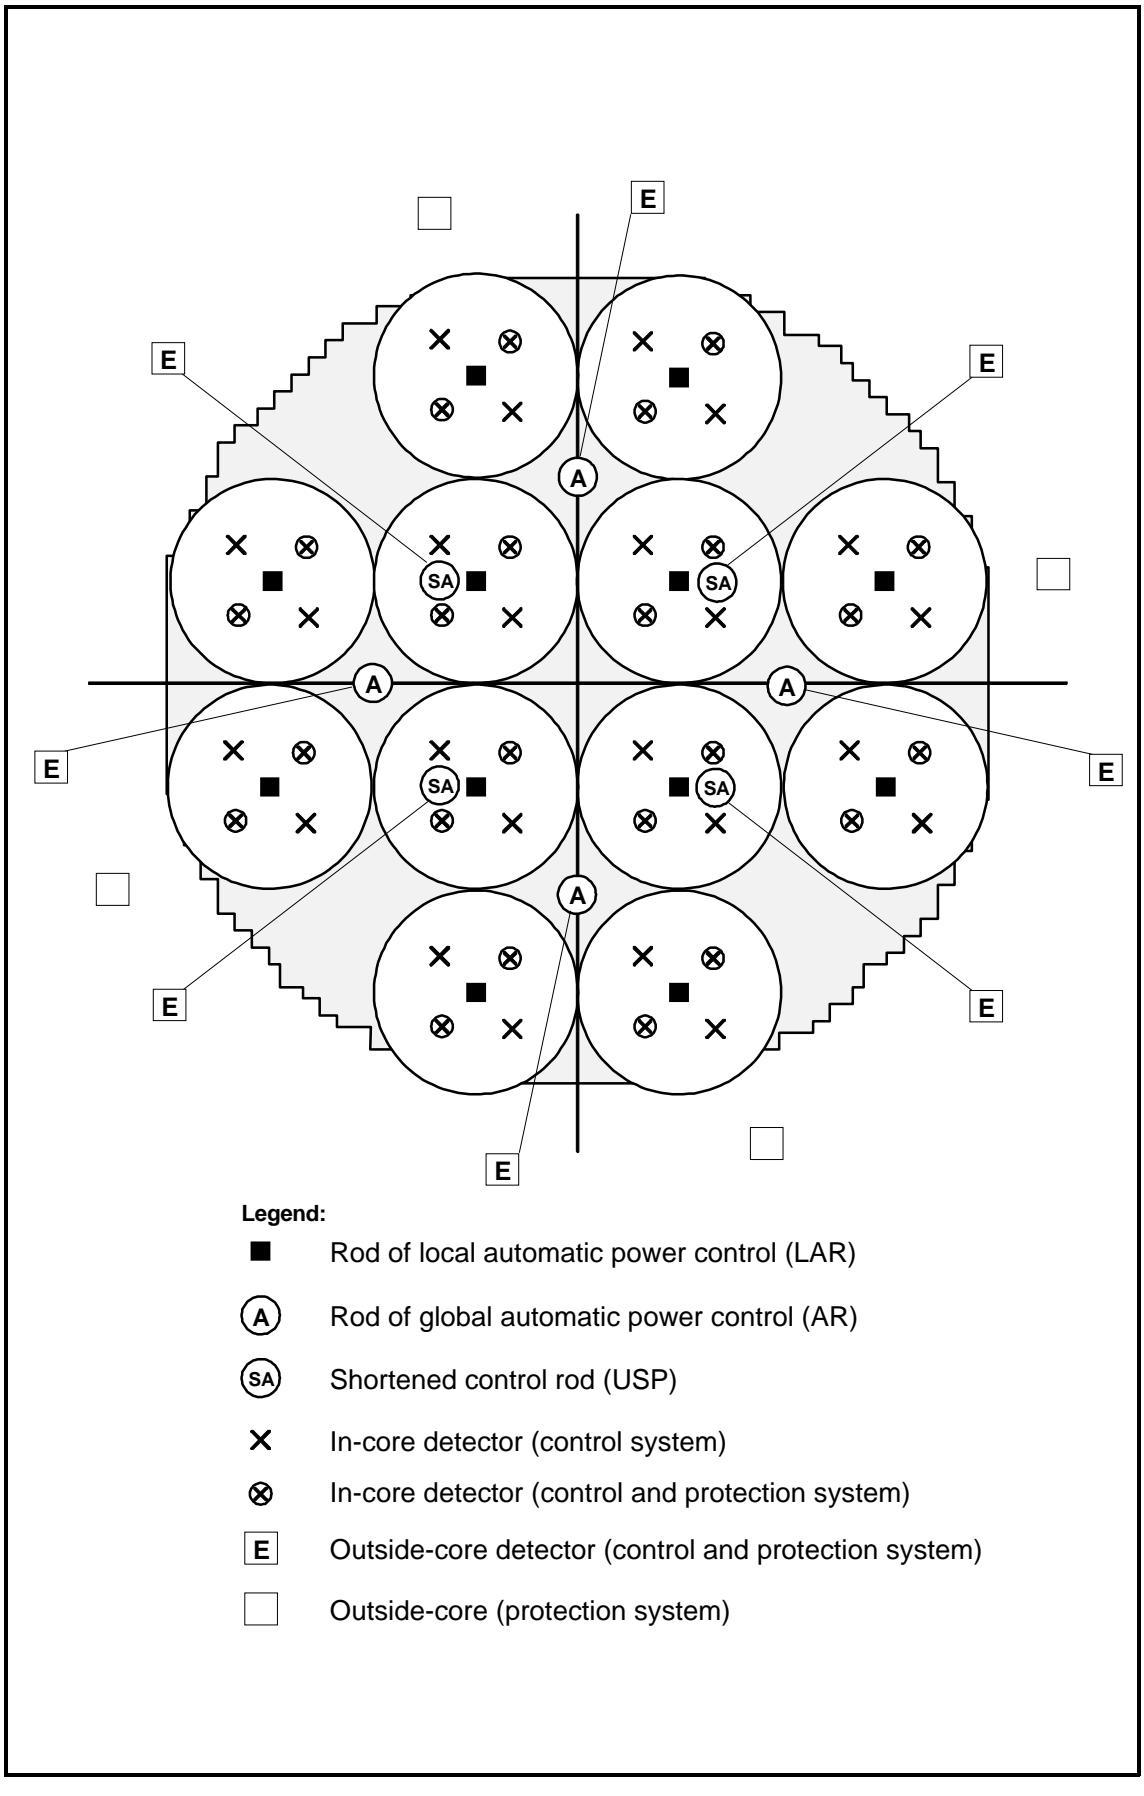
Fig. 7-5 Control and protection system of the Chernobyl-3 plant (12-zone-system)

Local monitoring of the reactor core requires a minimum number of zones to ensure sufficient control of all core areas. The present standard configuration comprises 12 zones (Fig. 7-5) which is considered to be sufficient. Most plants have in the meantime been equipped with this configuration. The remaining plants shall be backfitted with it. Chernobyl-1 is still equipped with the inadequate 7-zone system.

The radial and axial power distribution in the reactor core is recorded and analysed by an on-line computer (SKALA). First improvements have been carried out in all SKALA systems. Instead of the past maximum of every 30 minutes, the core condition is now displayed in intervals of five minutes. This also applies to the ORM value. But these

measures do not suffice yet. The SKALA system is outdated and its capacity is too restricted. Here further improvements are necessary and possible, as the concepts for modernizing Leningrad-1 and -2 show.

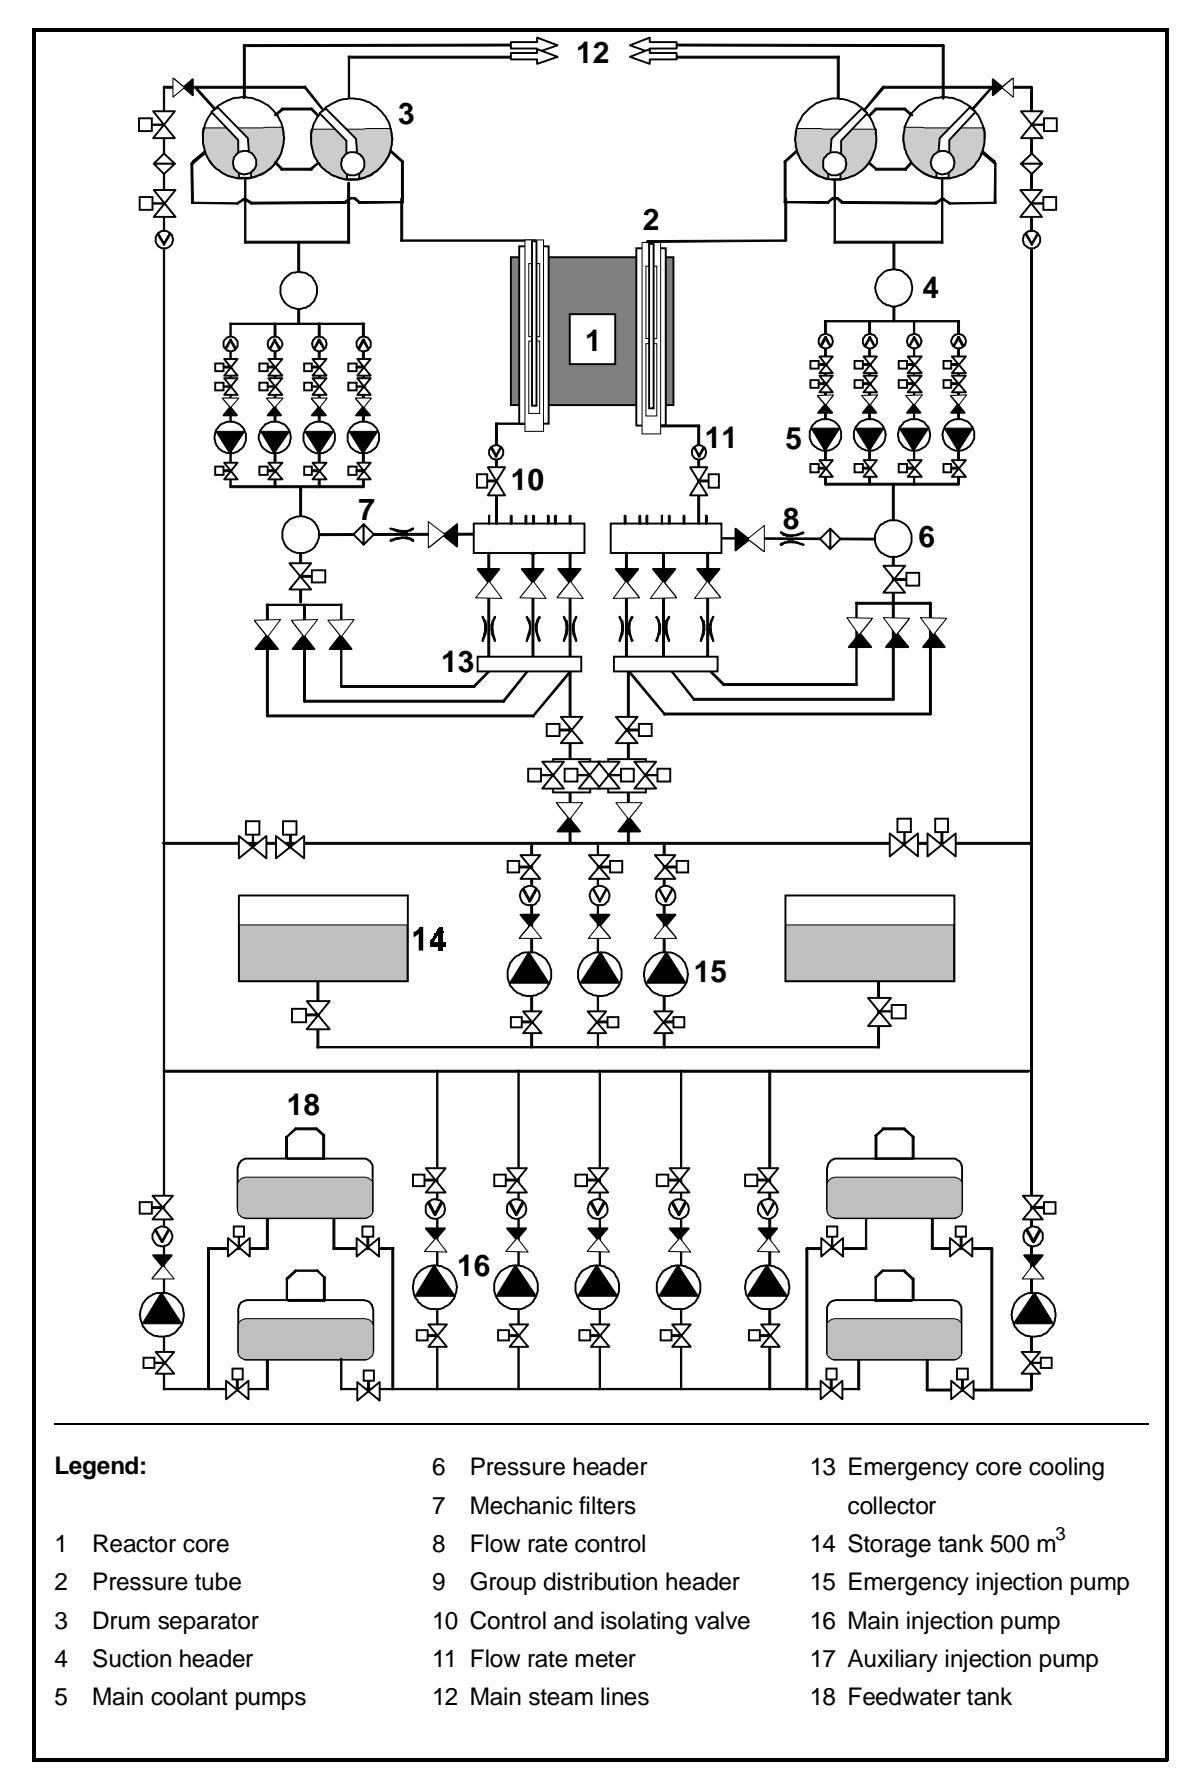
Fig. 7-6Emergency core cooling system of the first generation with backfittings
(Unit 1 and 2 of the Leningrad Nuclear Power Plant)

The emergency core cooling systems of RBMK plants are structured in different ways (see Section 1.4.4 and Fig. 1-18 as well as 1-19). The first generation does not possess an independent emergency core cooling system. The emergency feedwater supply system is used for core cooling. The deficiencies of the emergency feedwater supply

system thus also fully apply to emergency core cooling. It is urgently required to upgrade the emergency core cooling function in plants belonging to the first generation .

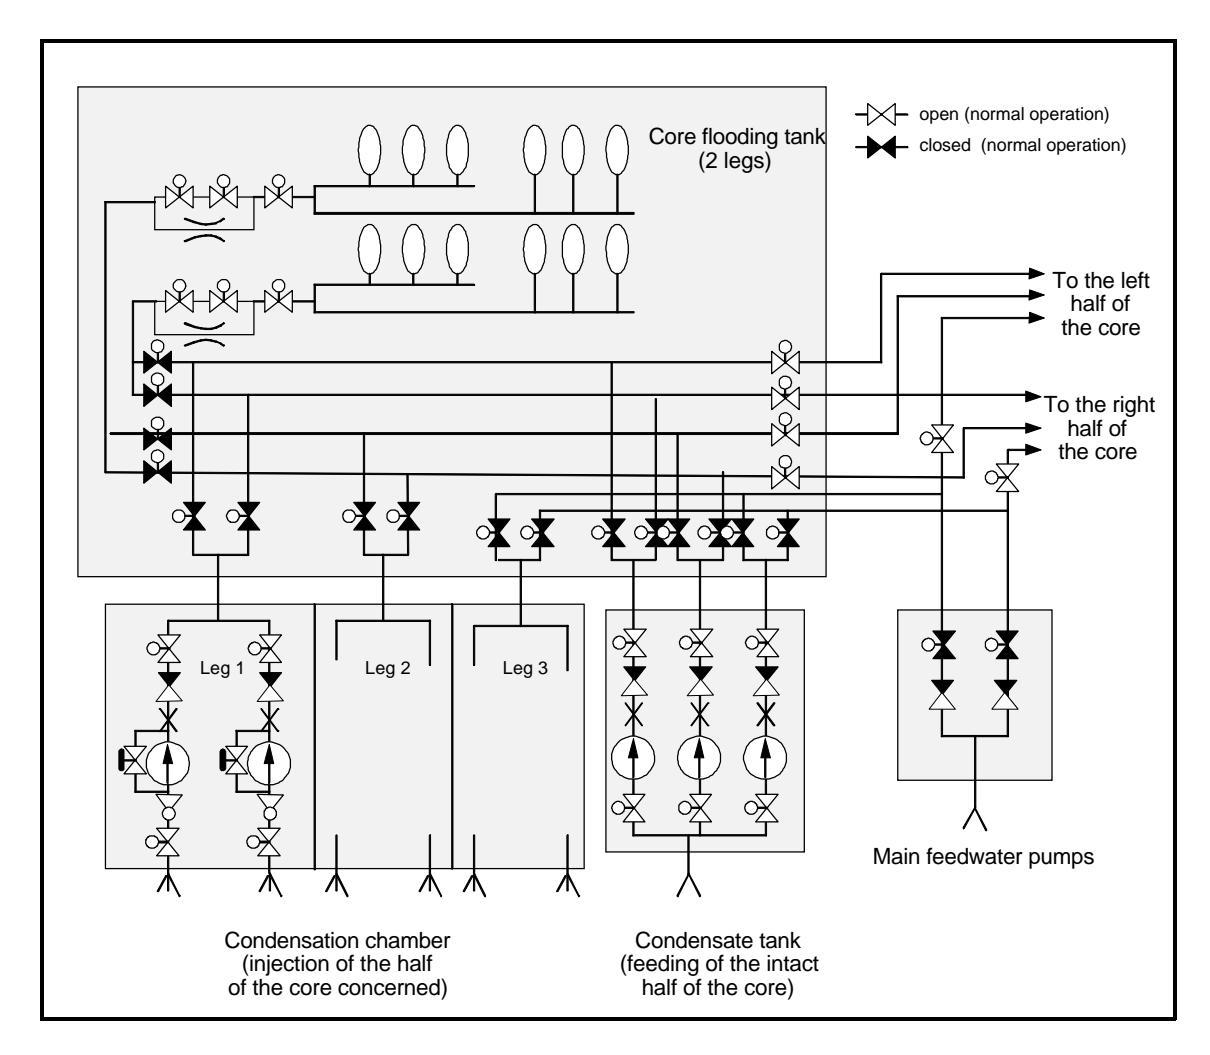
Fig. 7-7 Subsystems of the emergency core cooling system at Smolensk-3

The safety systems relating to core cooling of RBMK plants belonging to the first generation show substantial deficiencies. The emergency feedwater supply system over large areas is not redundant and not designed against spreading impacts, like fire or flooding. The plants of the first generation further do not comprise an independent emergency core cooling system. Comprehensive upgradings, like the ones currently

carried out at Leningrad-1 and -2, for example, are urgently required here to achieve a sufficient level of reliability.

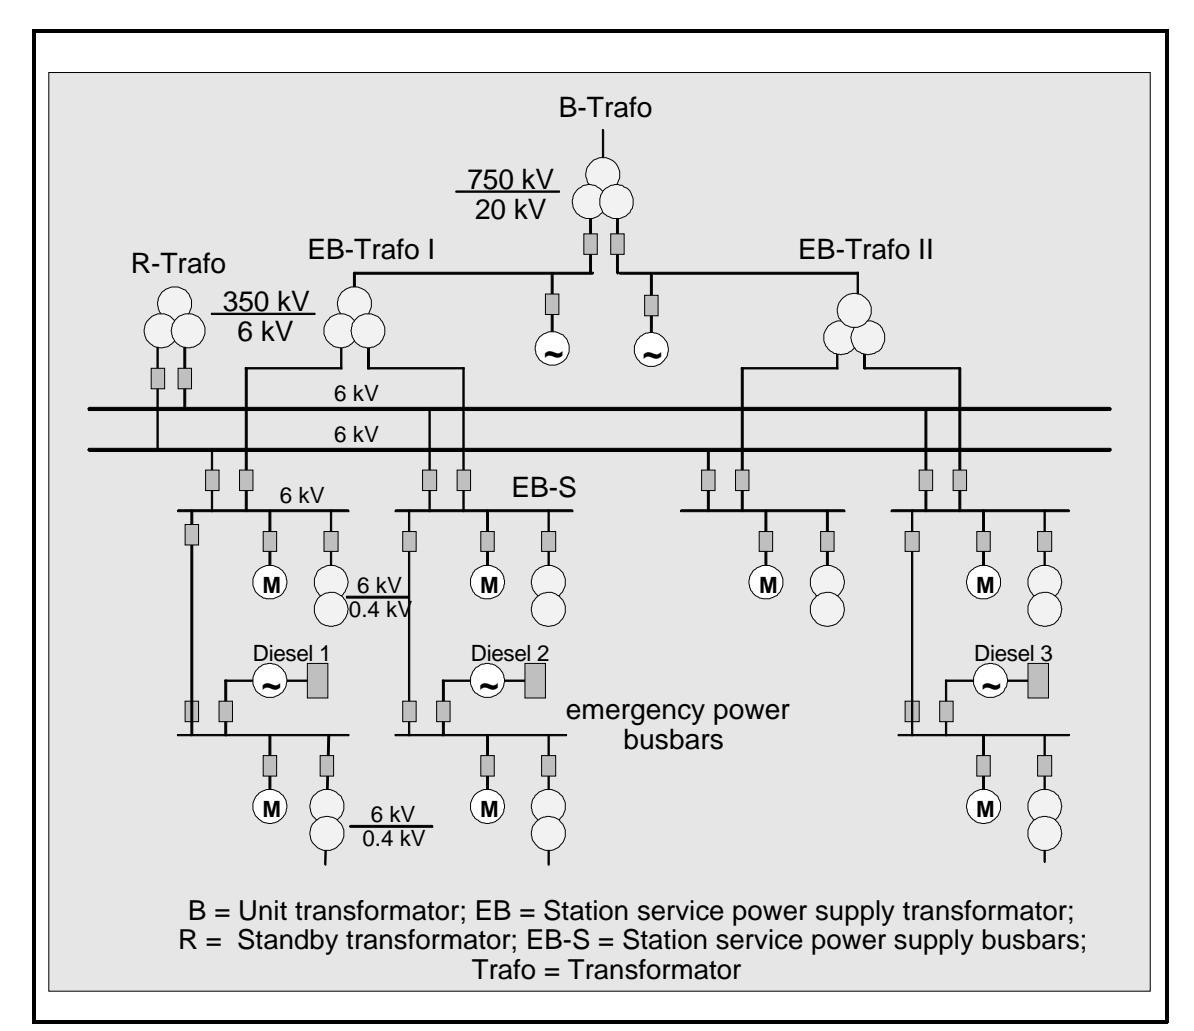
Fig. 7-10 Block diagram of the station service power supply and emergency power supply of the Chernobyl-4 plant

In the meantime improvements have been carried out in the field of instrumentation and control. Thus the safety instrumentation at Leningrad-2, for example, was exchanged completely. But in other plants only selective backfitting measures have been taken.

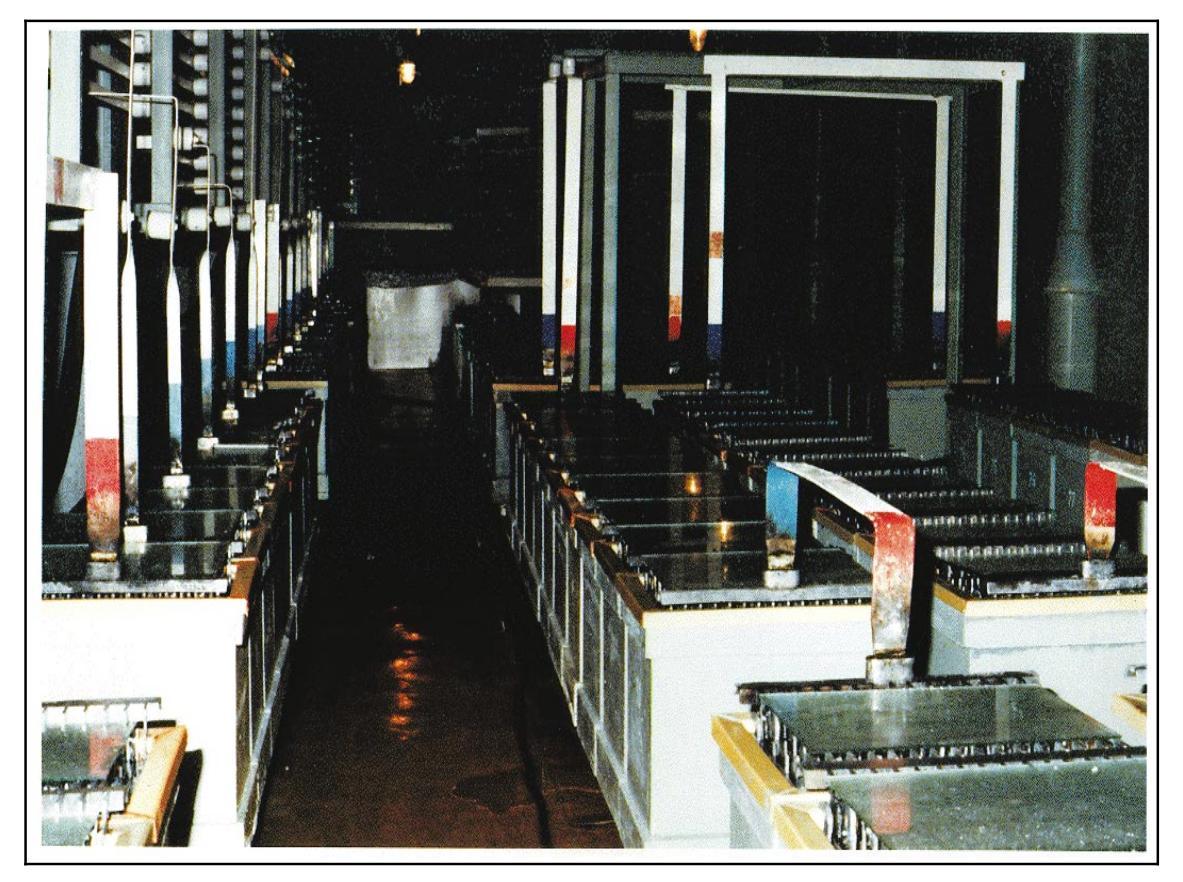
Fig. 7-11 Battery plant of the emergency power supply (example: RBMK-1500 at Ignalina, Lithuania)

In accordance with the great importance of fire protection, numerous backfitting measures have been carried out. These, for example, comprise the use of fire-resistant paints, fire-proof doors, protection doors, fire-resistant cables as well as the introduction of a spatial or fire-protective separation of the safety and auxiliary system, respectively. The present status of fire protection still continues to be regarded as being unsatisfactory.

Further upgradings are necessary. This applies to the 1st generation to a much greater extent than to the second and third generation. A fire protection concept is required which provides for fire prevention, reporting, extinction of fires, the limitation of fire loads

as well as the restriction of the effects of fires as prime elements of fire protection before fire fighting by plant fire brigades. In addition thereto, systematic fire hazard analyses, e.g. for cable routings, are to be carried out to identify local or fire protective weaknesses.

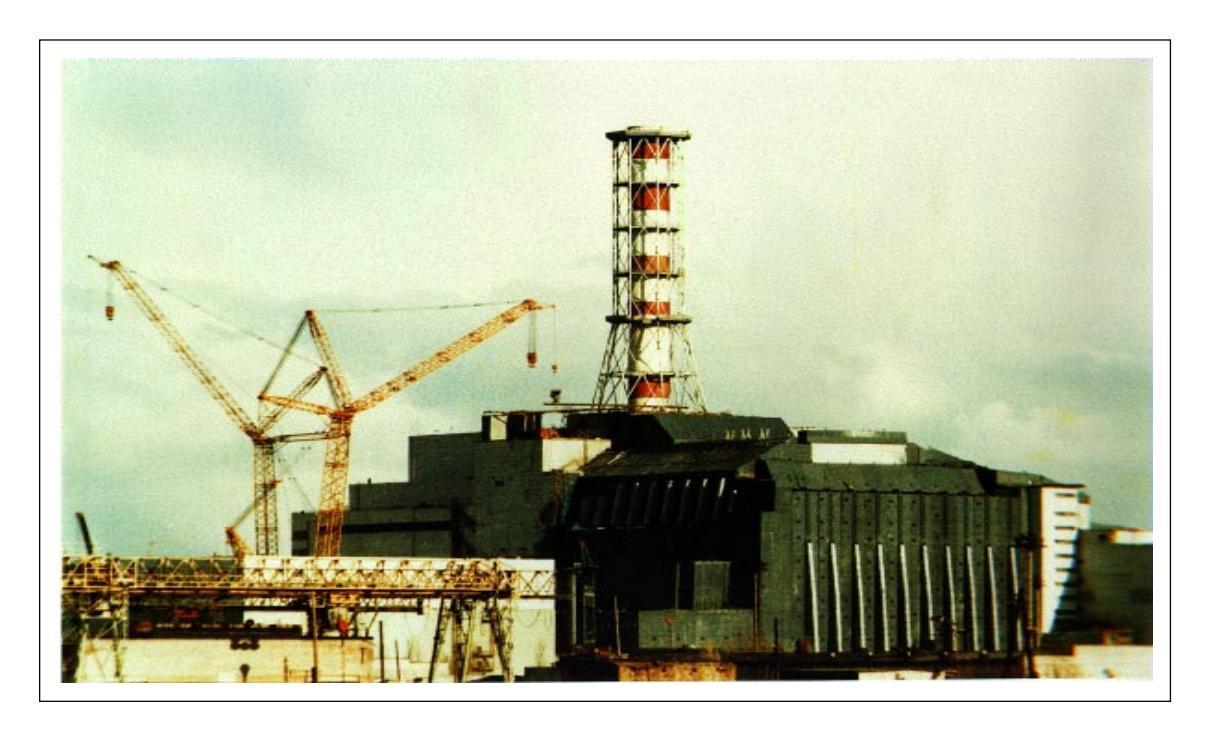
Fig. 10-2 The Sarcophagus

The sarcophagus hurruiedly built around the destroyed reactor has fulfilled its protective function during the last ten years. In the longterm its retaining power and stability is, however, questionable. Internal or external loads could lead to damages or even a col-

lapse of the sarcophagus and thus to a release of radioactive substances into the closer surrounding. The staff on the site, for example the operating staff of Unit 3 would be endangered. Wide-spread effects are, however, not to be expected. The new town of Slavutich which was build for the operating staff about 50 km east of the site, would practically not be affected.

Within the framework of an overall concept which, among other things, means that the destroyed reactor is permanently secured and that the site is reconstructed, realistic targets have to be developed which take into account the radiological conditions on the site and the priorities of the safety and disposal functions. The concept has to be implemented step-by-step. The suggested construction of a second enclosure which is to enclose the existing sarcophagus has to be examined within the framework of such an overall concept.

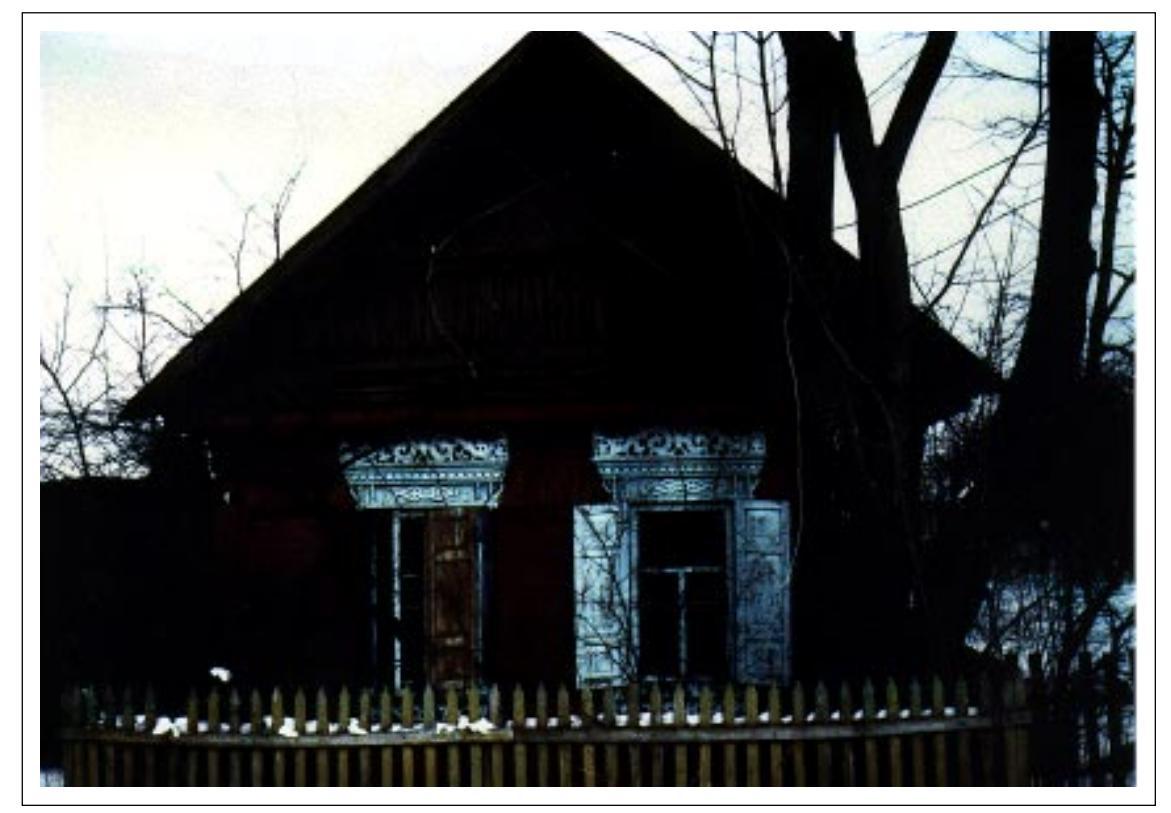
Fig. 10-3 Deserted Ukrainian farmhouse

About 10 000 km², 7 000 thereof in Belorussia, 2 000 in the Russian Federation and 1 000 in the Ukraine are prohibited because of the high contamination, above all by caesium 137. About 116 000 persons were resettled from these areas. They will remain inaccessible for many further decades. Contamination and radiation rates are quite detailed known by measurements. There is a regionally, even locally, complex picture with very different levels of contamination. Many of the almost 400 000 people who left their homes could return. Today about 273 000 people live in areas with increased contamination which is, however, not directly endangering health. The annual radiation dose is about five times as high as the natural level. As this radiation exposure mainly results from the consumption of contaminated food, the supply of the population concerned with sufficient, uncontaminated food is preeminent. The uncontrolled

return of the population into highly contaminated areas represents a special problem. Thus, about 2 000 people have returned to the 30 km zone. A few areas subsequently turned out to be highly contaminated. Some further 10 000 people would have to be resettled from these areas.
