Gesellschaft für
Reaktorsicherheit (GRS) mbH

Safety Assessment of the Nuclear Power Plant Greifswald, Units 1 to 4

A Documentation of Hitherto Existing Investigations
made by GRS

GRS-78 (February 1991)
ISBN 3 - 923875 - 28 - 2

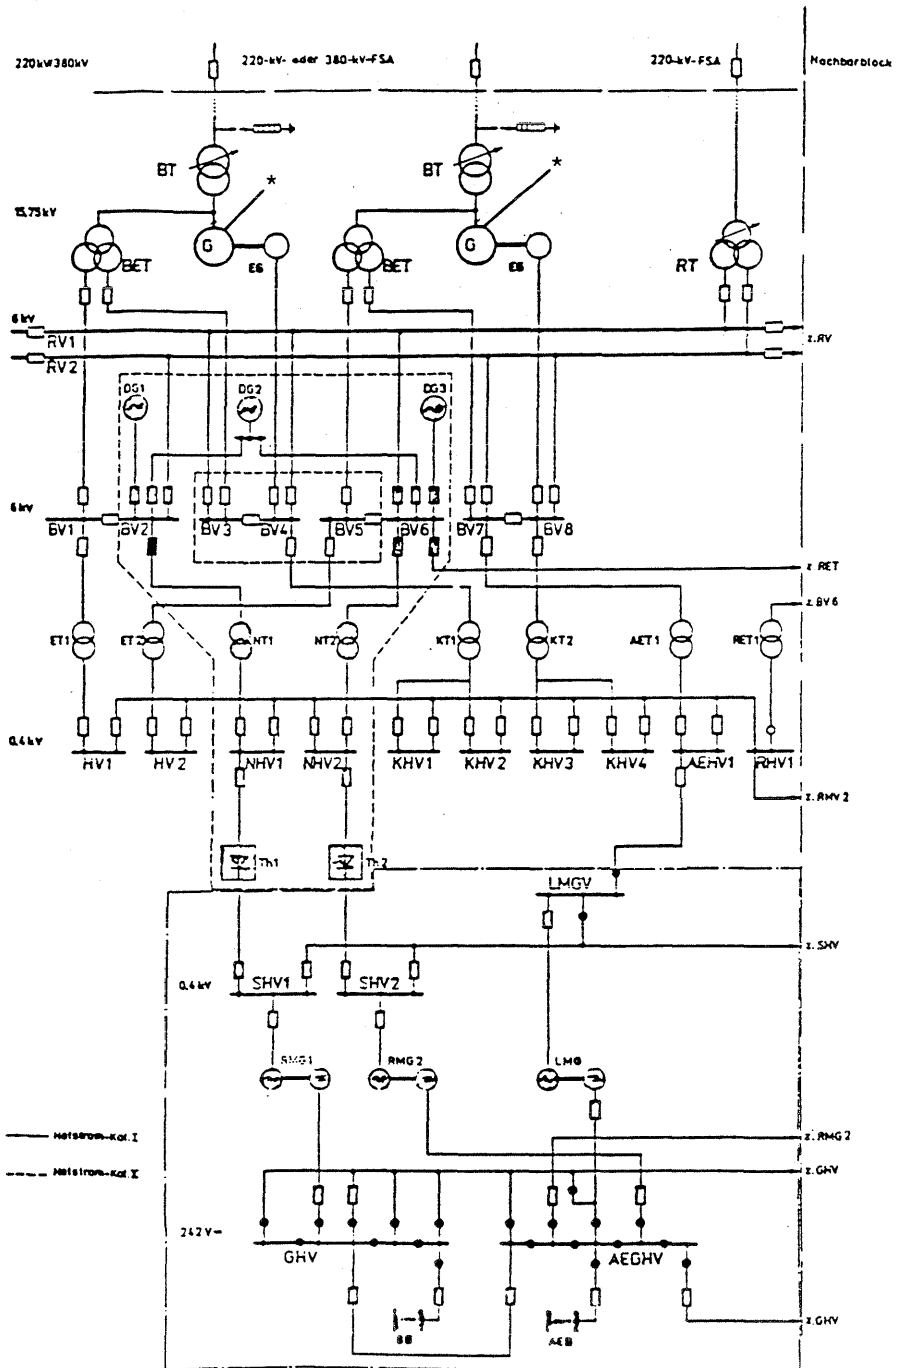
Fig. 2-4: Overview diagram of the electrical installation of the 440 MW-unit, North I-II.

In figure 2-4, the positions of the switches for the conduct from the generator to the transformer of the unit should be indicated. For the given position, the rest energy of the main generator may not be utilised, what contradicts the concept of the project.

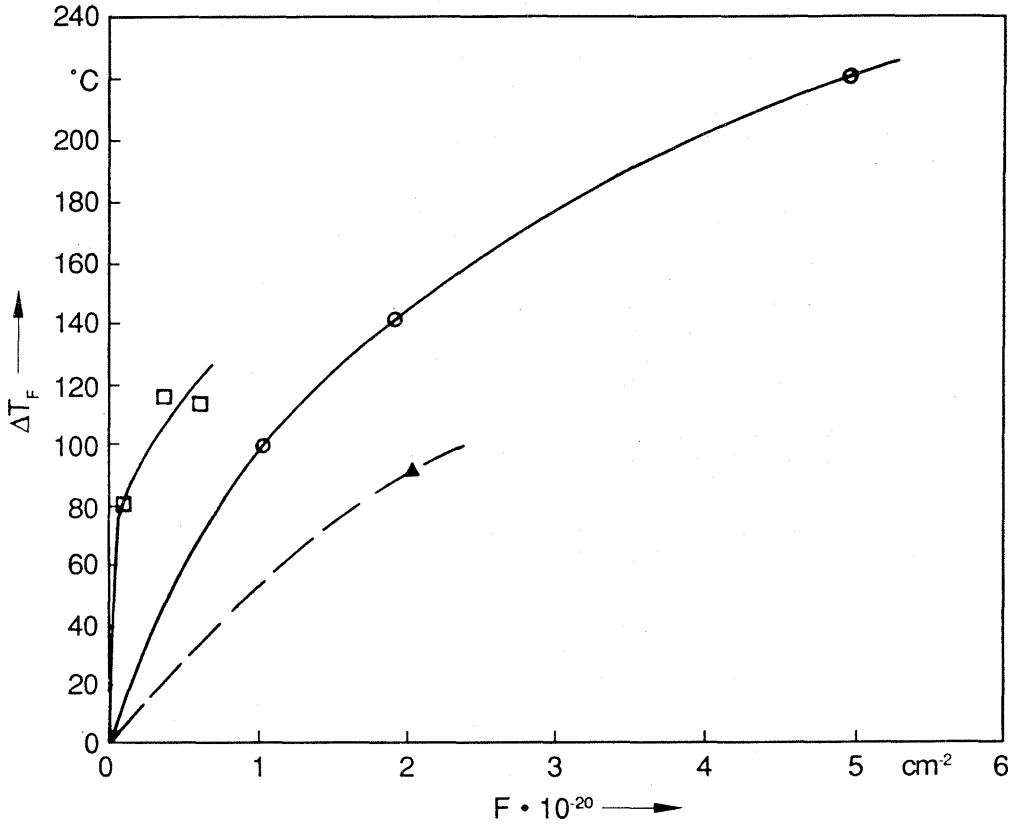
Fig. 3-3: Irradiation embrittlement of weld material for an environmental temperature of 270°C

the temperature shift due to an effect of flux density, cf. figure 3-3, must be checked whether they can be considered valid for the actual case.

Figure 3-3 is to be replaced by figure 1 in the annex "Reason of the influence of the neutron flux density on the resistance against embrittlement."

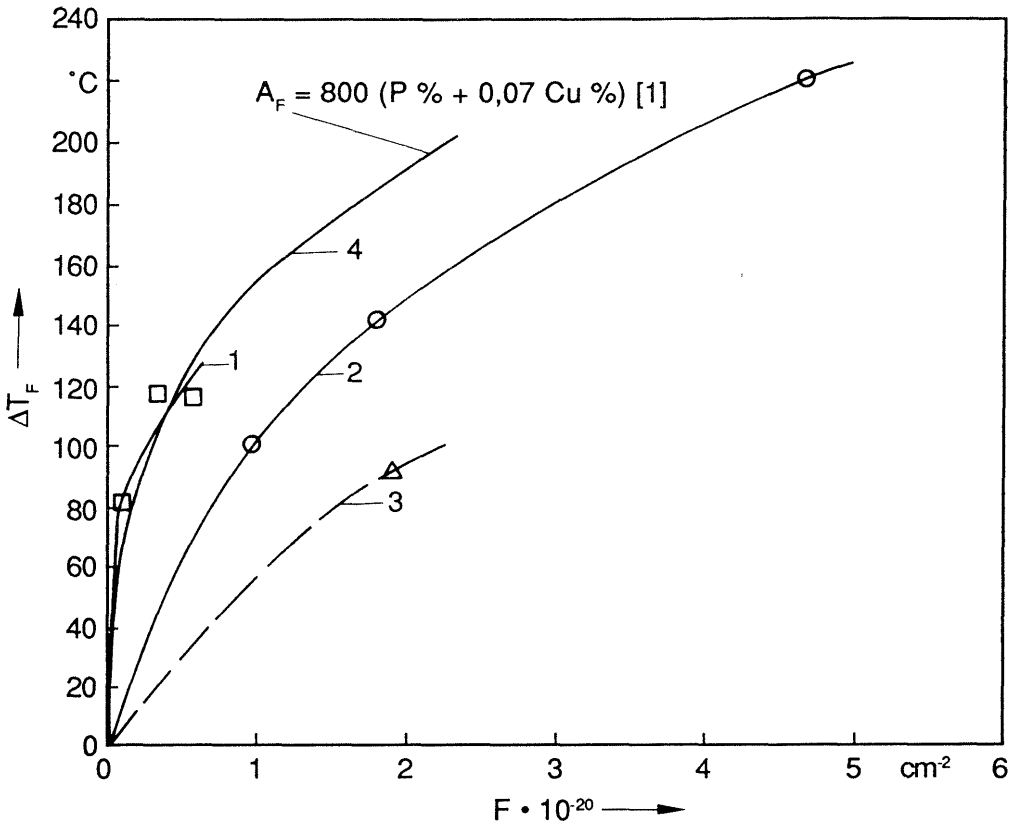
Fig. 1: Irradiation embrittlement of the weld metal, irradiated at a temperature of 270°

Recently test results were obtained from samples which had been irradiated in unit 1 of NPP Rovensk with shielding boxes at reduced neutron flux density (cf. figure 1).

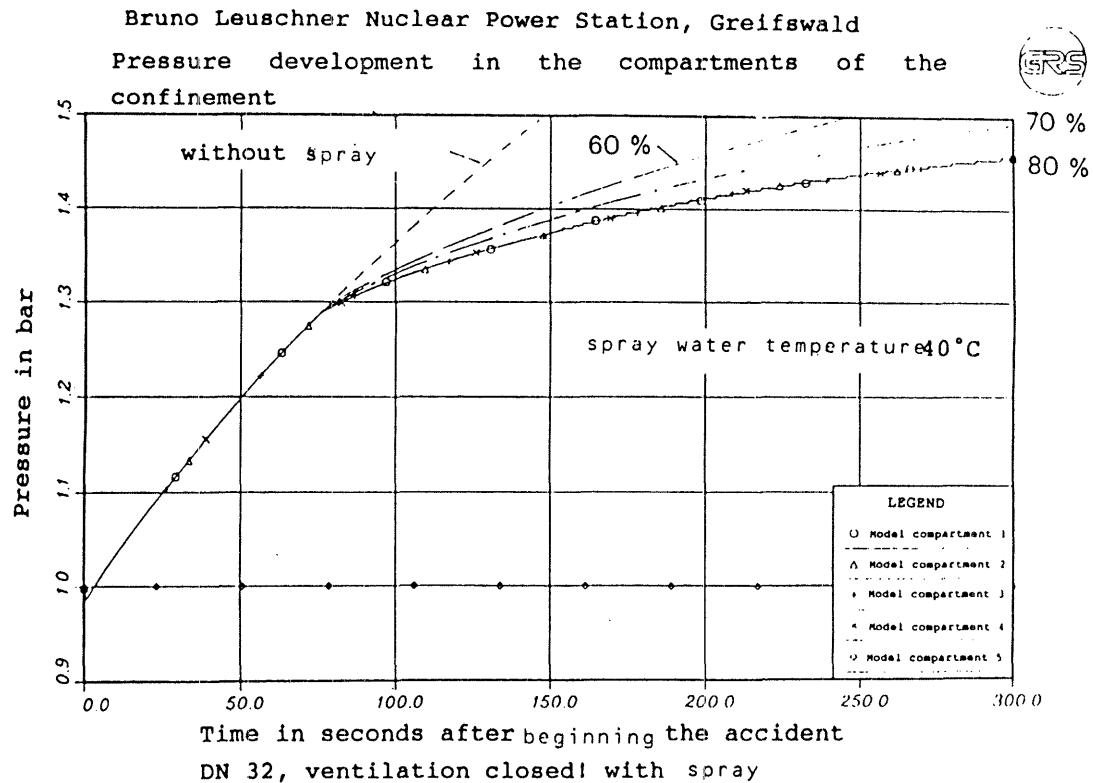
Fig. 6-1
Effect of the spray efficiency

The results of these calculations are shown in Fig. 6-1 for the influence of the spray efficiency and in Fig. 6-2 for the effect of the spray temperature on the pressure within the pressure resistant compartment system.

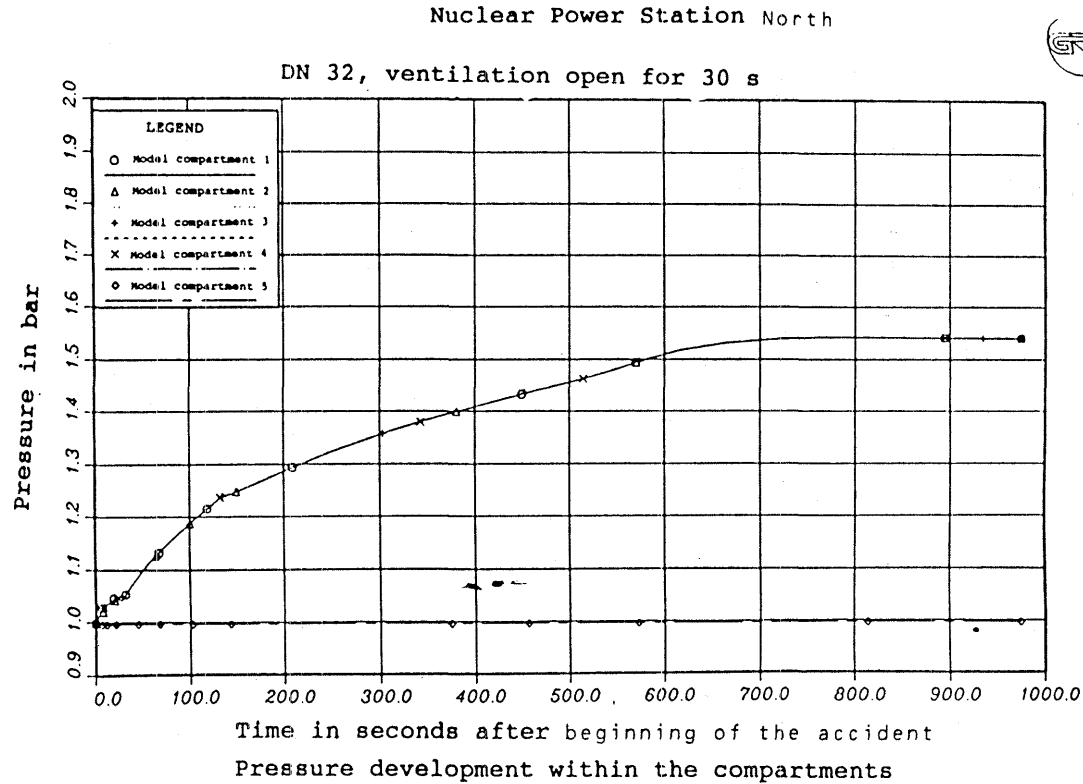
Fig. 6-4:
RALOC computation with only one spray cooler

If only one spray water cooler is available, the spray water flow rate is reduced from 155.5 to 145.6 kg/sec, and the spray water is increased from 40°C to 50°C. In this case (Fig. 6-4) the pressure within the pressure resistant compartment system remains below the operating pressure of the dampers. The removal of heat into the structures was taken into consideration here (see the lower curve in Fig. 6-3).

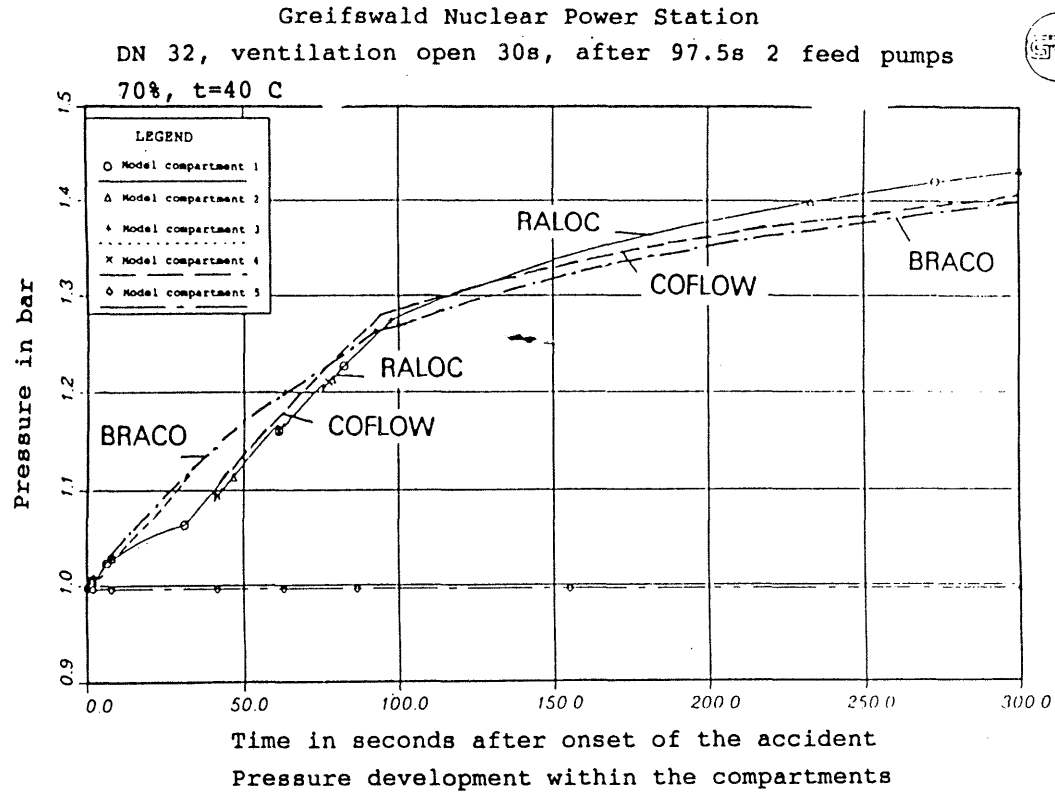
Fig. 6-5:
Program comparison between RALOC, COFLOW and BRACO

/6/ shows for the design basis accident a pressure development which was determined by the program BRACO (see annex 2). Comparative calculations using the programs RALOC and COFLOW show good agreement with the BRACO result under identical boundary conditions (see Fig. 6-5). In the calculations, different times for the spray system to become effective (without total loss of power) were assumed as a function of reaching the initiation criterion for the spray system (1.2 bar and 25 sec running time for filling the pipes). The analyses show that under realistic conditions in the case of the design basis accident (leakage equivalent to nominal diameter 32) the pressure relief dampers of the pressure resistant compartment system do not respond.
