Information on the earthquake in Japan on 11 March 2011

Compilation by GRS

Updated compilation of information

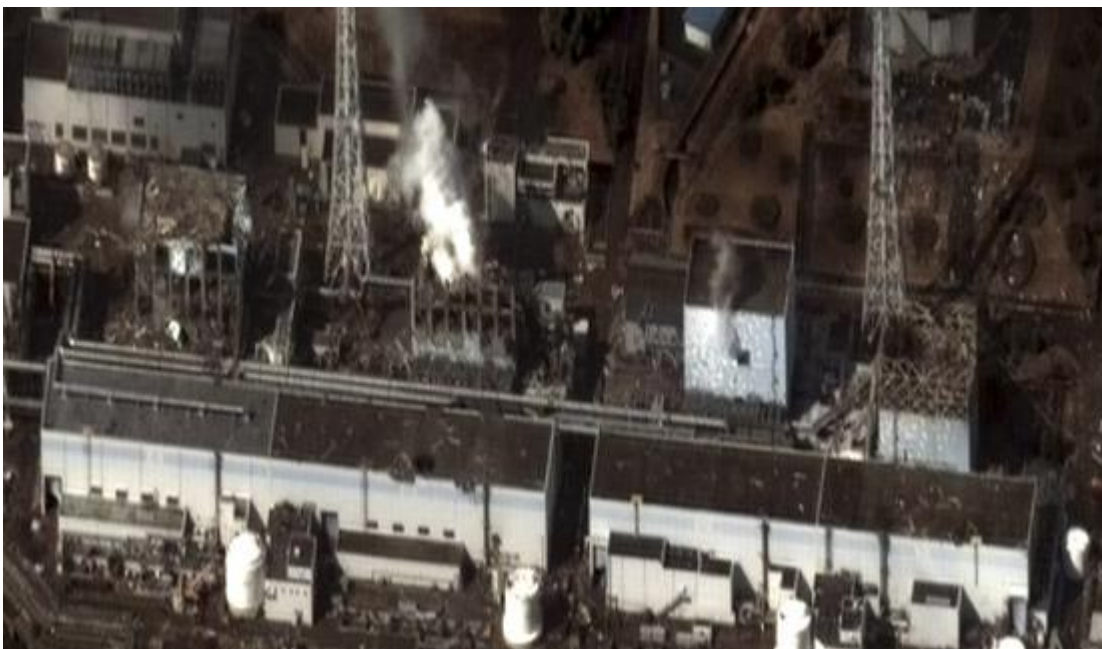
On a photo of Unit 4 published by TEPCO, a hole in the outer wall of the reactor building is visible, measuring approx. 8 m². The outer shell of the reactor building facing Unit 3 is damaged severely, also near the ground. The roof of the reactor hall is damaged. According to JAIF (12:30 h), the reactor building is also damaged.

Photo of the Fukushima Daiichi plant, Units 1-4 (from right to left) of 16-03-2011
